REPORT OF INVESTIGATION

Fatal Powered Haulage Accident
July 11, 2011

Voyager #7
Martin County Coal
Inez, Martin County, Kentucky
ID No. 15-19193

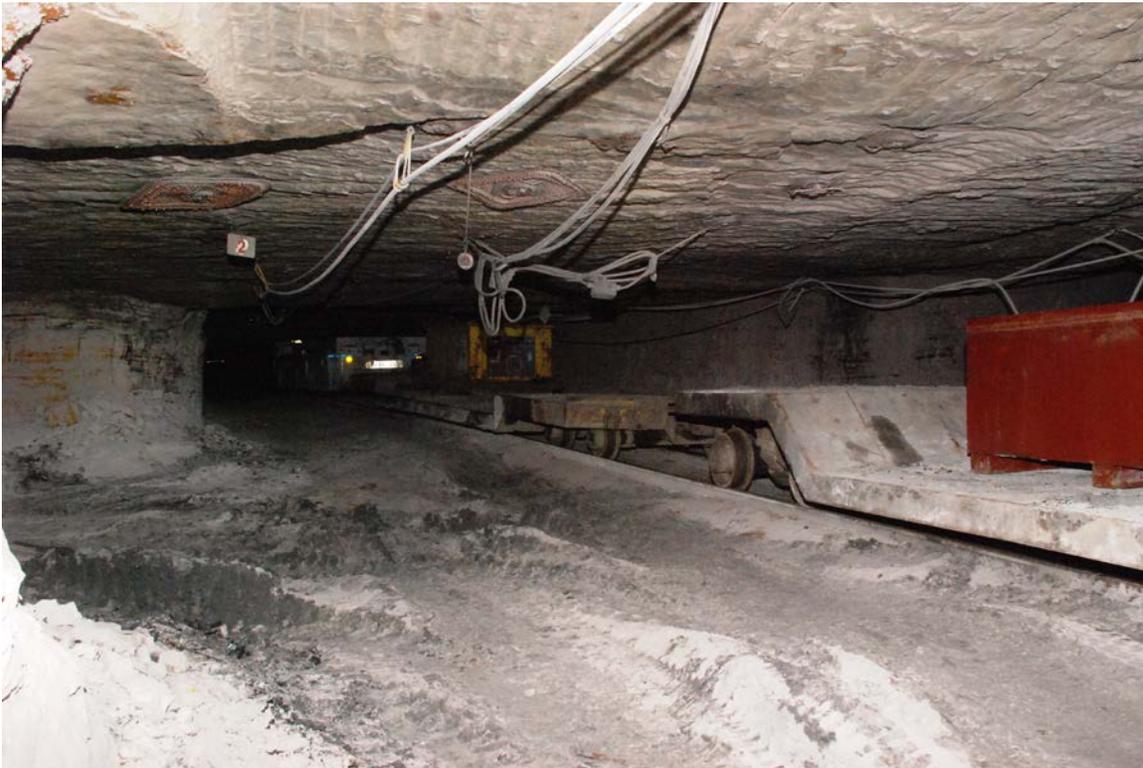
The "tram-box" and tool chest were taken underground using two flatcars. This was a violation of a previously issued Safeguard, dated December 10, 2008 which limits the number of flatcars being pushed to one.

Thatcher loaded the tram-box onto the first flatcar. The tram-box was needed on the 001-0 MMU or #1 Section to aid in tramming the continuous mining machine to the next panel. He then loaded May's tool chest onto the second flatcar and proceeded underground via the track travel way at approximately 6:30 p.m.
