REPORT OF INVESTIGATION

Fatal Rib Fall Accident
March 16, 2015

Deep Mine 41

Paramont Coal Company Virginia, LLC
McClure, Dickenson County, Virginia
ID No. 44-07223

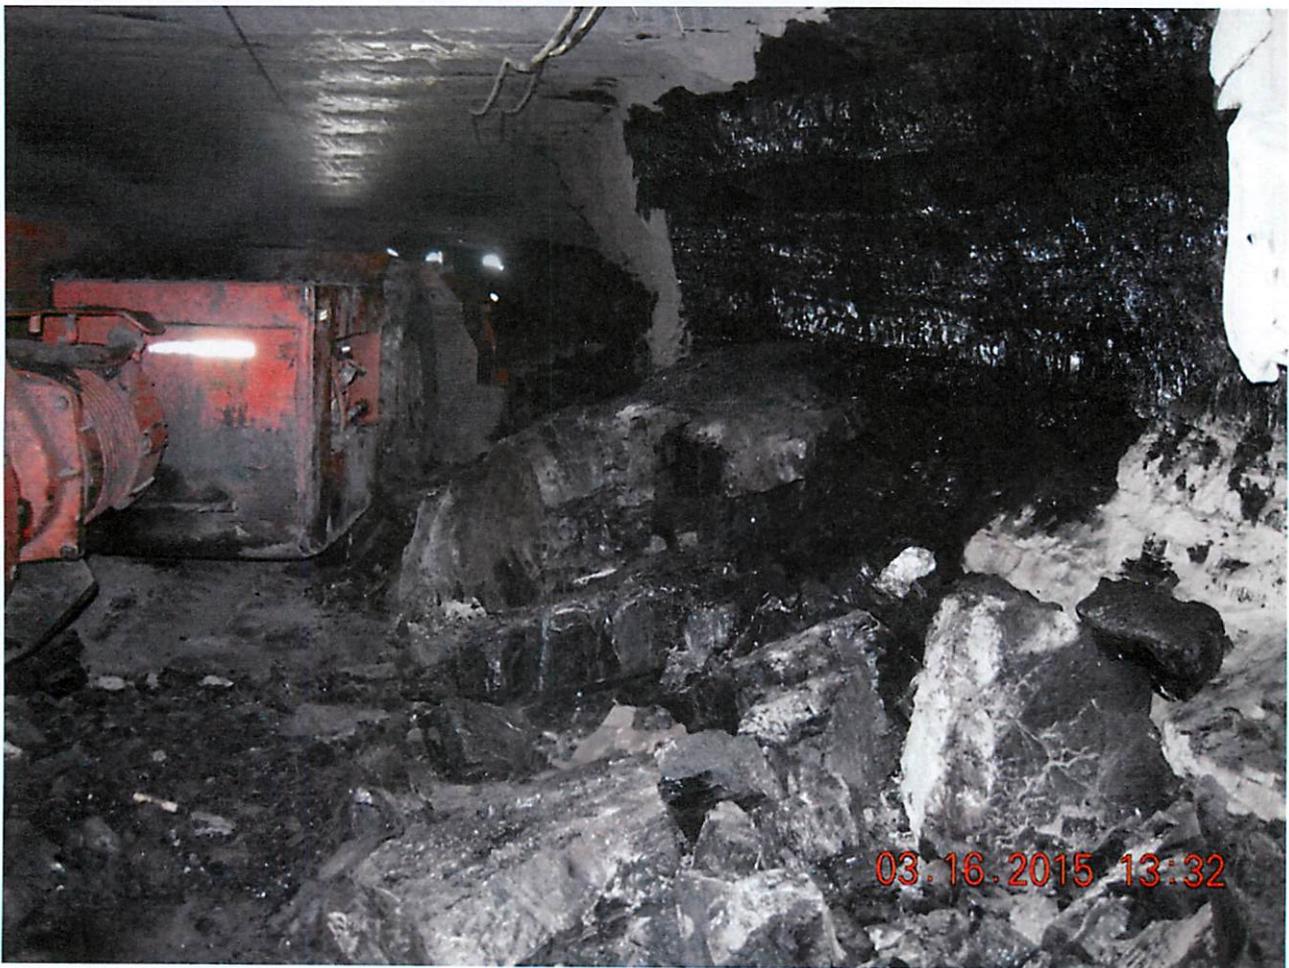
At approximately 5:00 a.m. on Monday, March 16, 2015, Section Foreman/Mine Examiner, David William Brummitte (Victim) was fatally injured while conducting a pre-shift examination. The victim was last seen performing the preshift examination duties on the 003-0 Mechanized Mining Unit (MMU) before being found trapped between fallen rib material and the frame of a shuttle car.

The accident occurred because the mine operator failed to support and/or control the mine ribs where miners are required to work or travel.
