**Internal Review of MSHA's  
Actions at the Upper Big Branch Mine-South  
Performance Coal Company  
Montcoal, Raleigh County, West Virginia**

U.S. Department of Labor  
Mine Safety and Health Administration  
Program Evaluation and Information Resources

March 6, 2012

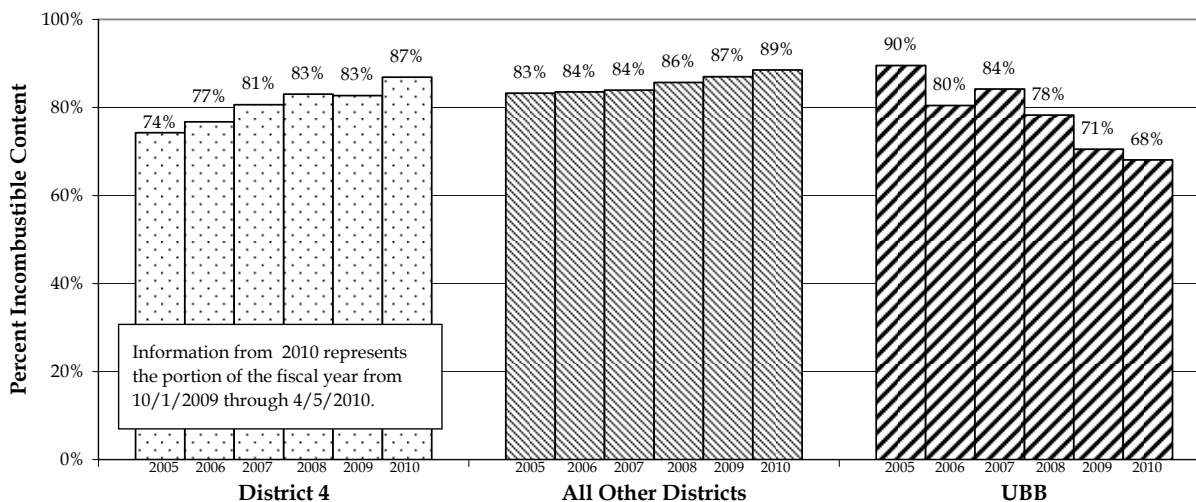
**Figure 10 - Average Incombustible Content of Rock Dust Survey Samples by Fiscal Year**

To measure the effect of increased sampling and enforcement on actual mine conditions, the average incombustible content (% IC) of survey samples were plotted over time. As shown in Figure 10, this value trended upward, both nationally and in District 4, which indicated that most operators increased their rock dust application rates each year during this period. However, the average % IC of rock dust samples declined at UBB from 90% in fiscal 2005 to 68% during the first two quarters of fiscal 2010.

Nationally, prior to the explosion, samples collected during compliant surveys averaged 91% IC and the non-compliant surveys averaged 77% IC. The % IC at UBB during fiscal years 2009 and 2010 averaged well below levels expected to result in compliant surveys.

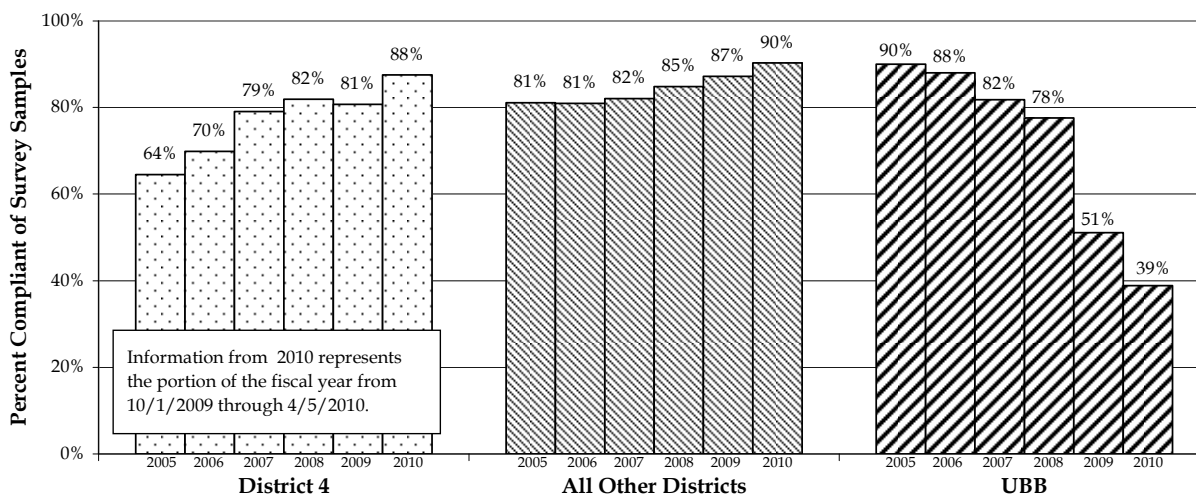
**Figure 11 - Percent Compliant Rock Dust Survey Samples by Fiscal Year**

Trends in rock dust application correlated to that of individual rock dust sample compliance. As shown in Figure 11, the percentage of compliant rock dust samples collected during surveys increased both

nationally and in District 4. However, the percentage of compliant samples at UBB dropped from 90% to 39% during fiscals 2005 to 2010.

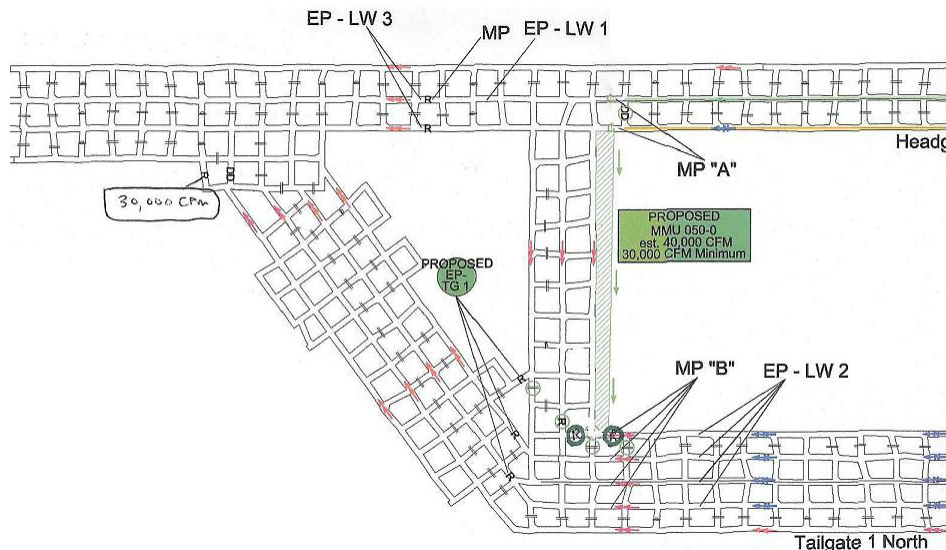
**Figure 15 - Original evaluation point locations approved September 11, 2009, in mine ventilation plan**

Before the 1 North Longwall started production, the Operator submitted a method to evaluate the bleeder system for the longwall panel in a ventilation plan supplement approved by the District 4 Manager on August 6, 2009. The supplement was later incorporated into a new base ventilation plan approved on September 11, 2009. The approval included a mine map with the evaluation points (EPs) identified. A section of that map is shown in Figure 15.

Inlet and outlet evaluation points established by the Operator for the system were identified in the approved base ventilation plan. The No. 1 entry of the 1 North Longwall tailgate and the No. 3 entry of the longwall headgate were maintained as isolated development section returns. Air flow into the worked-out area from these splits was limited to leakage. Therefore the initial evaluation points established did not need to account for airflow in these air courses.

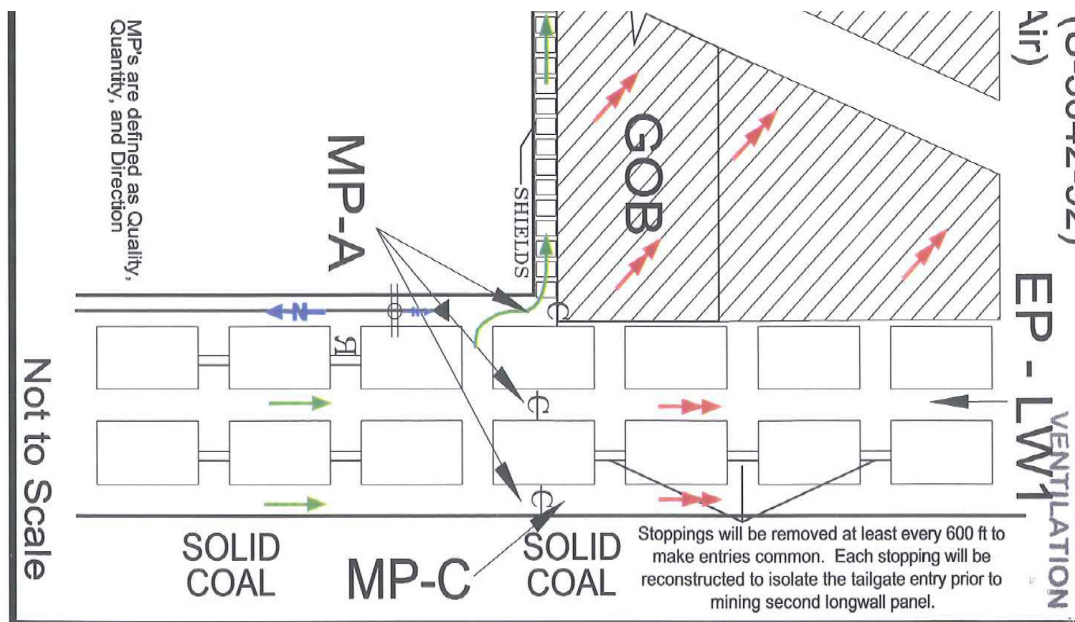
**Figure 16 - Portion of drawing from ventilation plan supplement approved December 18, 2009**

The Operator submitted a ventilation plan supplement on December 14, 2009, that provided for stoppings to be removed at intervals of at least every 600 feet between the No. 3 and No. 2 longwall Headgate entries. As a result, the No. 3 and No. 2 longwall headgate entries became common, with the No. 3 entry becoming part of the worked-out area. The supplement specified these stoppings would be reconstructed to isolate the future tailgate entry prior to mining the adjacent longwall panel. The supplement also established an additional measuring point where intake air entered the worked out area in the No. 3 entry of the headgate, identified as MP-C in Figure 16.

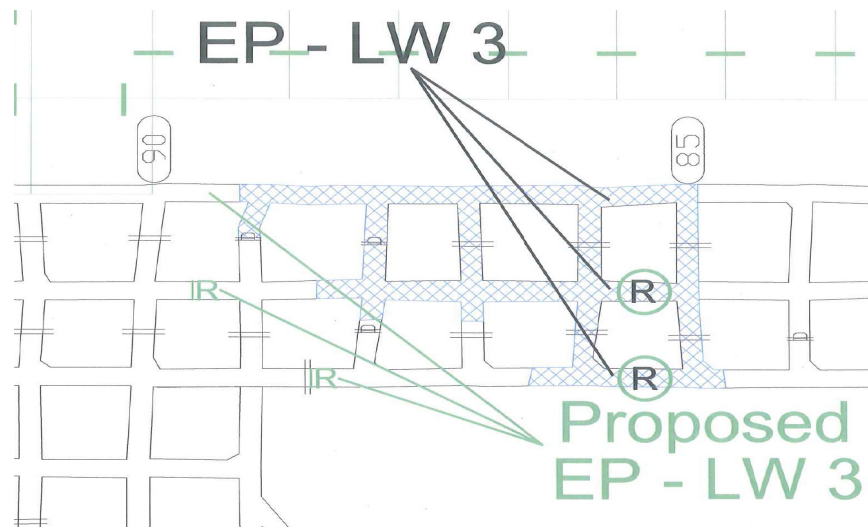
**Figure 17 - Drawing of evaluation points from supplement approved February 22, 2010**

In addition, an evaluation point was established in the No. 3 entry at EP-LW3 behind the longwall panel. This EP was needed since air was exiting the worked-out area at this location, and would have been necessary to properly evaluate the bleeder system. In a ventilation plan supplement approved on February 22, 2010, this EP was relocated from crosscut 85 to crosscut 90 due to a water accumulation. (See Figure 17.)

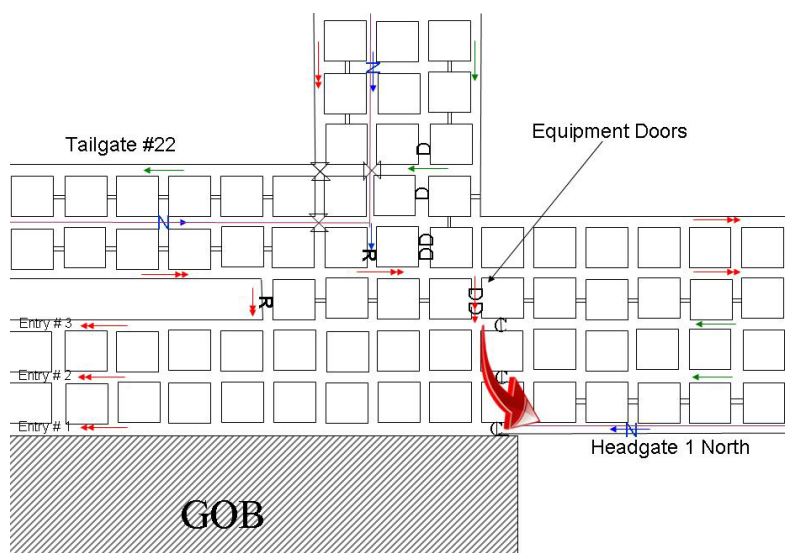
**Figure 21 - Latest Headgate Ventilation Design**

The MSHA Accident Investigation team found that open equipment doors at key locations would not have caused a dramatic decrease in the intake air quantity for the 1 North Longwall. However, some reductions on the Headgate #22 and Tailgate #22 development sections were possible when equipment doors installed on the longwall intake were opened. The Accident Investigation team also found that return air from the development sections could be routed to the longwall face when equipment doors between the No. 3 entry of the longwall headgate and the No. 1 entry of Tailgate #22 were left open (see Figure 21). The Accident Investigation team determined through interviews with miners that there was at least one occasion when this occurred.

**Conclusion:** Mine design and plans incorporating equipment doors in critical areas often create a ventilation system too fragile to maintain an acceptable degree of safety for miners. Currently, regulations address the use of equipment doors to separate air courses in lieu of stoppings. However, the proper installation, operation, and maintenance of equipment doors are critical for maintaining a safe and effectively ventilated mine.

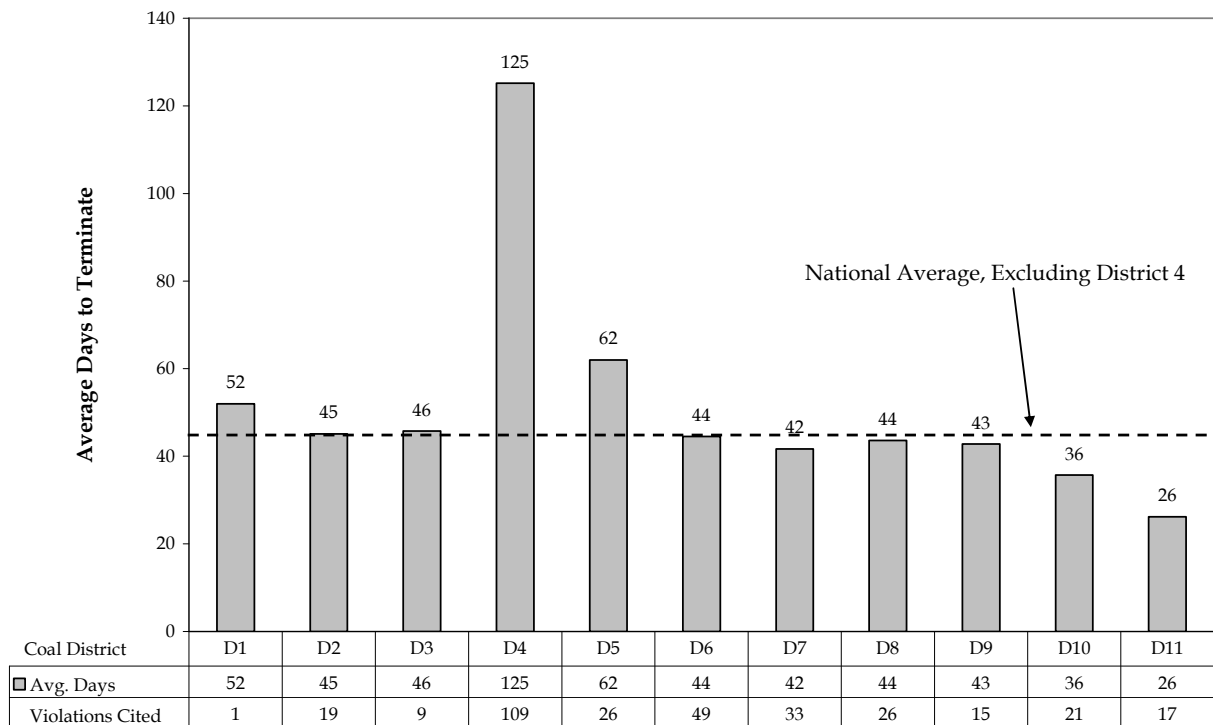
Figure 23 shows the average number of days in each Coal district to terminate citations issued for violations of 30 CFR 70.100(a) or 30 CFR 70.101 when miners' exposures exceeded the applicable respirable dust standard during the review period. The average time to abate violations of 30 CFR 70.100(a) and 30 CFR 70.101 at UBB was consistent with the average time to abate similar violations at other mines in District 4. However, the average time to abate violations of these respirable dust standards in District 4 was almost three times the average for all other districts.

**Figure 23 - Average Days to Terminate Violations for Exceeding Respirable Dust Standards.**

The District 4 Health Department supervisor stated in an interview that, when a mine operator was cited for an overexposure under 30 CFR 70.100(a) or 30 CFR 70.101, the district required an upgrade to the existing plan to enhance dust controls. If noncompliance continued, a section 104(b) order was issued and the MMU was shut down until “meaningful” changes to the plan were made and additional dust control measures were implemented. During the review period, District 4 inspectors and specialists issued nine section 104(b) orders, including the aforementioned order at UBB.
