Coal Mine Fatal Accident 2003-23

| Operator: | Twin Star Mining, Inc. |
| Mine: | No. 2 Surface Mine |
| Classification: | Exploding Vessel |

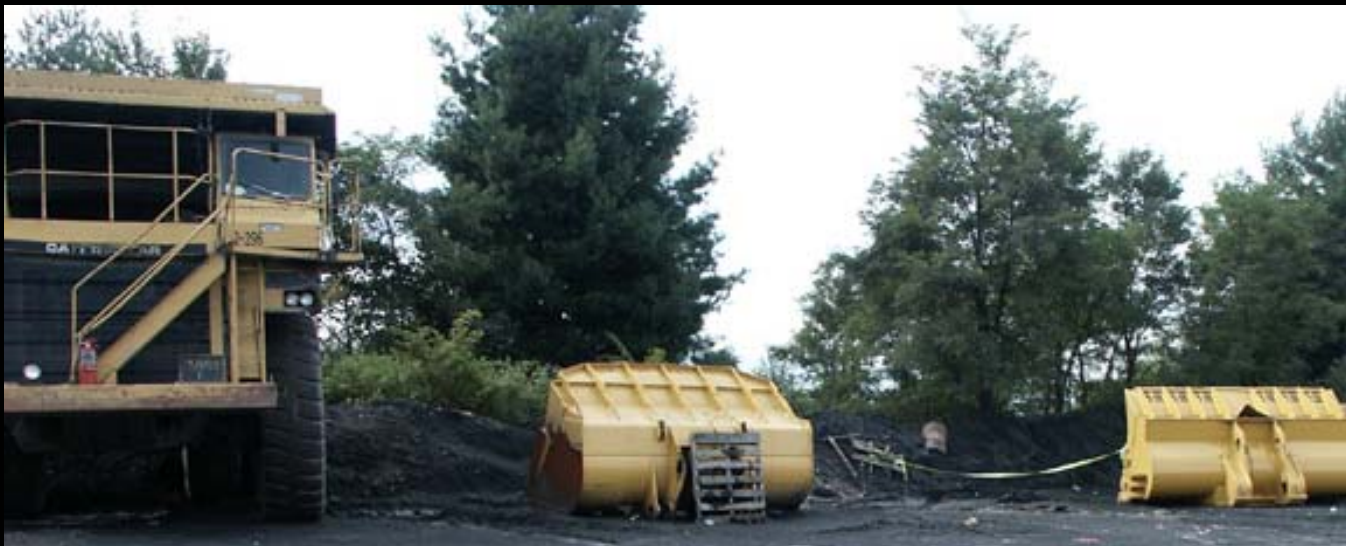
- The evening shift began operation at 5:00 p.m., under the supervision of Glen Mullins, Evening Shift Foreman. Mullins began his shift on the Kentucky side of the mine, where he supervised the moving of a loader spread.
- Jason Layne, Mechanic, and James Estep, Contract Mechanic, went to an area approximately 200 feet south of the maintenance shop to work on a haul truck, located near two front-end loader buckets.

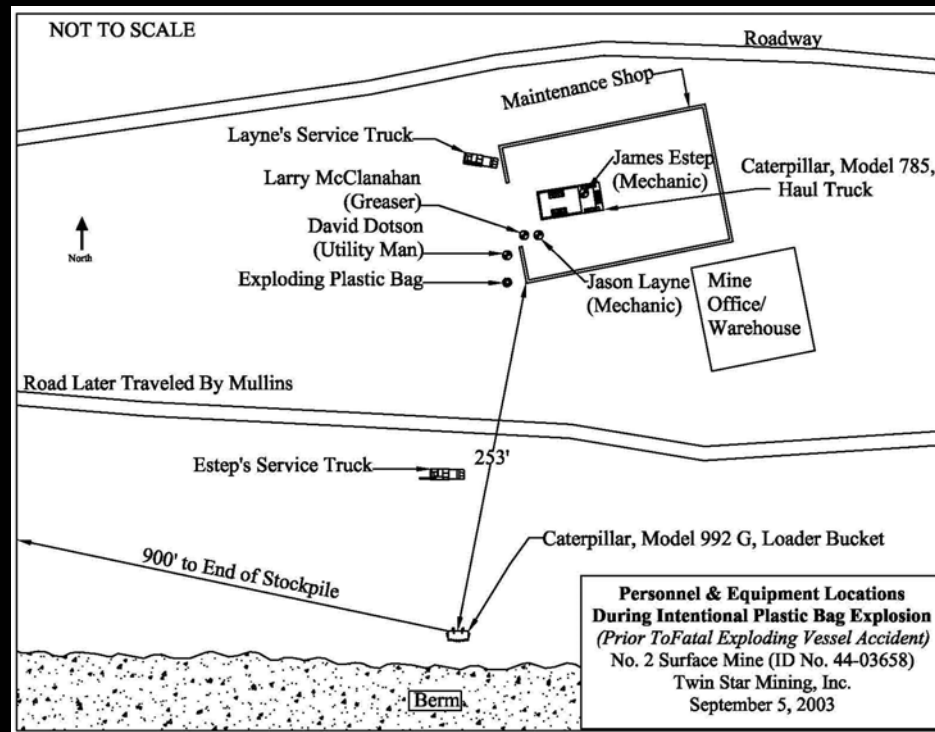
- Dotson, McClanahan, and Layne met in the maintenance shop while Estep was retrieving the haul truck. Dotson took an empty plastic bag to the opposite side of Layne's service truck and filled it with acetylene.
- When Estep arrived with the haul truck, Layne and McClanahan directed Estep into the maintenance shop. Meanwhile, Dotson placed the bag outside the shop, sprayed a trail of starter fluid to the bag, ignited the trail, and exploded the bag. Layne thought a tire on the haul truck had burst; Dotson reentered the maintenance shop laughing.
