**REPORT OF INVESTIGATION**

**Fatal Exploding Vessel Accident  
September 5, 2003**

**No. 2 Surface Mine  
Twin Star Mining, Inc.  
Hurley, Buchanan County, Virginia  
ID No. 44-03658**

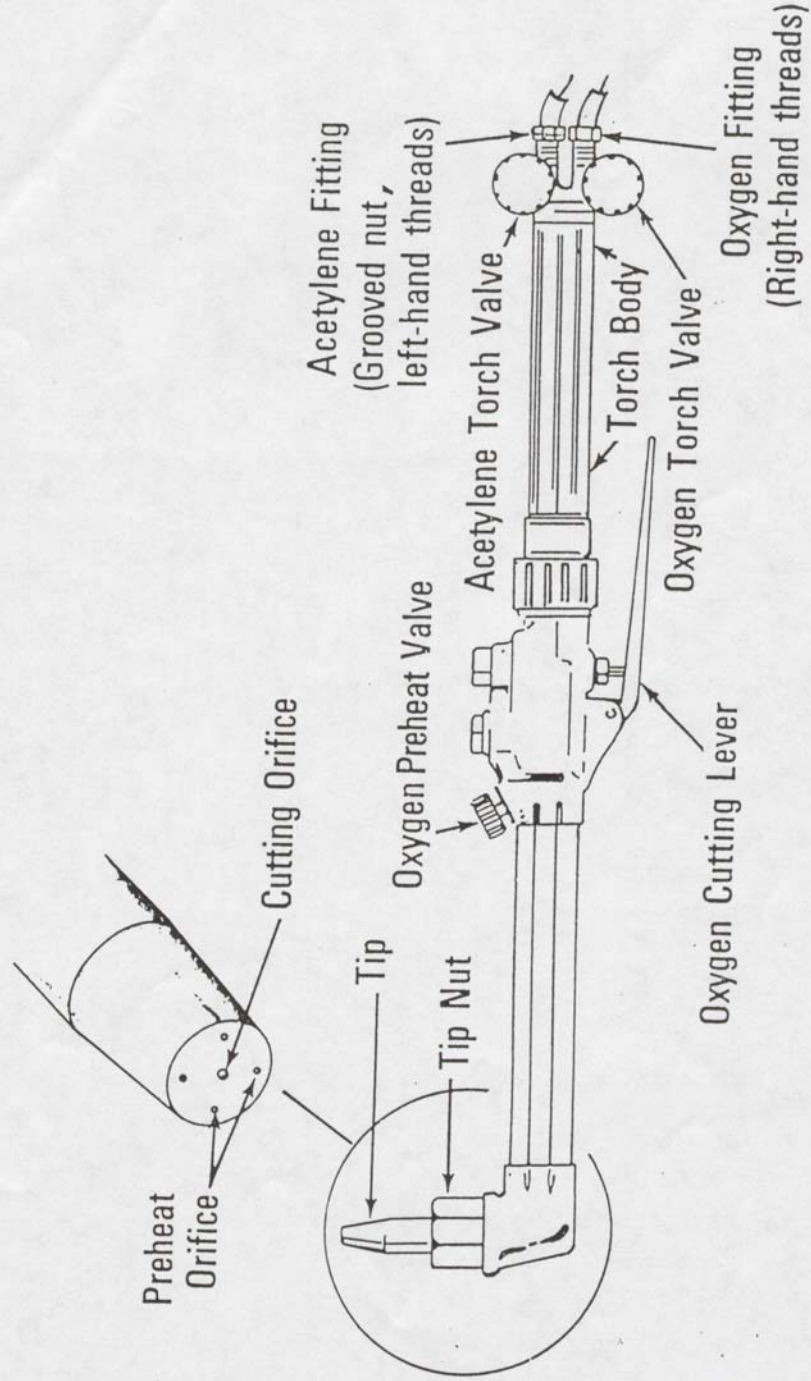
APPENDIX C  
Typical Torch Body and Cutting Attachment

arriving at the site, consisted of the oxygen cutting lever, oxygen preheat valve, torch head, tip and tip nut (a typical cutting attachment is illustrated in Appendix C). Neither the torch tip nor the tip nut was found during the investigation. Mullins stated that neither the torch tip nor the tip nut were on the torch after the accident.
