UNITED STATES
DEPARTMENT OF LABOR
MINE SAFETY AND HEALTH ADMINISTRATION
COAL MINE SAFETY AND HEALTH

REPORT OF INVESTIGATION
Fatal Underground Coal Mine Explosion
January 2, 2006
Sago Mine, Wolf Run Mining Company
Tallmansville, Upshur County, West Virginia
ID No. 46-08791
By

Originating Office
Mine Safety and Health Administration
Office of the Administrator
Coal Mine Safety and Health
1100 Wilson Boulevard
Arlington, Virginia, 22209
Kevin G. Stricklin, Acting Administrator
May 9, 2007

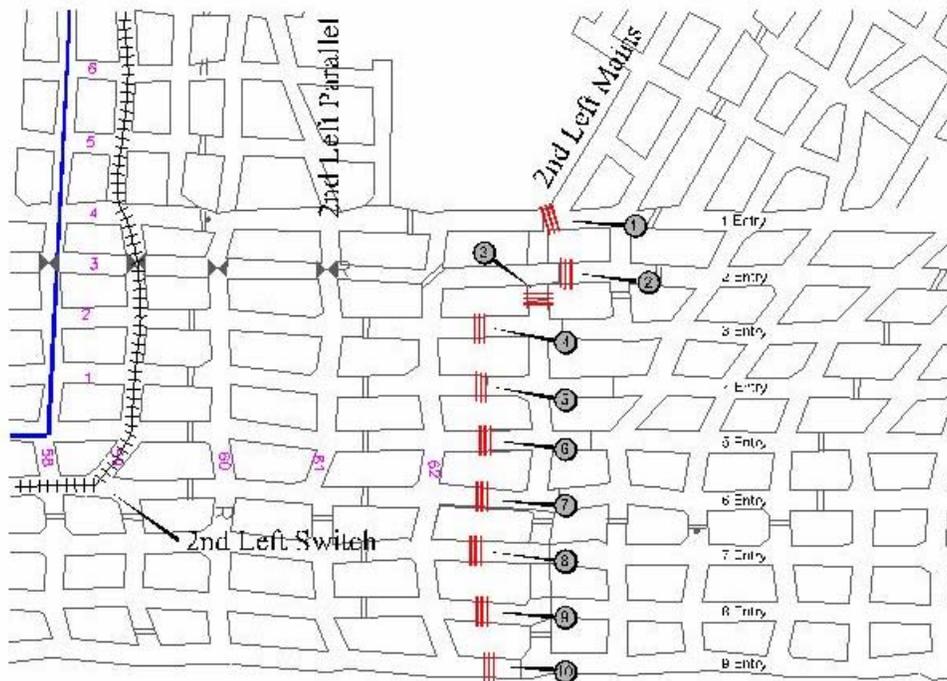
Figure 2 - Location of 2 North Main Seals

On October 12, the mine operator submitted a plan to MSHA to seal the 2 North Mains inby the 2nd Left Parallel. The mine operator also submitted a plan to use Omega Blocks to construct 40 inch thick Omega Block seals. On October 24, the mine operator's requests were approved. Seal construction began on October 24, 2005. By November 9, seven seals had been completed. The operator subsequently completed the next seal in the 63 Crosscut, No. 4 Belt between entry Nos. 2 and 3. The locations of the seals are shown in Figure 2.

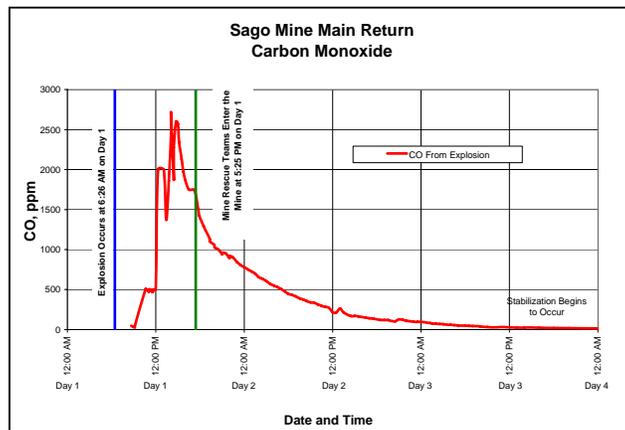
Figure 3 - CO Measurements at the No. 1 Drift Opening

The air quality readings continued trending downward. Figure 3 illustrates the results of CO measurements obtained in the No. 1 Drift Opening. While they were still at dangerous levels, it was determined that they were low enough to allow rescue efforts to commence. At 4:55 p.m., the mine operator submitted a plan for the start of exploration which was approved by MSHA and WVMHS&T. The plan called for Tri-State Team A to enter the No. 5 intake entry and to explore the first 1,000 feet. Tri-State Team B would serve as their backup in the event Team A personnel experienced any type of difficulty. At 5:12 p.m., the mine operator submitted a new plan switching the Tri-State teams to the CONSOL teams, since CONSOL's teams had more experience in mine rescue than any other team present.

The forces of the explosion disrupted the mine ventilation system. It took a period of time for the CO generated from the explosion to reach the main return, No. 1 Drift Opening. As previously shown in Figure 3, the CO began to increase dramatically, peaked and then began to decrease. The CO trend eventually stabilized.

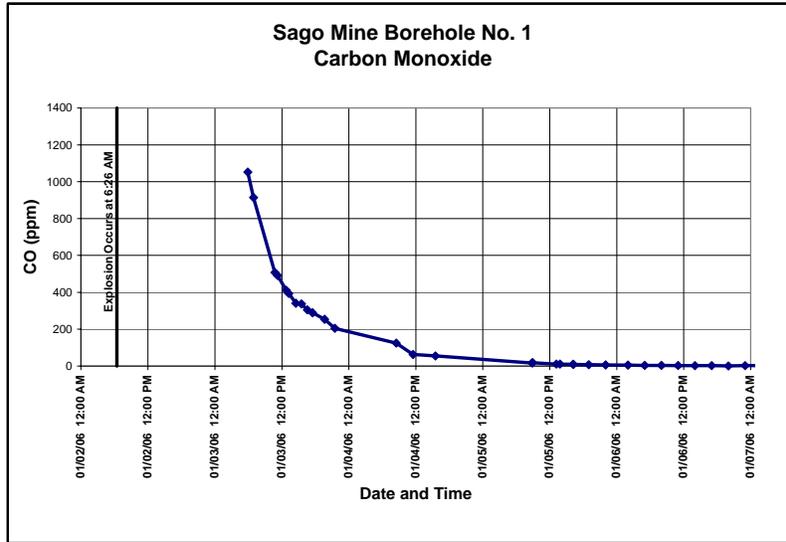
Figure 5 - Borehole No. 1 Carbon Monoxide Results

ppm CO and 20.4% oxygen. Figure 5 illustrates the results of CO measurements obtained in Borehole No. 1. Appendix E contains the gas chromatograph analysis results for samples collected at the Borehole No. 1.

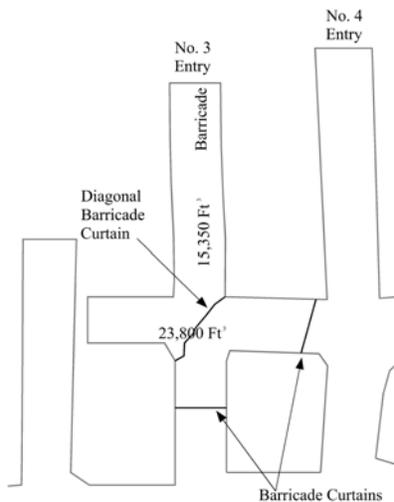
Figure 8 -Drawing of Barricade

Experiments by the USBM show that a man in a confined space needs about a cubic yard of normal air each hour. The barricade location selected by the miners was inby and included the last open crosscut of the No. 3 entry. The width of the crosscut between the Nos. 3 and 4 entries was about 17 to 20 feet. The width of the No. 3 entry outby the last open crosscut was about 18 to 20 feet. Curtains were installed across these locations. A diagonal curtain was installed from the right rib of the inby corner, to the left rib of the outby corner, in the No. 3 entry.

The diagonal curtain was approximately 29 feet in length from rib to rib and balled up on the outby end, according to the captain of the McElroy mine rescue team. The volume of the larger area, (curtain in the crosscut and the curtain in the entry to the face) was about 23,800 cubic feet. The volume of the smaller area, (diagonal curtain to the face) was 15,350 cubic feet. The larger area calculated into cubic yards for 12 miners would be 73 cubic yards per miner. The smaller area for 12 miners would be only 47 cubic yards per miner. This shows that the miners had enough air to sustain them for at least 47 hours if they remained in the smaller area within the barricade and if normal air was in the barricade. This is about 6 hours longer than it took for mine rescue teams to reach the barricade. Figure 8 is a drawing of the barricade.

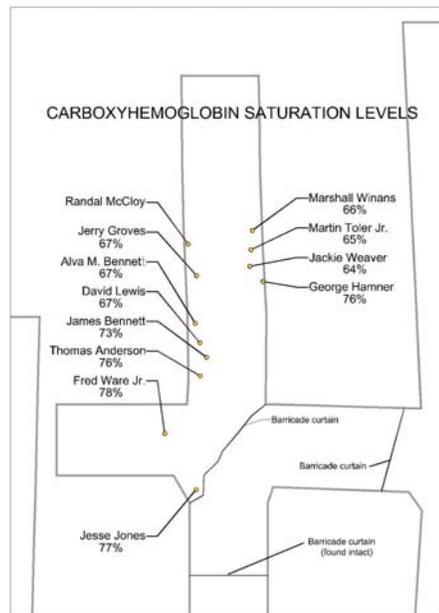
Figure 9 - Location of Miners and Their Carboxyhemoglobin Levels

The cause of death for all of the victims was carbon monoxide intoxication/poisoning. Helms was found near the mouth of the 2nd Left Parallel section and had a carboxyhemoglobin saturation of 78%. The deceased miners found in the barricade had carboxyhemoglobin saturation levels ranging from 64% to 78%. The levels do not appear to be age or size dependent but indicate a trend relative to their distance from the barricade curtains with McCloy, the surviving miner, being the furthest in by.

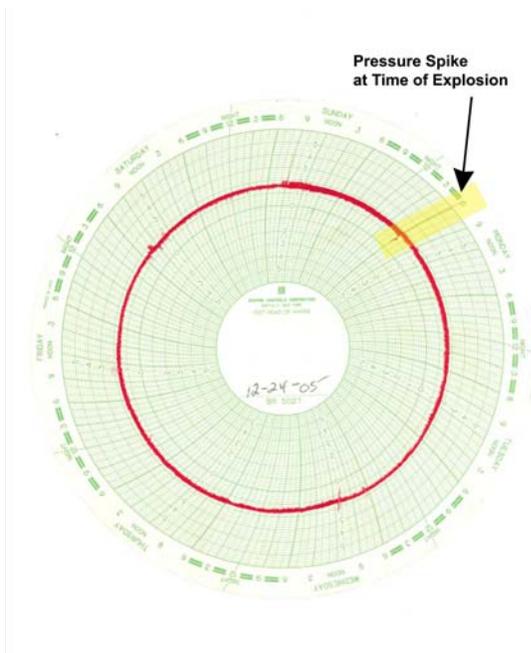
Figure 12 - Fan Chart

146,566 cfm on December 28, 2005. The total quantity of return air exiting the mine through the No. 1 Drift Opening was 101,088 cfm. The remaining 45,478 cfm would have exited the mine through the Nos. 2, 3 and 4 Drift Openings. The blowing fan was an 8 foot diameter, Joy Model Number M96-50 fan, with a blade setting of 8 degrees and operating at about 1.9 inches of water gauge. Figure 12 is a copy of the chart which was on the fan pressure recorder when the explosion occurred. Although the fan chart shows a pressure spike about 6:00 a.m., the explosion occurred about 6:26 a.m. This indicates that the fan chart was not correctly aligned on the pressure recorder to correspond with actual time.

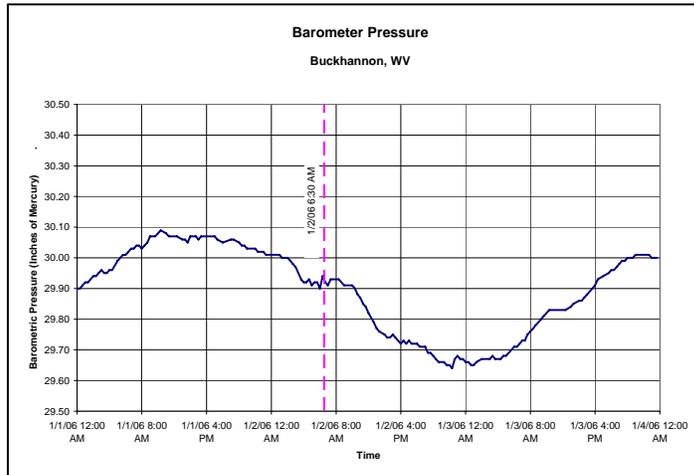
Figure 13 - Barometric Pressure for Buckhannon, WV

Figure 13 is a graph of the barometric pressure for Buckhannon, West Virginia from 12:00 a.m. on January 1 through 12:00 a.m. on January 4, 2006. These

changes in barometric pressure did not appear to significantly influence the conditions within the sealed area just prior to the explosion, since the point of origin for this explosion was more than 300 feet from the seals.

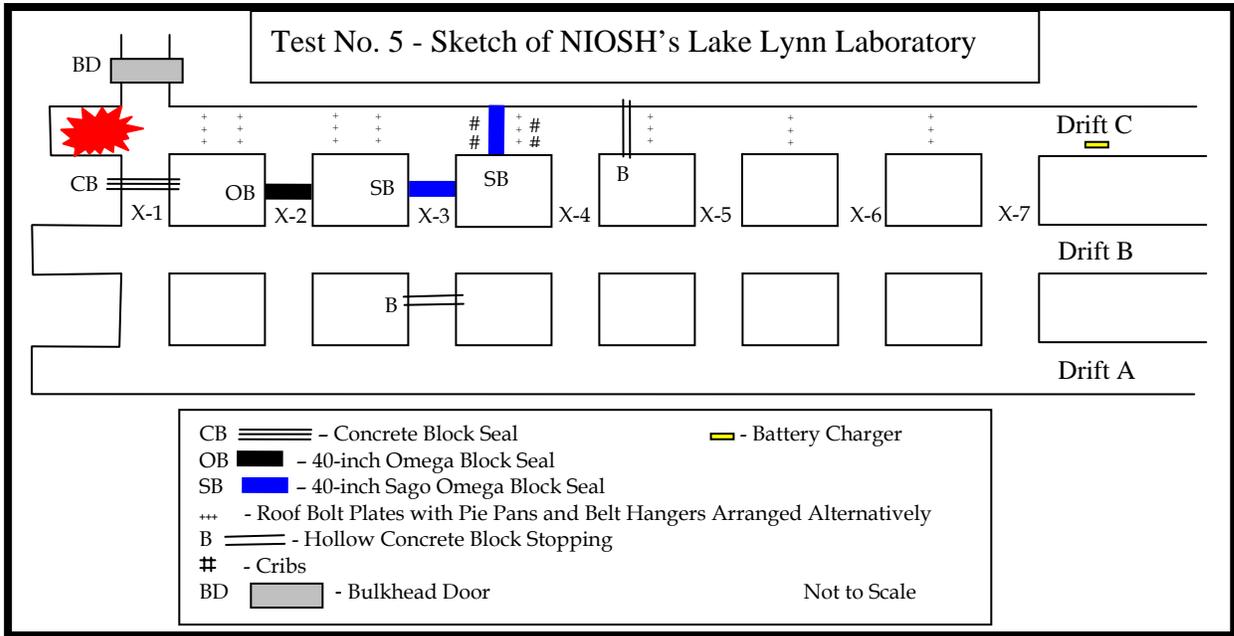
Figure 34 - Test No. 5 Lake Lynn Mine Layout

For the fifth test explosion, the four seals from the previous test remained in place. The fifth test was designed to significantly increase the static and total pressures. The explosion was initiated in the sealed area. The explosion generated a pressure of 26 psi on the seal in No. 2 Crosscut, 35 psi on the seal in No. 3 Crosscut, and 57 psi on the seal constructed in Drift C. The test was conducted on August 23, 2006. The solid concrete block seal and the Omega block seal constructed in No. 2 Crosscut successfully withstood the pressure pulse. Both of the Omega block seals that were similar to those constructed at Sago Mine were destroyed by the pressure pulse. The battery charger was

moved outby by a distance of about 30 feet as a result of this explosion. The crib blocks were blown a maximum distance of about 438 feet as a result of this explosion. Figure 34 is a sketch of the Lake Lynn Mine layout for Test No. 5.

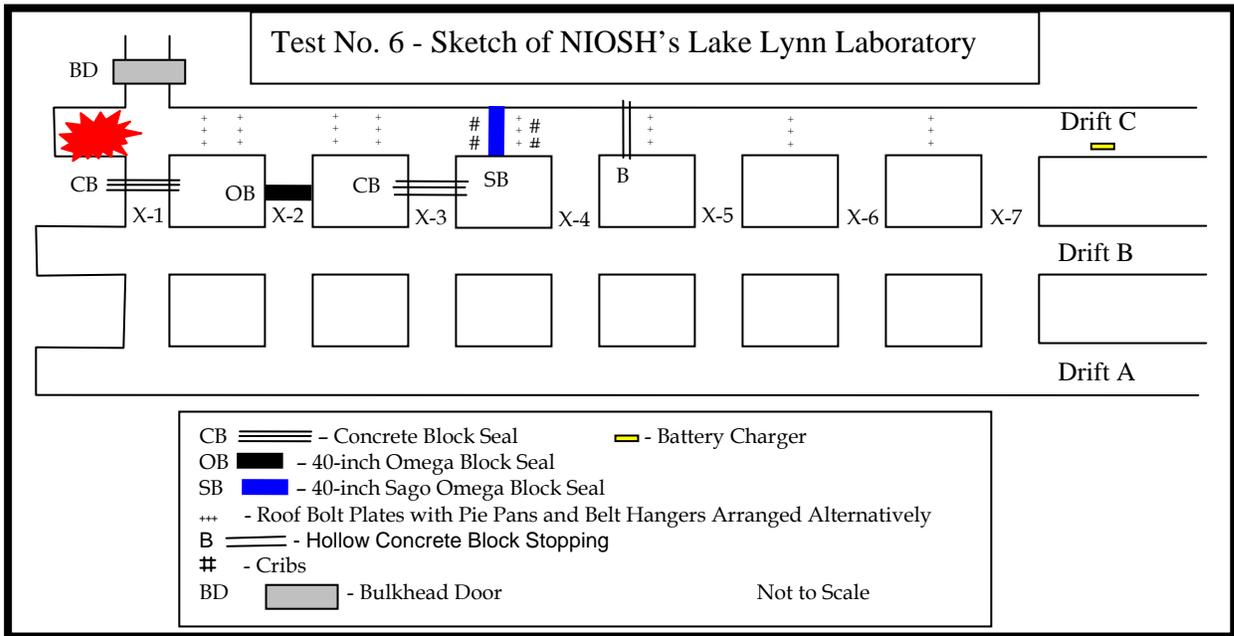
Figure 35 - Test No. 6 Lake Lynn Mine Layout

For the sixth test explosion, the solid concrete block seal and the Omega block seal in No. 2 Crosscut remained in place. A solid concrete block seal was constructed in No. 3 Crosscut and a seal constructed of Omega blocks from the Sago Mine was constructed in Drift C. The sixth test was designed to significantly increase the static and total pressures. The seals cured for 28 days. Two cribs were built on both the inby and outby side of the seal in the drift. One dry-stacked stopping was constructed in No. 3 Crosscut, behind the seal. The explosion was initiated in the sealed area. The explosion generated a pressure of 51 psi on the seal in No. 2 Crosscut, 49 psi on the seal in No. 3 Crosscut, and 93 psi on the seal constructed in Drift C. The test was conducted on October 19, 2006. Both of the solid block seals successfully withstood the pressure pulse. The Omega block seal in No. 2 Crosscut withstood the pressure pulse. The Omega block seal constructed in Drift C was destroyed by the explosion.

The greatest distance that seal debris was thrown as a result of this explosion was about 918 feet. The battery charger was moved outby by a distance of about 356 feet as a result of this explosion. The greatest distance stopping debris was thrown, as a result of this explosion, was about 748 feet. Figure 35 is a sketch of the Lake Lynn Mine layout for Test No. 6.

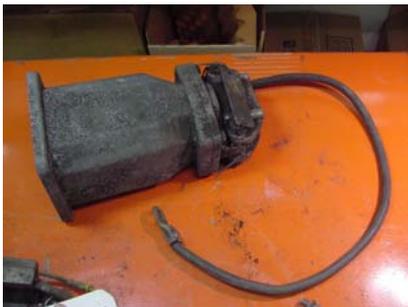
Figure 43 - Cable Coupler

When a cable is connected to a coupler, the four insulated conductors are in close proximity to grounded conductors and the grounded shell of the coupler. A cable coupler contains exposed bare copper pins that connect to the red, white, black, ground and ground check conductor. Figure 43 is a photograph of the cable coupler.

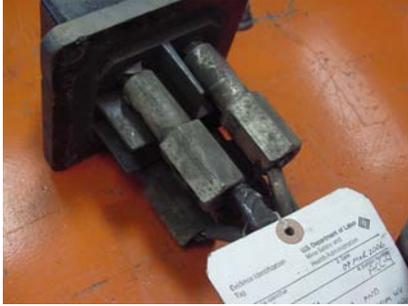
Figure 44 - Coupler with Pins and Conductors

Figure 44 is a photograph of the end of the cable coupler containing the connecting pins and the conductors. These pins become energized to the same level as their connected conductors. The coupler was lying on the damp mine floor, the coupler pins were exposed to moist dirt that could provide a path to the grounded metal shell resulting in an arc.

Any of these arcs are potential ignition sources for the methane. Although there was no observed sign of arcing on the conductors, this does not rule out the possibility that an arc occurred, initiating the explosion.

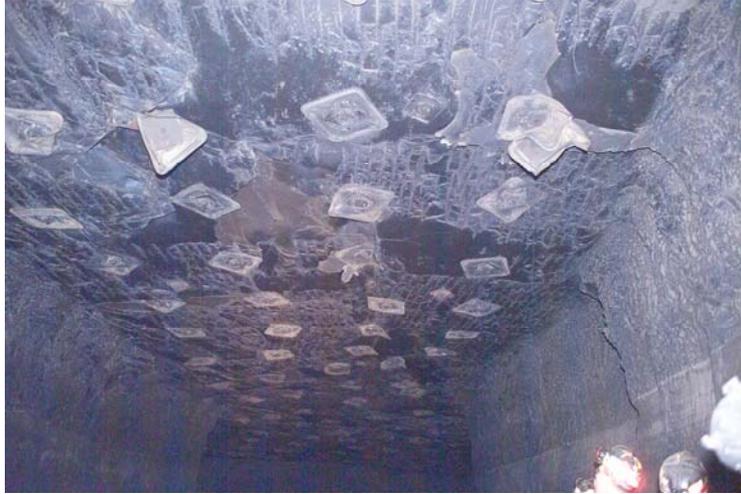
Figure 46 - Picture taken Near Survey Station 4010

Figure 46 was taken near survey station 4010, facing outby in an area that had been second mined. All but two of the roof plates appear to be unaffected by the forces of the explosion, indicating that forces had not reached their peak magnitude.

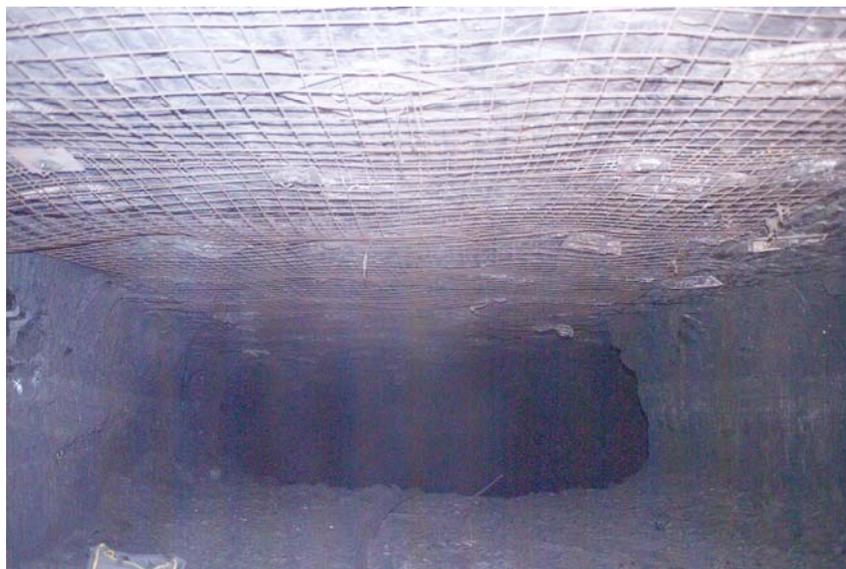
Figure 47 - Picture Taken Near Survey Station 4011

The picture shown in Figure 47 was taken from a location near survey station 4011. There is no damage to roof support members, including wire mesh or roof plates. The origin of this deflagration-type explosion was located within the sealed area near survey stations 4010 and 4011 in the 2nd Left Mains. This particular location did not appear to be exposed to the same magnitude of pressures as the surrounding areas.

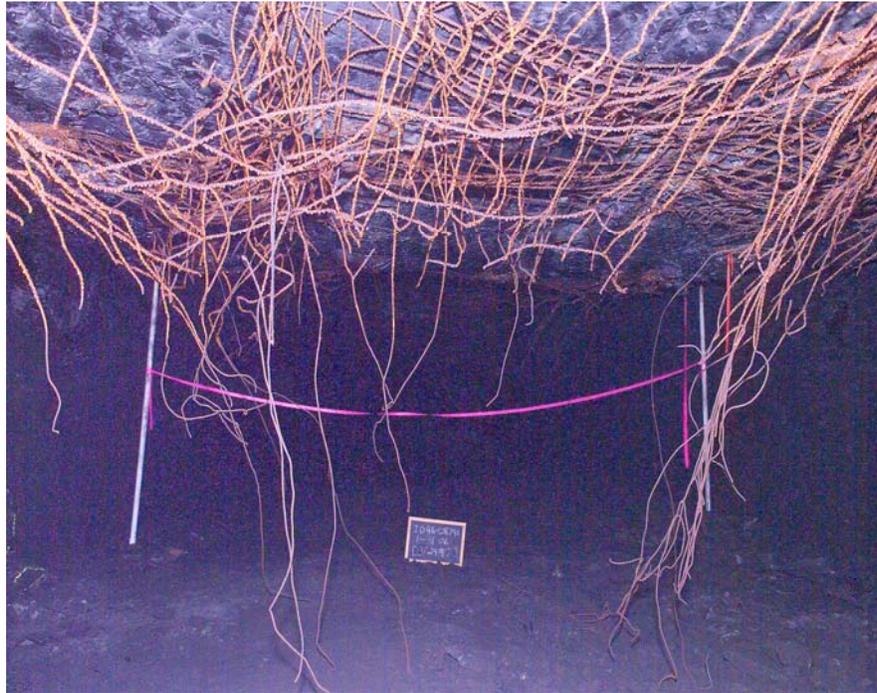
Figure 48 - Picture Taken Near Seal No. 8

Figure 48 was taken near Seal No. 8. It shows extensive damage to the wire mesh. Pressures from a deflagration increase as the flame travels away from the origin in all directions. Higher pressures are achieved as the flame speed continues to increase.

Bottom mining was not conducted in the areas where the seals were constructed. Therefore, as the flame approached the location of the seals, the size of the entries decreased. These restrictions caused the mine atmosphere to become pressurized prior to the arrival of the flame front. When the flame entered the pressurized mine atmosphere, the pressures increase. This is commonly known as pressure piling.

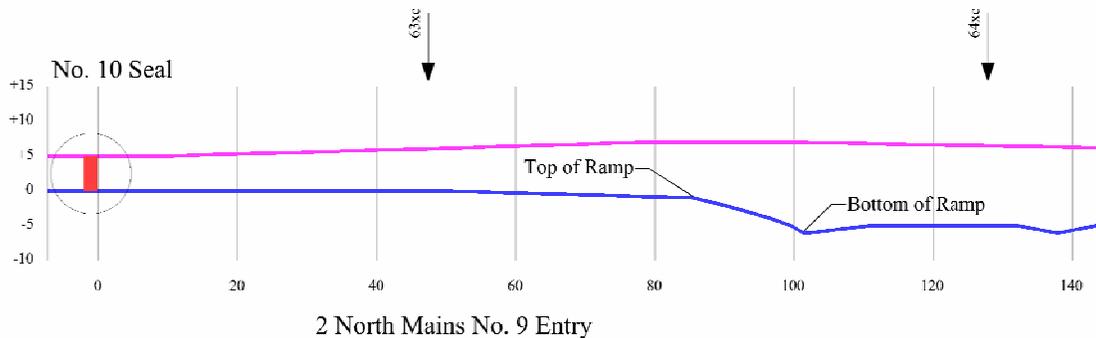
Figure 50 - Contours Near Seal No. 10 in 2 North Mains, No. 9 Entry

Figure 50 shows a typical side view of the entry in which Seal No. 10 was constructed. The seal is shown on the left. The line across the top of the figure shows the elevation of the roof. The line across the bottom of the figure details changes in the mine floor due to bottom mining. Those areas to the right of the seal location shown in the figure are part of the sealed area. The height of the entry at the bottom of the ramp, where bottom mining commenced, is approximately 2.5 times the height at the location of the seal.

As the explosion propagated toward the location of the ten seals, the mine atmosphere immediately behind the seals would have experienced increased pressure due to the shock wave of the approaching flame front. Pressures would have increased dramatically as the explosion propagated up the ramp into more restricted entry heights. The pressurized mine atmosphere immediately behind the seals would have caused pressure piling effects.
