Use of an Inertisation Unit during a Coal Mine Fire Recovery Operation

ABSTRACT: On February 13, 2003, a fire occurred in a large underground coal mine located in West Virginia. Firefighting activities were unsuccessful. The mine was sealed at the surface openings on February 14, with the intent of inerting the mine atmosphere naturally. However, the mine operator proposed a novel approach for controlling the mine atmosphere. The Mine Safety and Health Administration worked closely with the mine operator on a plan to recover the mine. Queensland Mine Rescue Service Limited was consulted and contracted to provide technology, equipment and personnel to operate an Inertisation Unit. The primary component of the unit was a jet engine. The engine was capable of producing large quantities of inert gases and forcing the gases into the mine. The unit was installed on the surface at the slope and the injection of inert gases was started on April 4, 2003. After the mine atmosphere was successfully stabilized to a non-explosive condition, re-ventilation of the remainder of the mine was initiated. Mine rescue teams entered the mine and began exploration toward the fire area. The progress of t

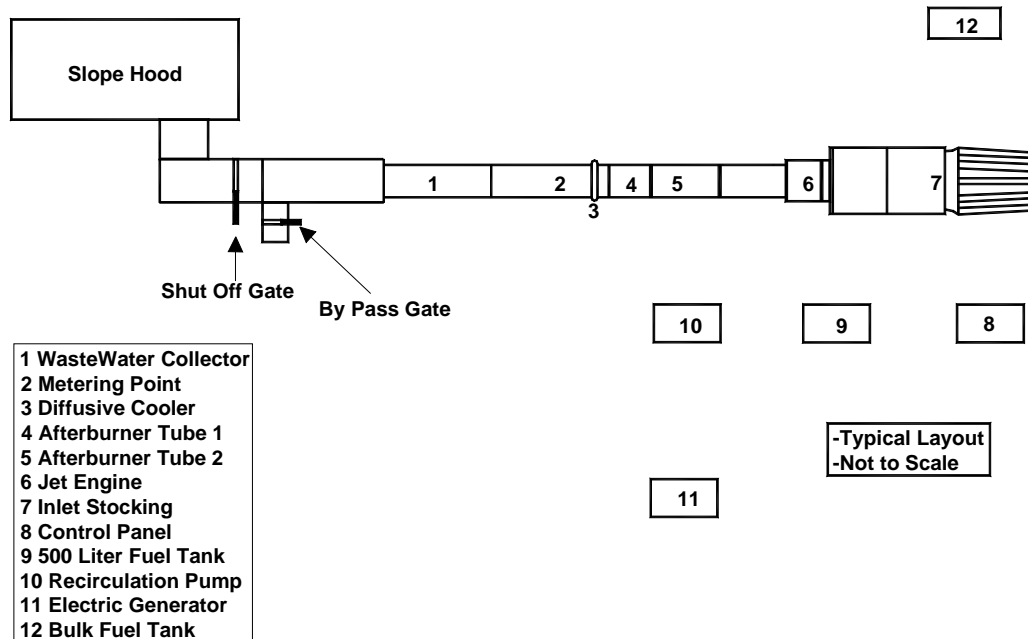
Figure 3. Inertisation Unit Components

The components of the Unit included a modified jet engine, after-burner, cooling duct, diffusive cooler and waste water collection duct. Figure 3 is a drawing that shows the various components of the unit and the ducting fabricated to allow injection of the Unit exhaust into the mine at the slope opening. A fuel-air mixture was burned in the jet engine, with additional combustion occurring in the after-burner. Most of the oxygen was consumed in the combustion process, resulting in an exhaust composed primarily of nitrogen, carbon dioxide and water vapor.

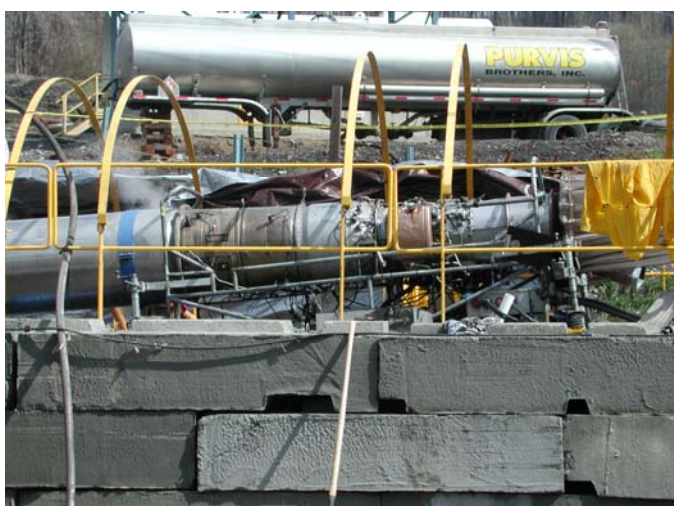
Figure 4. Inertisation Unit and Control Panel

A 14-man crew maintained continuous operation of the Unit. A control panel continuously monitored temperature, pressure, and engine speed. Adjustments in engine operation were made to control the composition of the Unit exhaust. The engine was operated at speeds that did not develop significant thrust. Table 1 summarizes the operational parameters of the Unit. The rated information was provided by Queensland Mine Rescue Service.

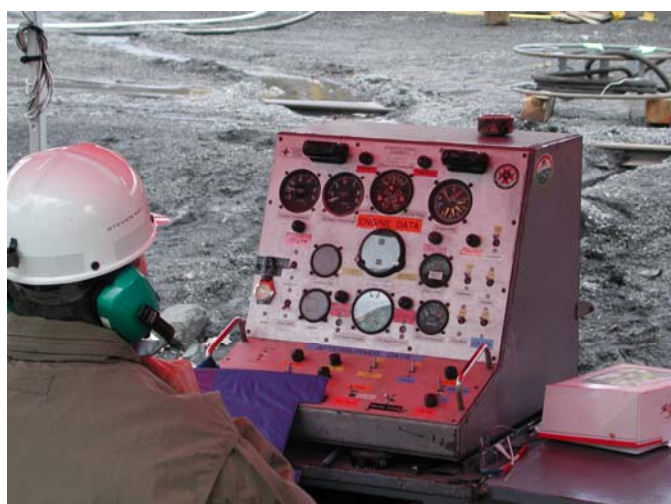
Table 1. Operational Parameters of the Inertisation Unit

Typically, gas composition of the exhaust gas was 5 percent oxygen, 82 percent nitrogen, 1700 ppm carbon monoxide, and 11.5 percent carbon dioxide. The anticipated lower oxygen concentrations were not attainable because back

pressure on the engine affected the operation. The back pressure resulted from the buoyancy of the hot exhaust gases in the slope and the restrictions in the mine caused by roof falls, accumulation of materials, and ventilation controls near the slope bottom. The back pressure reached values in excess of 1.7 kPa (7 inches water gauge).
