MNM Fatal 2004 - 01

- Fall of Person Accident
- January 29, 2004 (South Carolina)
- Cement Plant
- Contractor Laborer
- 24 years old
- Four days experience

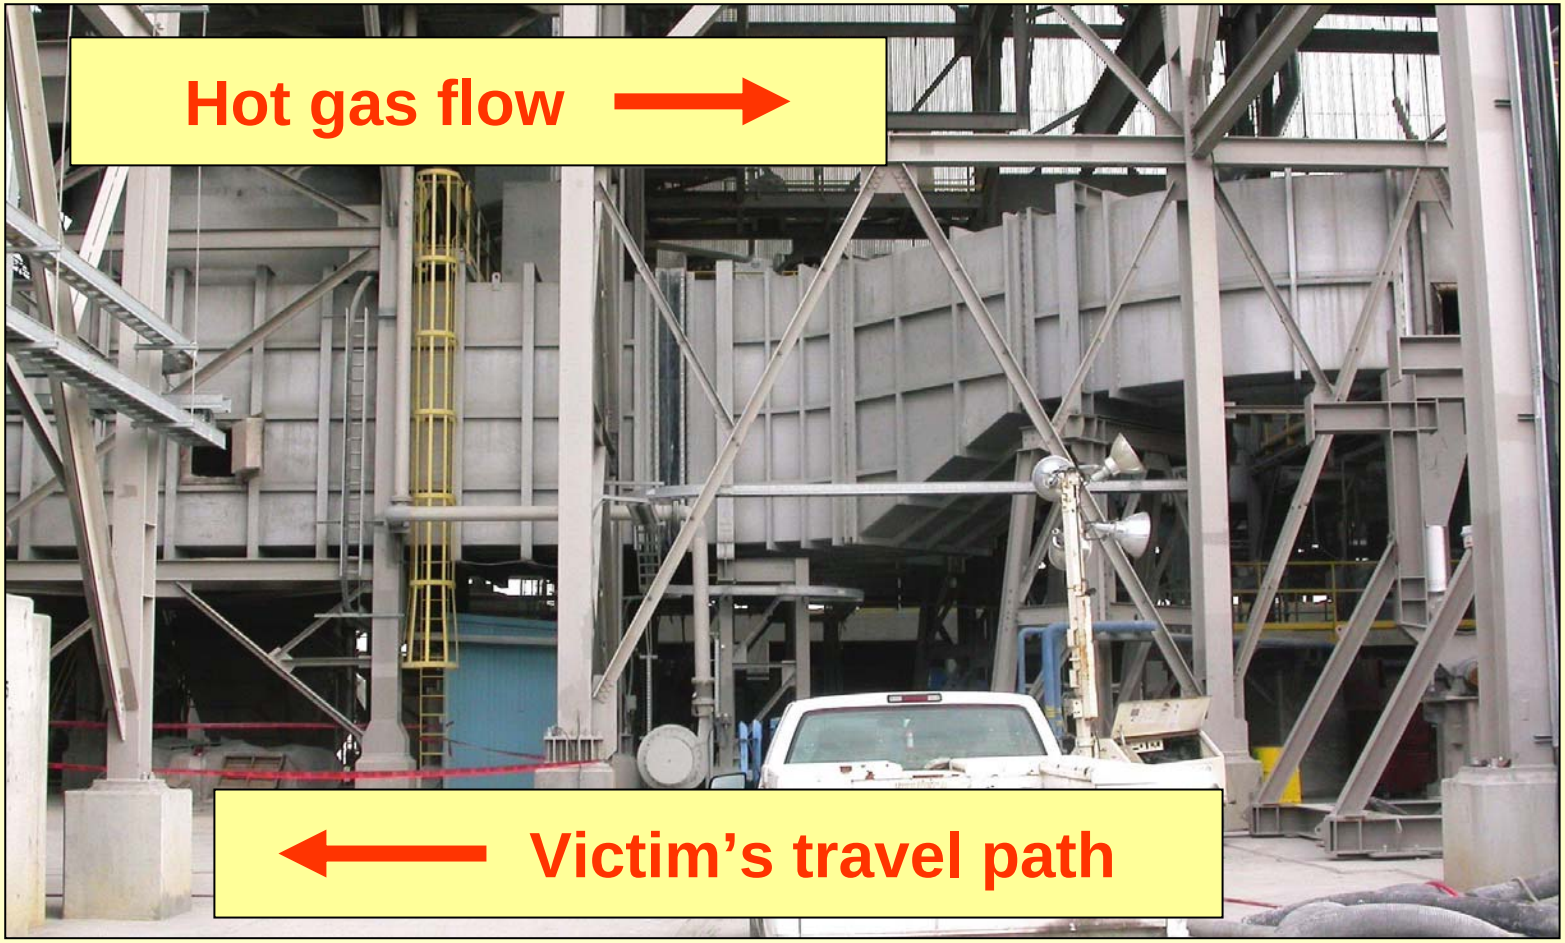
- The victim walked on the crusted surface of a mound of hot dust that had accumulated directly beneath a hot gas generator.
- He received fatal burns when the material unexpectedly gave way and he fell waist deep into the hot dust.

He had entered the raw mill hot gas supply duct that connected to the roller mill where he was assigned to work.

Victim crawled through this 36-inch high opening where he had been working.

Area where victim fell.

- Train employees in safe work procedures and workplace hazards before beginning any work.
- Restrict access, using warning signs indicating the hazards and/or barricades, to areas where hazards may exist that are not apparent to employees.
- Ensure that employees stay in the work areas they are assigned and not venture into unfamiliar areas.
- Monitor new employees closely.
