United Mine Workers of America
Comments
on the
Mine Safety and Health Administration's
Proposed Rule
Refuge Alternatives for Underground Coal Mines
"RIN 1219-AB58"

Aracoma Coal Company
 Alma No.1 Mine
 State ID# U-5006-99

**Conveyor Belt Fire/Double Fatality
Aracoma Coal Company, Inc.
Aracoma Alma No. 1
Permit No. U-5006-99**

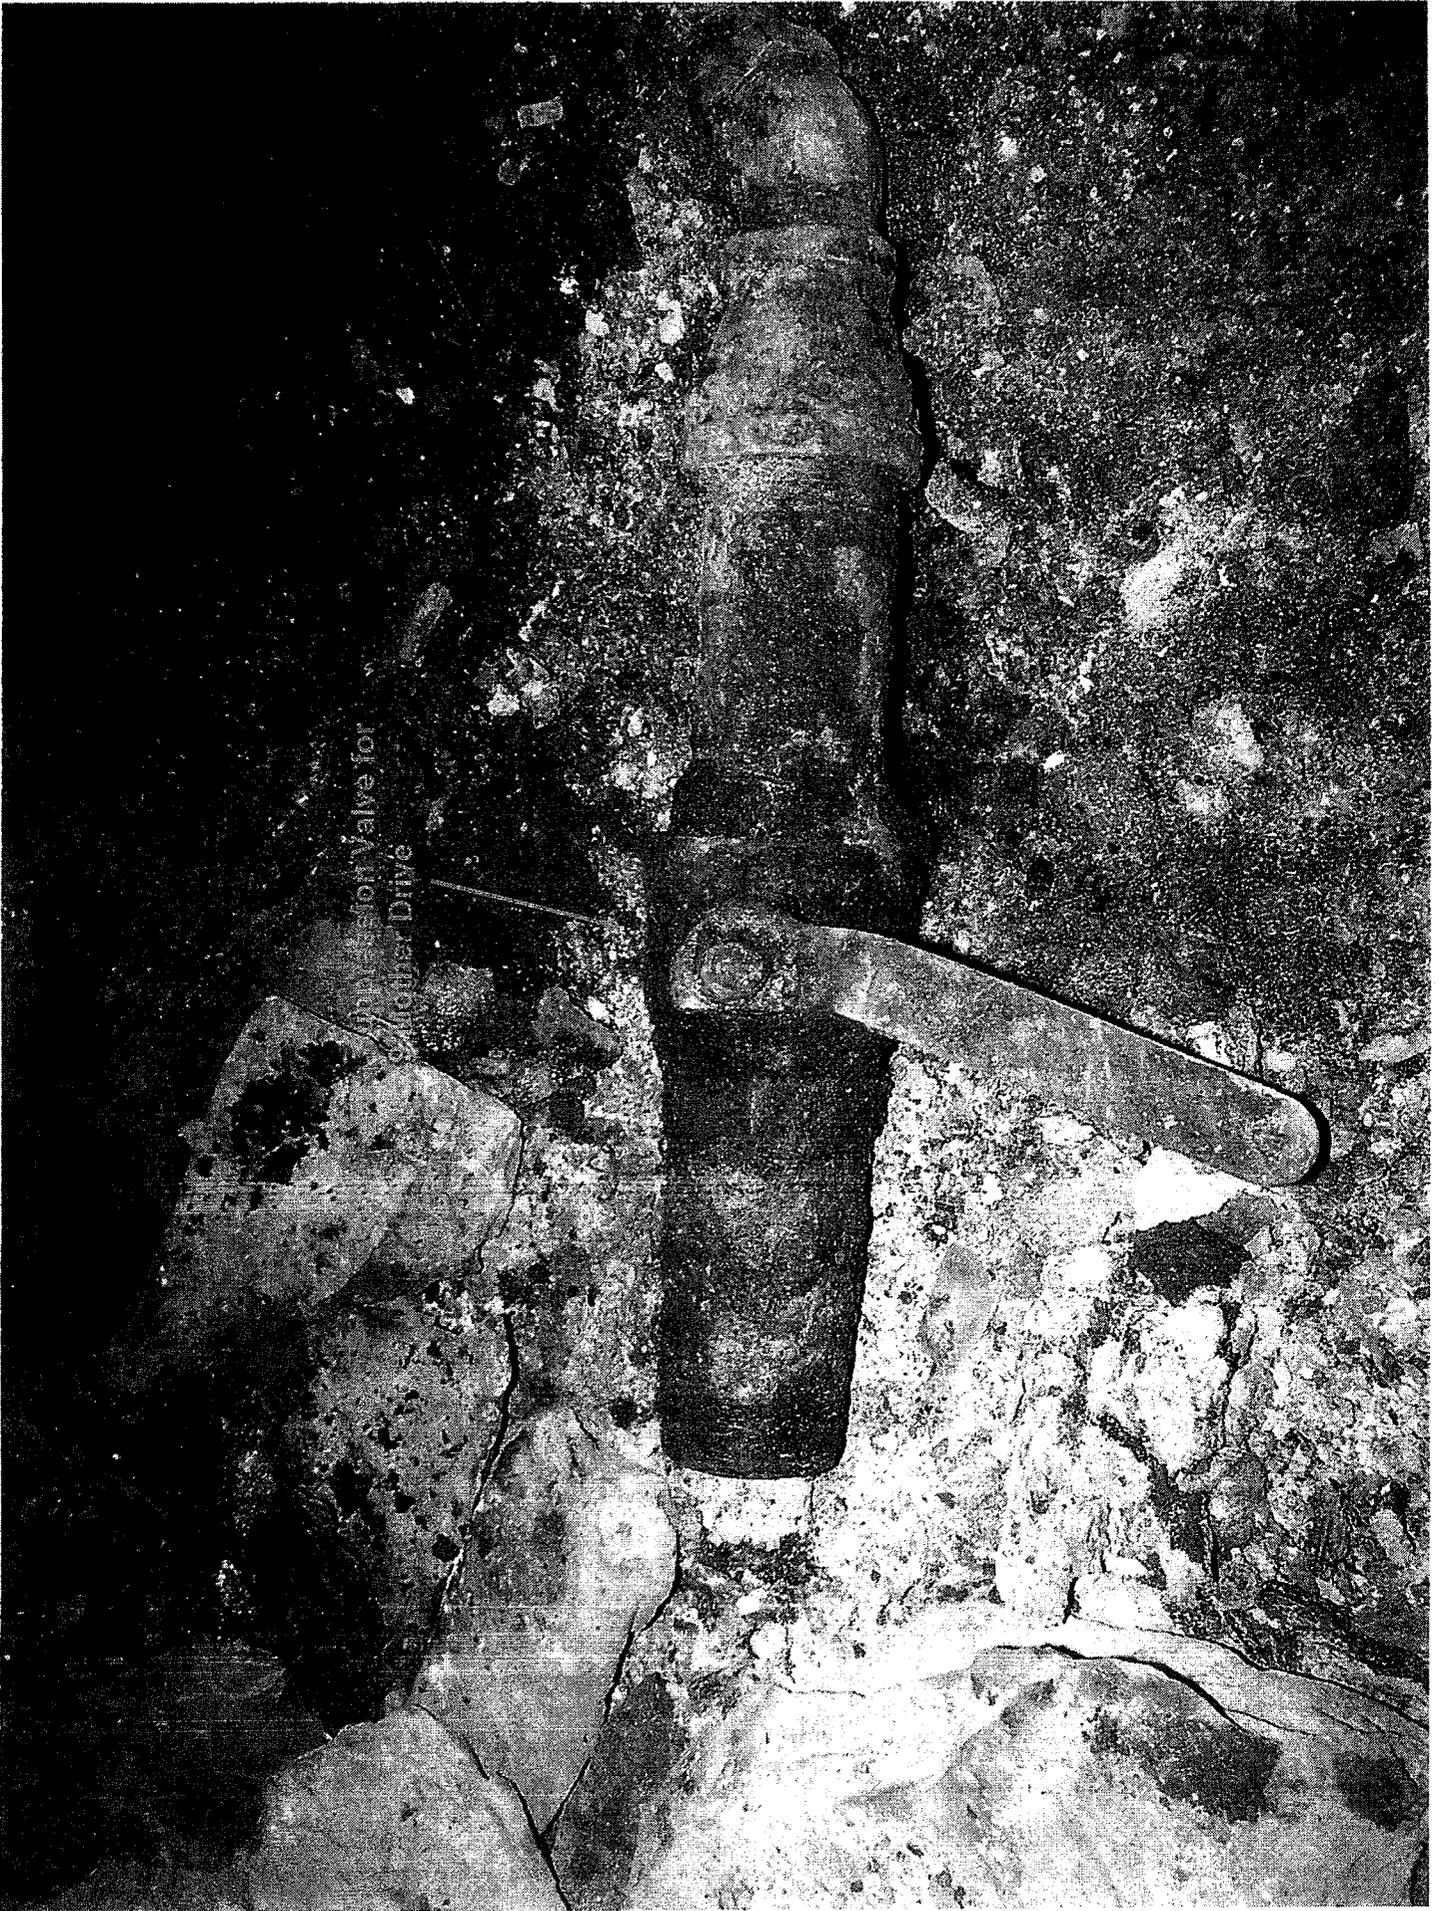
No. 9 Headgate Water
Supply Line

No. 7 Belt Water Supply Line

Injection Valve for
Mother Drive

9. The fire hose outlets provided at the mother drive storage unit area for the No. 9 longwall belt could not be utilized because the shut-off valve for the water supply for the fire hose outlets was found in the closed position.

10. The water sprinkler fire suppression system installed on the No. 9 headgate longwall belt conveyor drive area could not activate in the event of a fire or a rise in temperature because the water supply valve was found in the closed position.

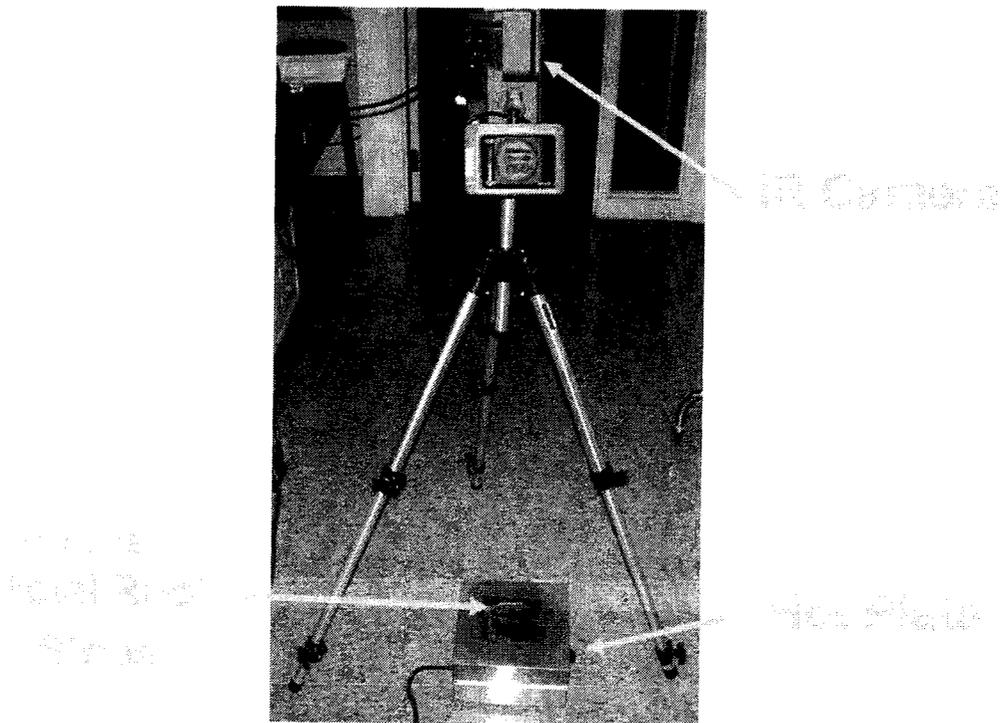
FIGURE 2. EXPERIMENTAL SETUP TO OBTAIN EMISSIVITY VALUE OF A METAL ROOF STRAP

In order to get accurate temperature measurements from the metal roof strap flame cutting experiments, emissivity experiments were conducted on samples of each metal roof strap that was flame cut at LLEM at NIOSH Pittsburgh Research Laboratory (PRL). The samples were painted (approximately 50 % of the area) with high temperature black paint. These strips were placed on a hot plate and heated until thermal equilibrium was reached. The IR camera emissivity was set to 1.0 and the black painted area temperature was measured and recorded. The temperature of the unpainted area was then measured and recorded. The emissivity was then readjusted so that the unpainted area temperature was equal to the initial temperature of the black painted area. Figure 2 show the experimental setup and Table 1 shows the results of these experiments. The average emissivity of the unpainted metal strips was 0.87. This value was used for analysis of the thermal data from the LLEM flame cutting experiments.

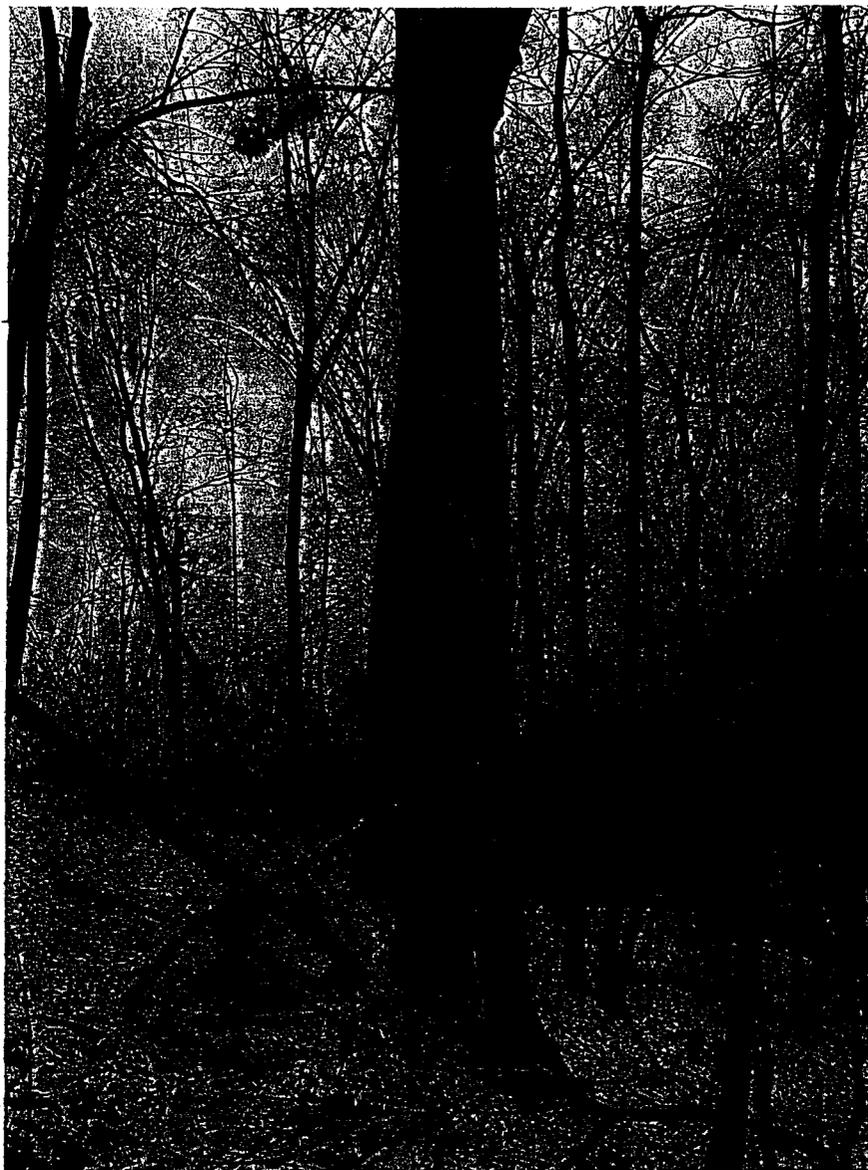
Photo 1. Poplar tree very recently hit by lightning and in close proximity to +110 kA hit recorded by Vaisala (StrikeNet) at LAT 38.926, LONG -80.233 at 06:26:35.680 am on January 2, 2006, Photo by Kermit Melvin, January 6, 2006.

This corresponds precisely with the timing of two nearly simultaneous **lightning strikes** approx. 2 miles apart, located on the attached map. The strongest of these, recorded by Vaisala (StrikeNet), was reported to be a +101.0 kA hit at LAT 38.926, LONG -80.233 at **06:26:35.680 am** on January 2, 2006. This is the location where Sago engineer Kermit Melvin and myself found the lightning-struck tree last Friday (see Photo 1).
