# **Ground Control at Surface Mines**

## **Spoil Pile Safety**

**Mine Waste and Geotechnical Engineering Division**  
**Pittsburgh Safety and Health Technology Center**  
**Directorate of Technical Support**  
**Mine Safety and Health Administration, USDOL**

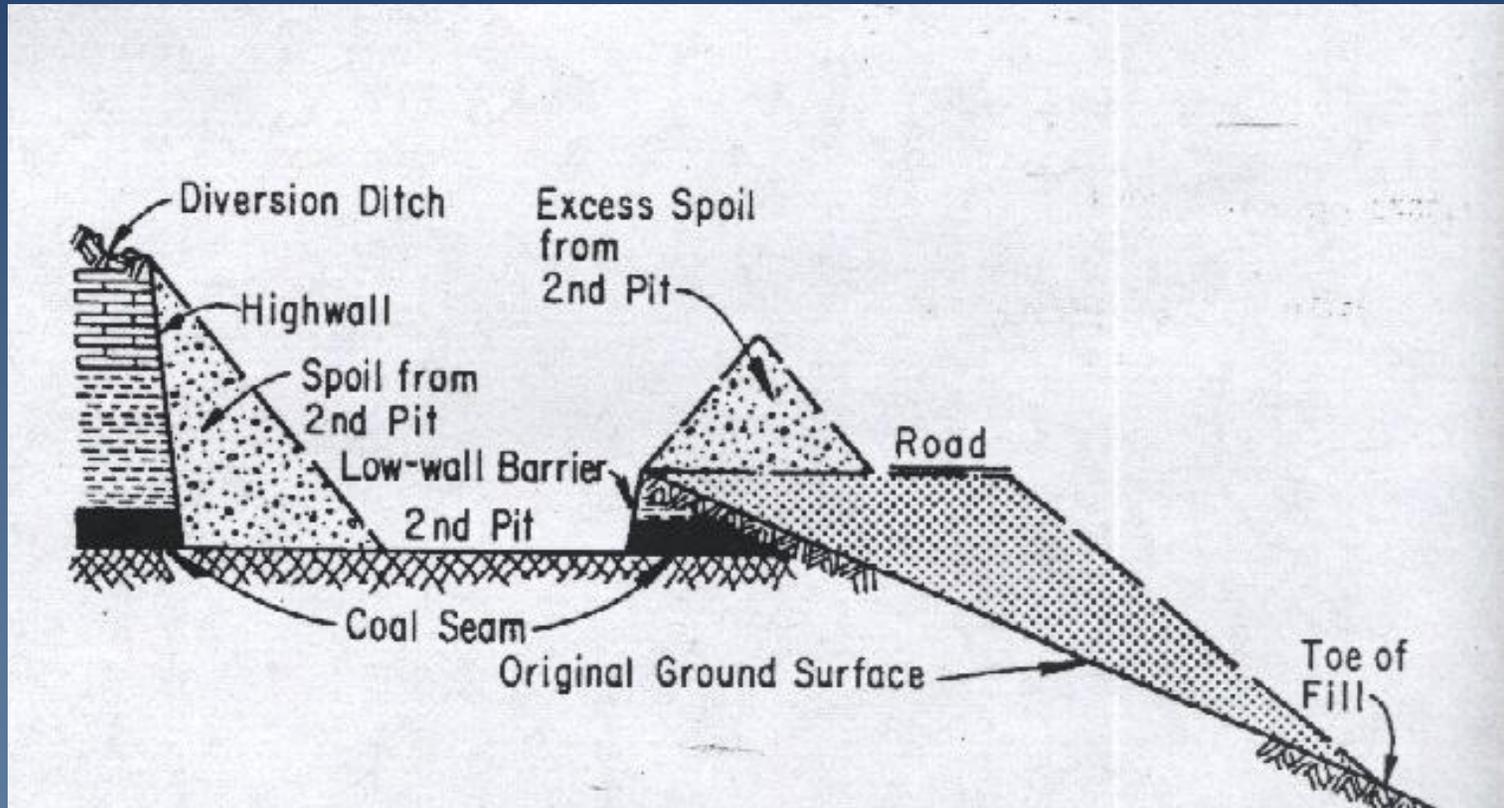
# Highwall, Spoil Bank, Lowwall

- **Highwall** - The unexcavated face of exposed overburden and coal.
- **Spoil** – Overburden or other waste material removed during mining.

- **Lowwall:** An unexcavated face of overburden and coal directly across the pit from the highwall.

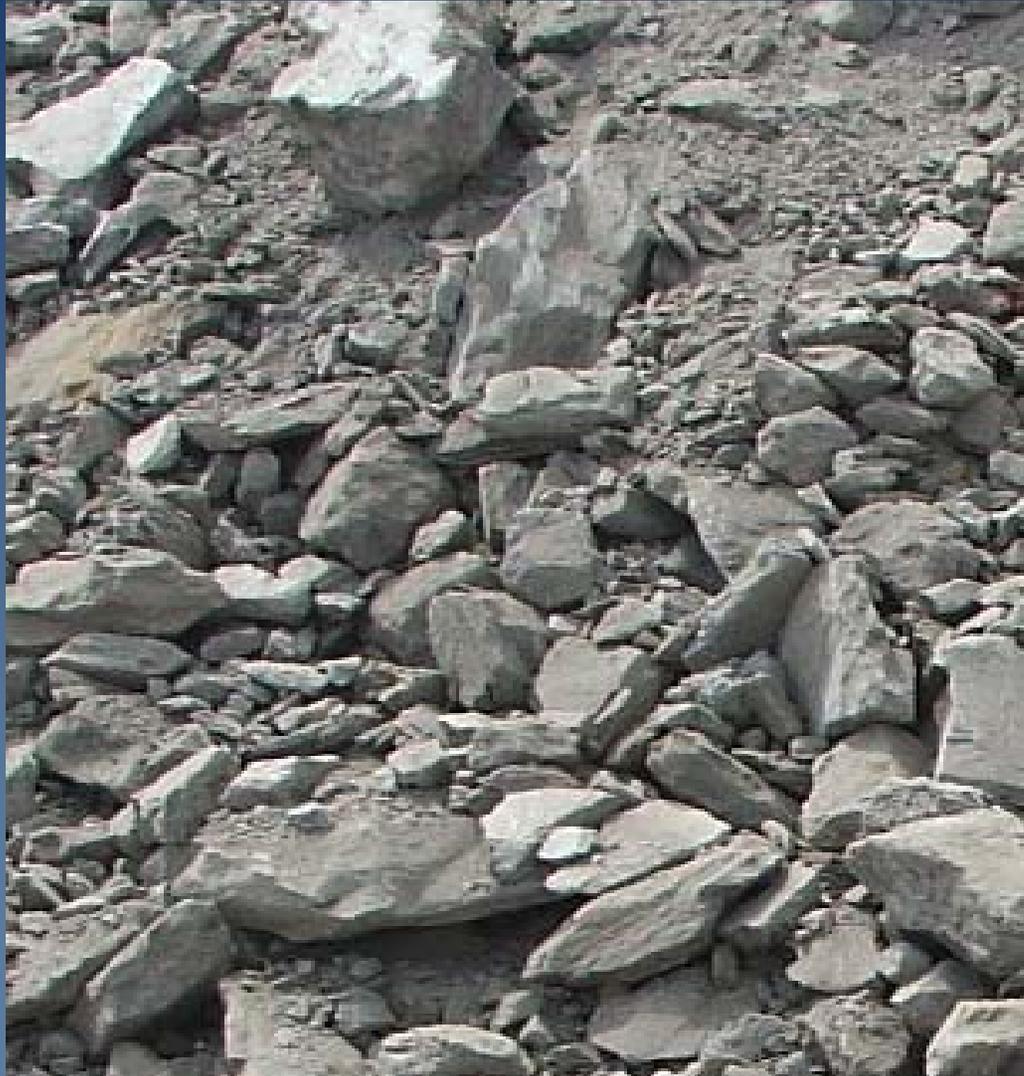
# Granular Material

- Spoil consists of soil, shot rock, or more commonly, a mixture of both
  - **Gradation** – distribution of material sizes in the mix.
  - **Granular Material** - material such as shot rock, gravel, and sand, where the strength depends on the interlocking of particles and the friction between them.
  - **Cohesive Material** – clays - strength depends on “stickiness”, which on a particle level is the electrical attraction between microscopic particles.

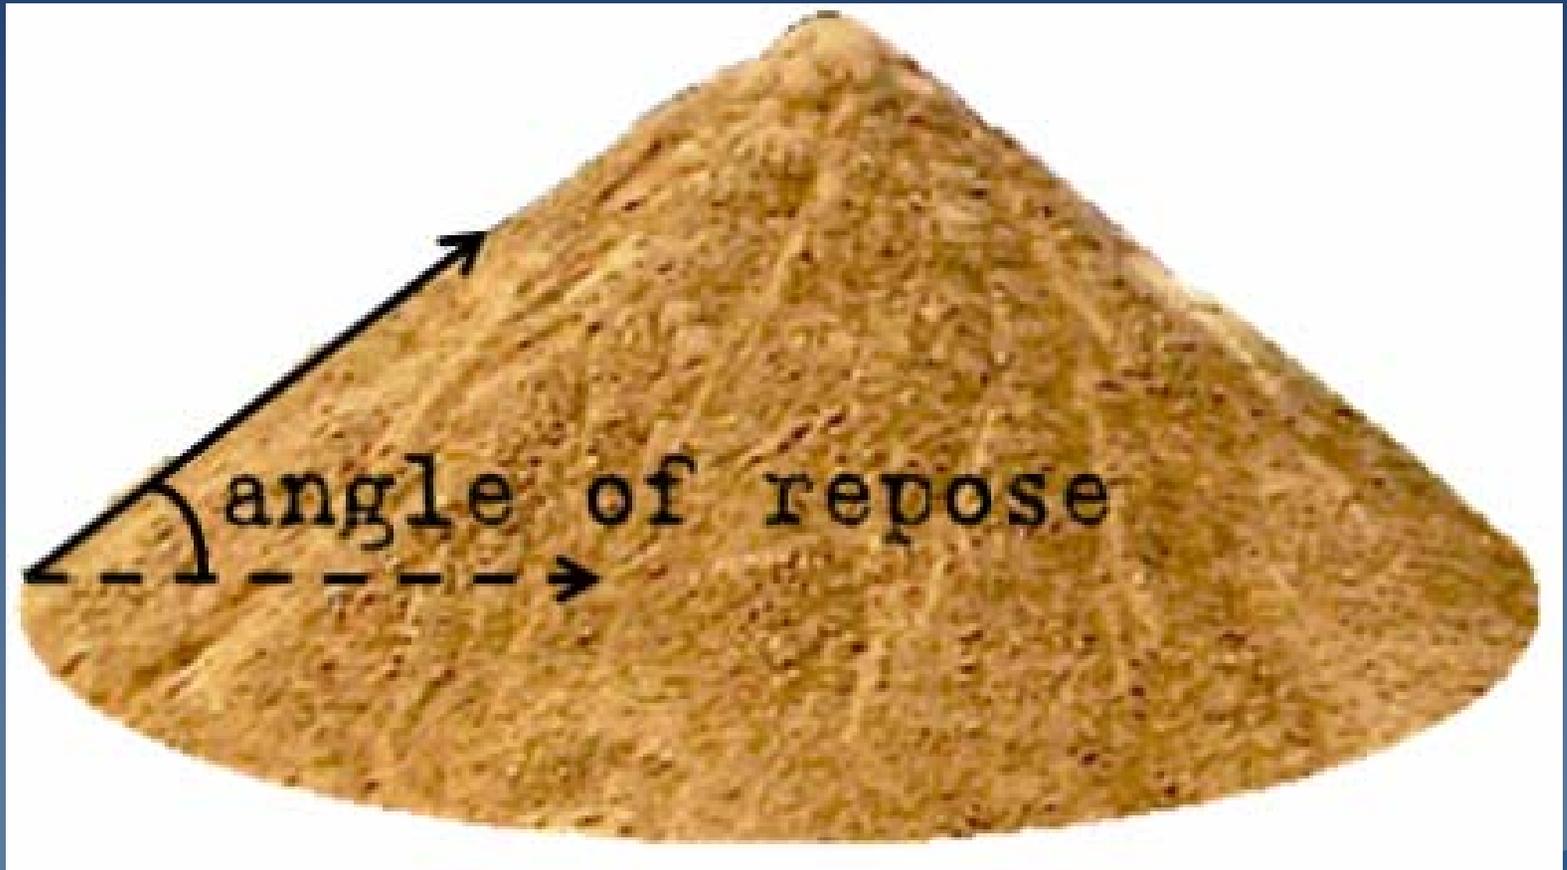
# Angle of Repose

- The angle that a dry, granular, material in a very loose condition will form with respect to the horizontal.
- In a practical sense, it is the angle that spoil will assume when dumped loosely into place.

- The angle of repose depends on characteristics of the material.
  - Roundedness or angularity of particles
  - Gradation
  - Surface roughness
- Typical Range
- Can materials stand steeper than their angles of repose?

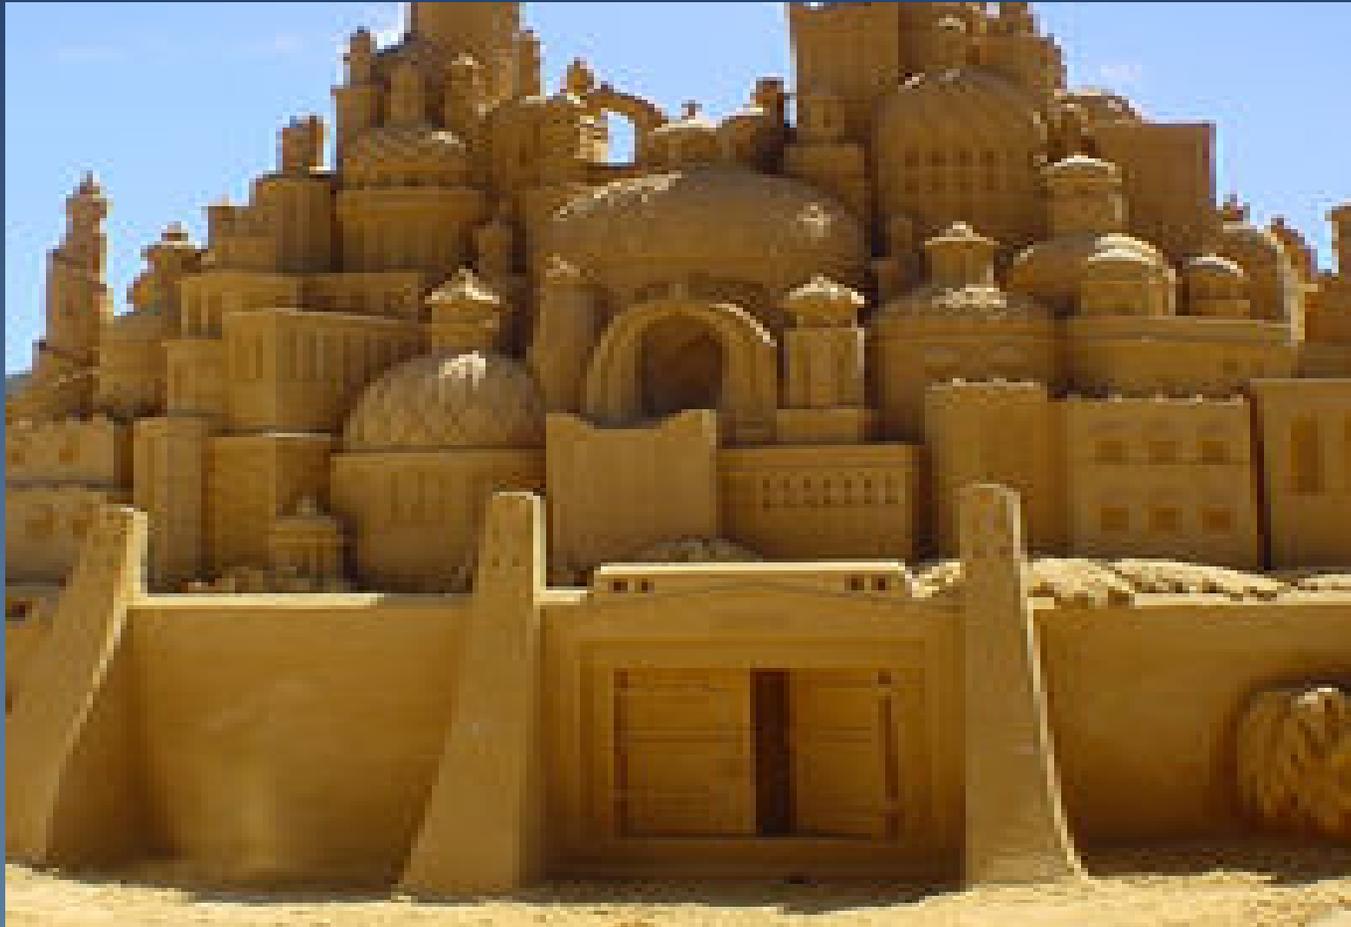
# Apparent Cohesion

- The phenomenon where a moist sandy material can be held in this position by the tension of the water in its pores.
- This is a temporary condition which can change if the material dries out or becomes fully saturated, and should not be relied upon when the safety of miners is involved.

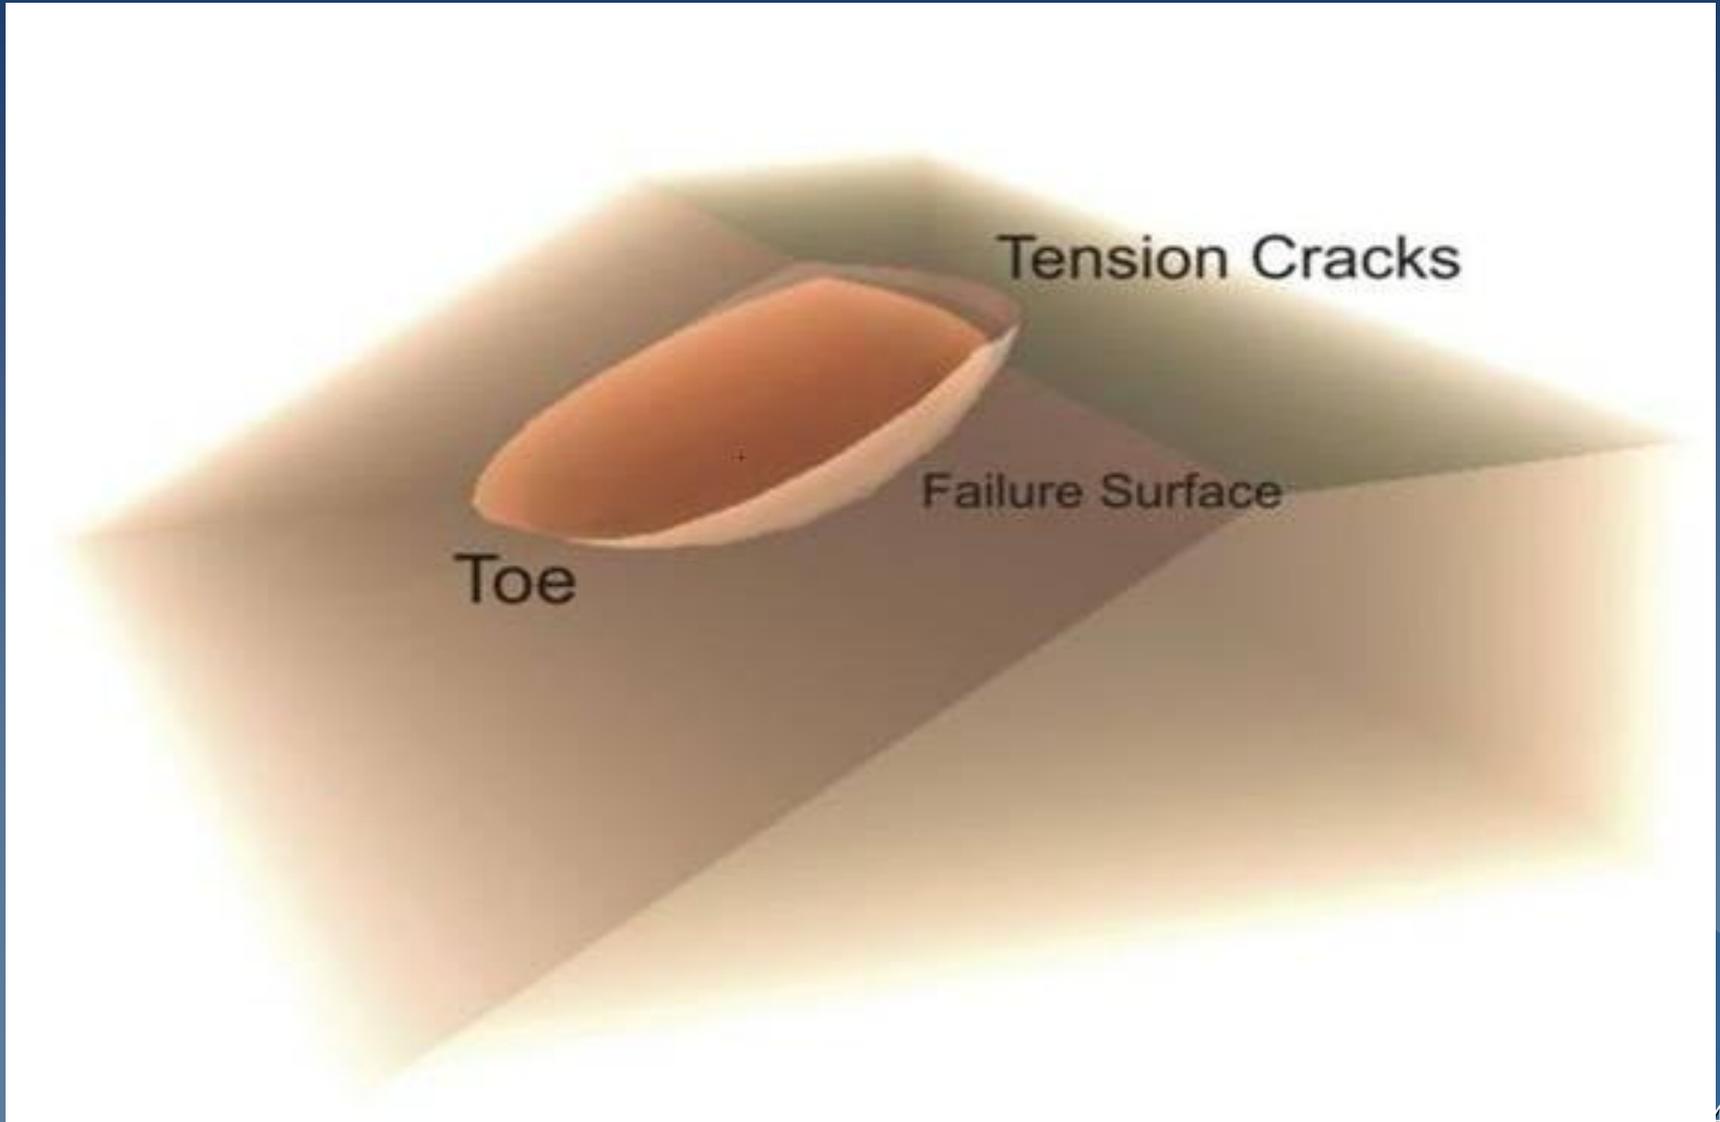
# Spherical Slope Failure

Variety of Slope Failure Circles Analysed at Varying Radii from a Single Circle Centre.

Failure Circle Centre +

Critical Failure Surface

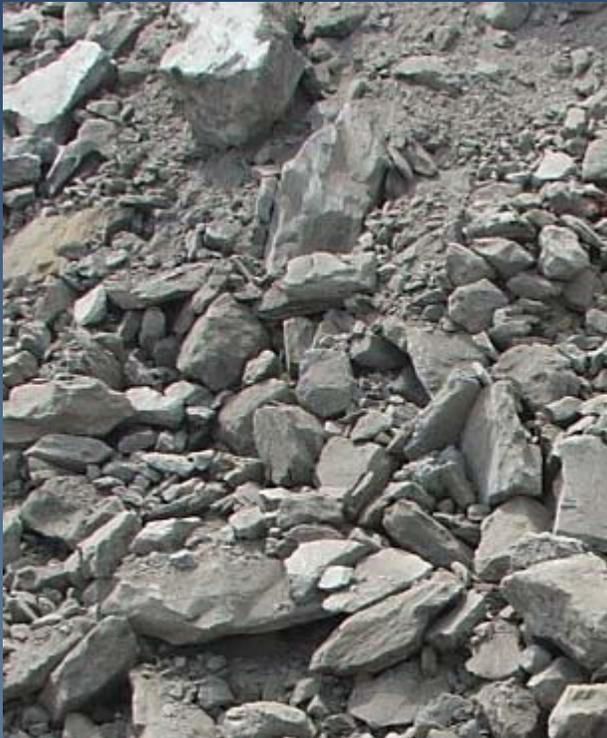
# Granular Material

- Strength of Granular Materials comes from interlocking and frictional resistance between particles.
- Granular materials will have a relatively high value of  $\phi$ .

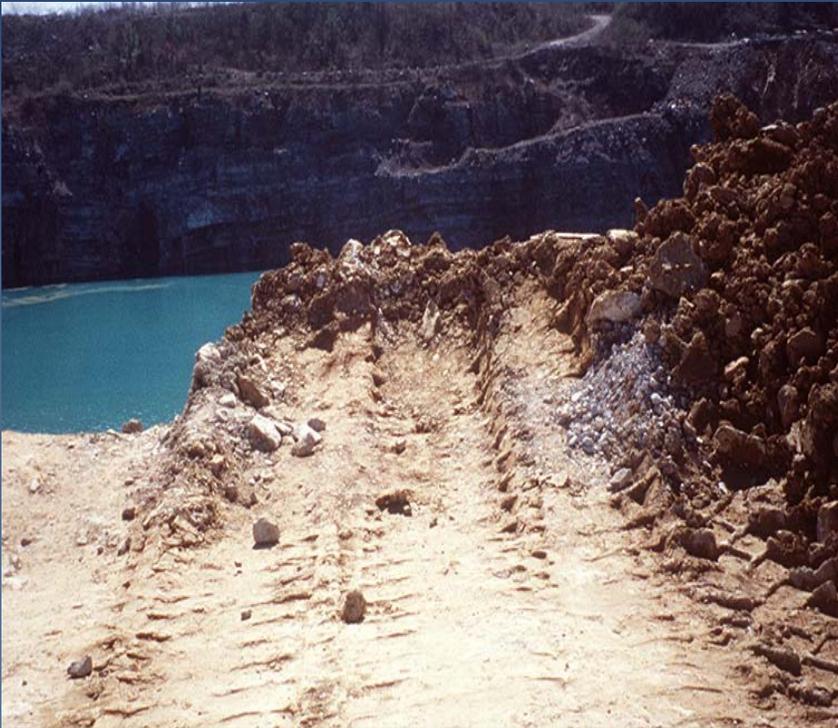
# Cohesive Material

- Strength of Cohesive Materials comes from electrical attraction between microscopic particles.
- Cohesive soils will have a high value of  $C$ .

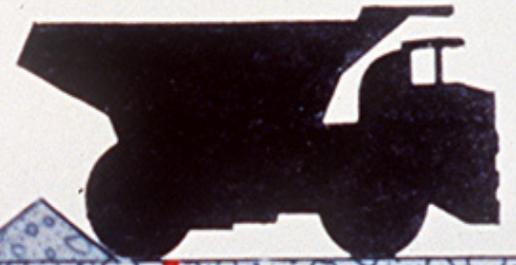
22 TON TRUCK

35° SLOPE

50' HIGH

F.S.=1.2

{6' FROM EDGE}

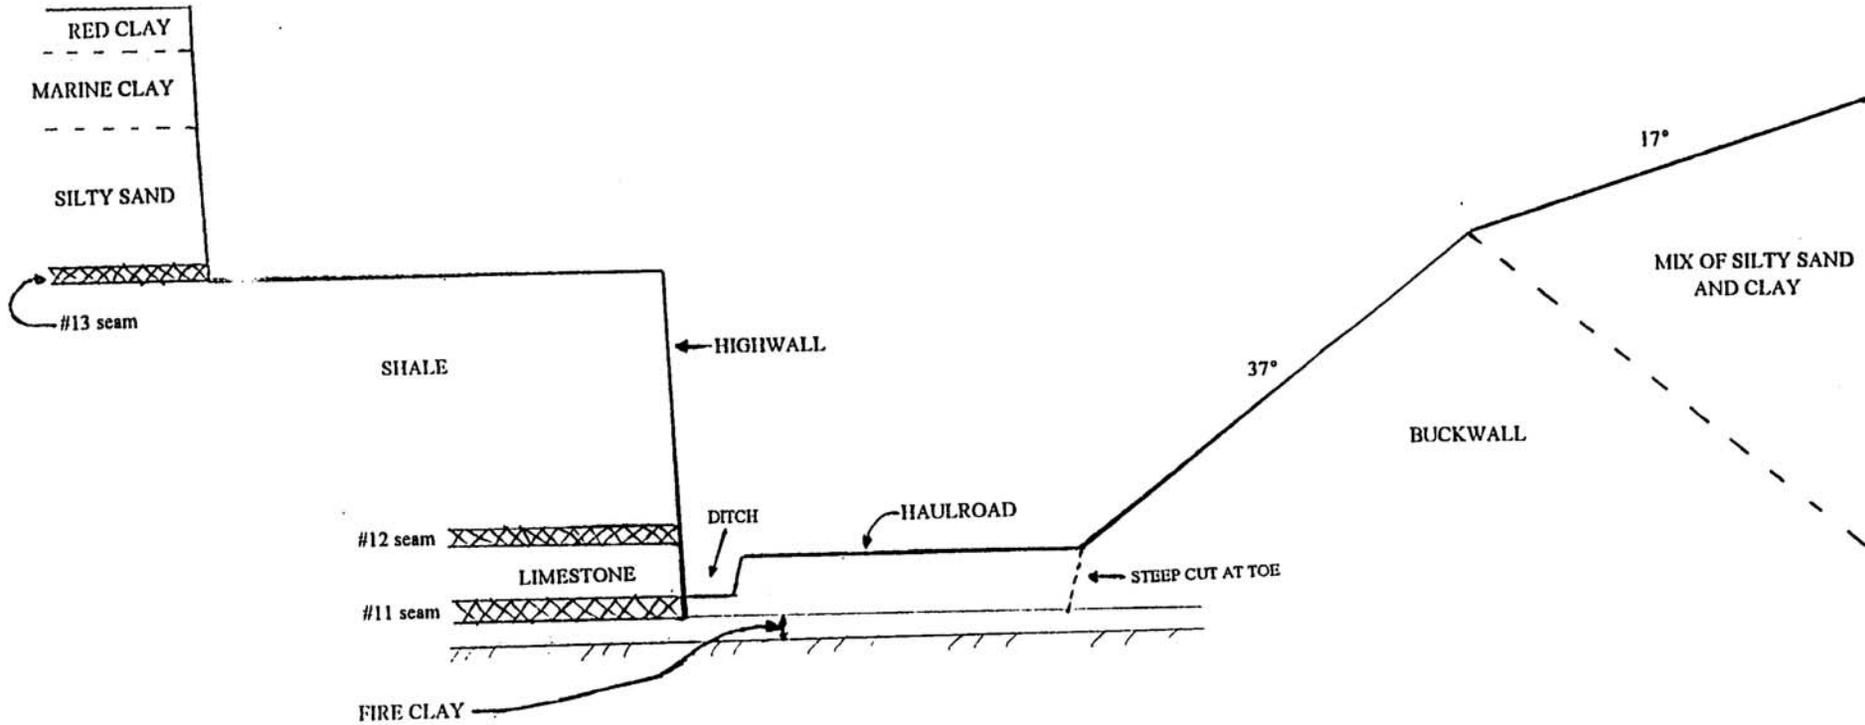
TYPICAL CROSS-SECTION

- 45 cu. yd. dragline used to remove 80 ft of overburden to expose 2 coal seams, creating a 100 ft wide pit
- Pit floor comprised of soft fireclay layer
- Mining through the flood plane of an old river channel, consisting of very soft wet stream deposits.
- In order to deal with these difficult conditions, the dragline was used to cast the shot rock (shale) on opposite side of pit to form a 80 ft high buckwall (angle of repose 37 deg.)
- clay material was placed immediately behind buckwall, followed by silty sands and other wet soil/mud material (angle of repose 17 deg.)

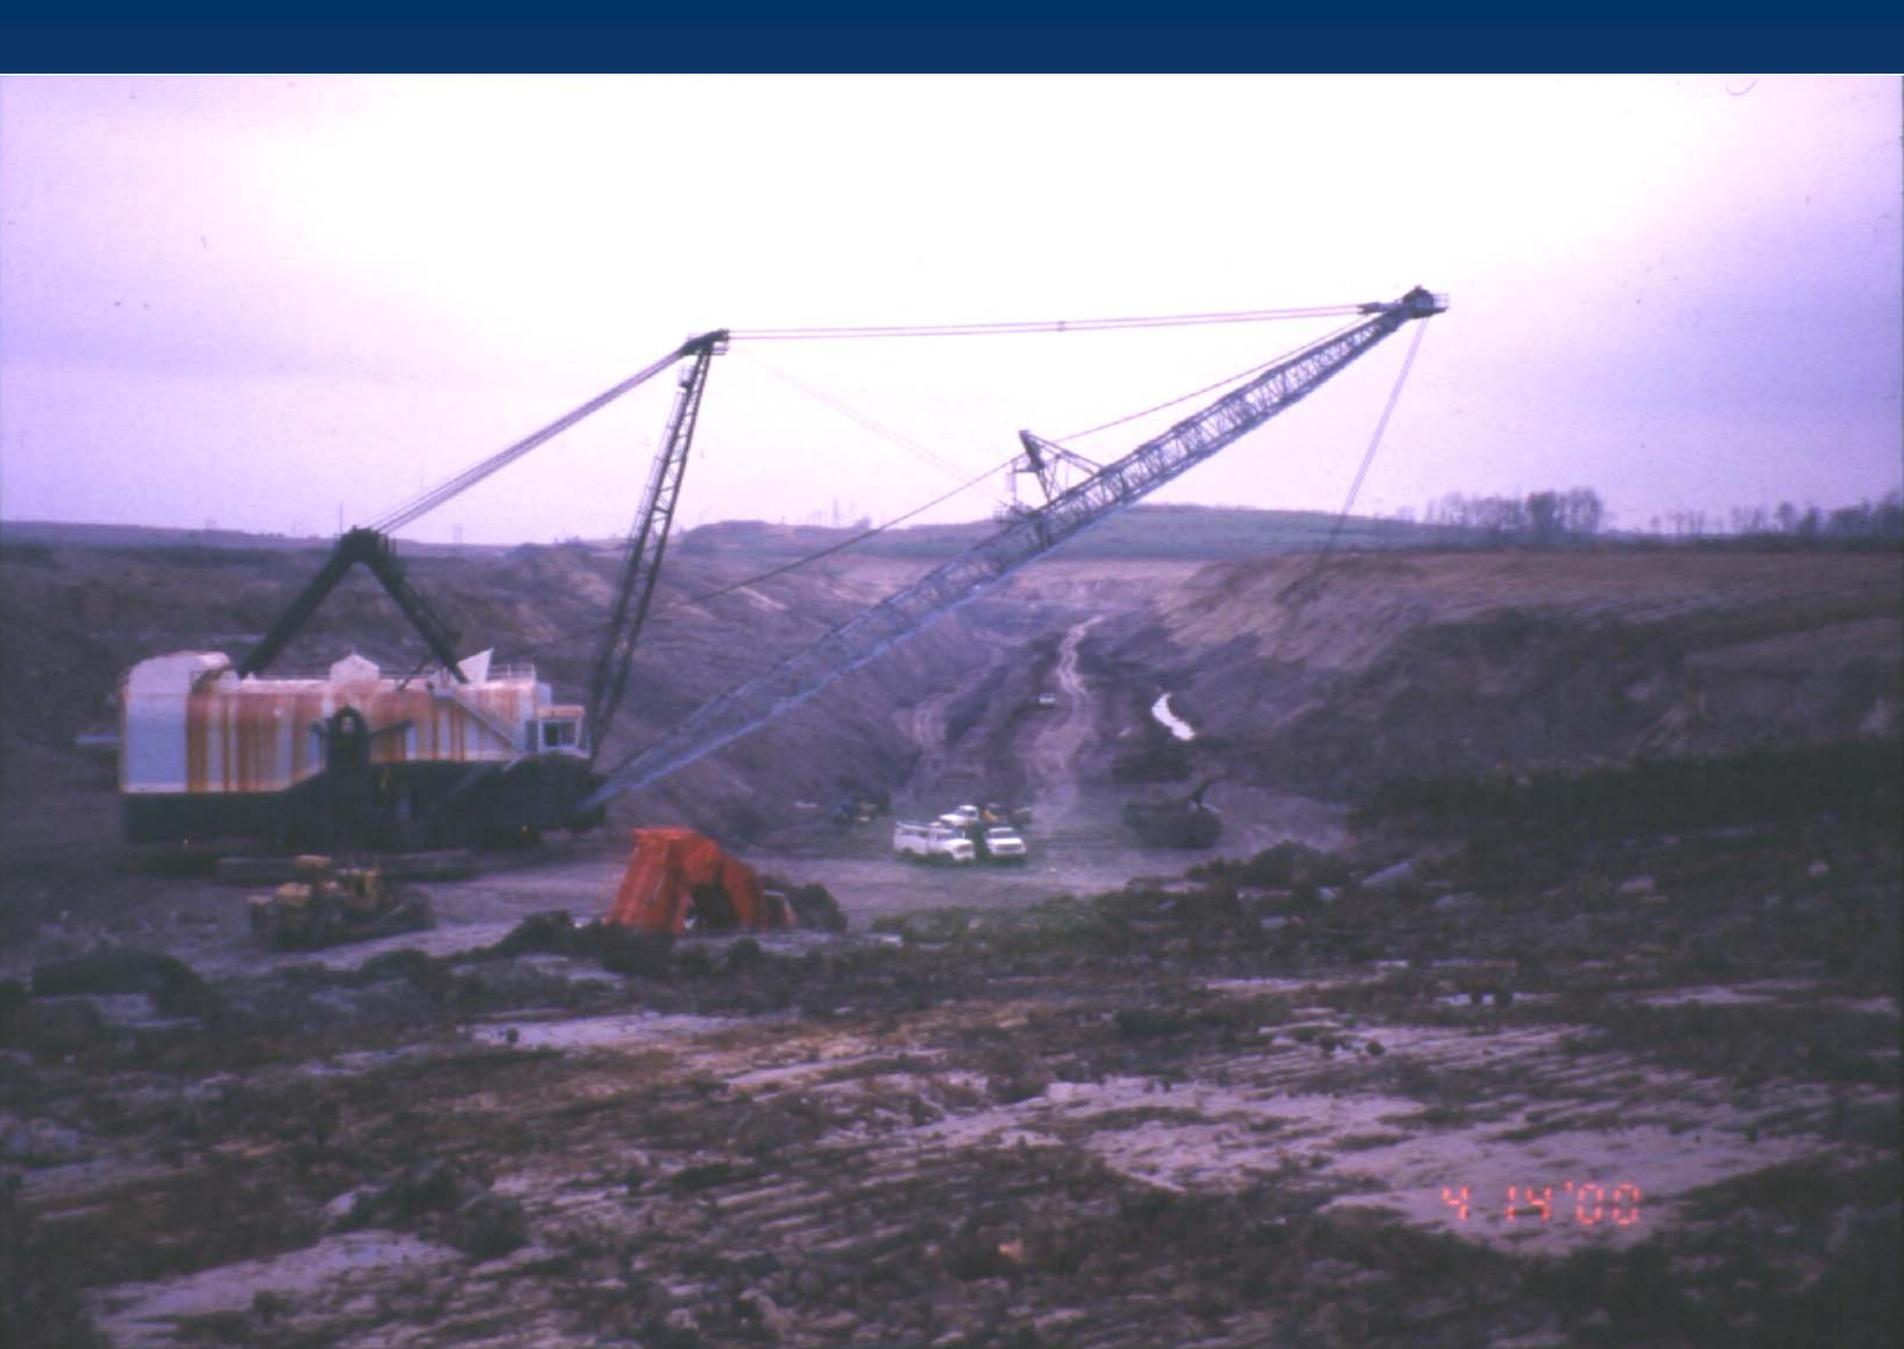
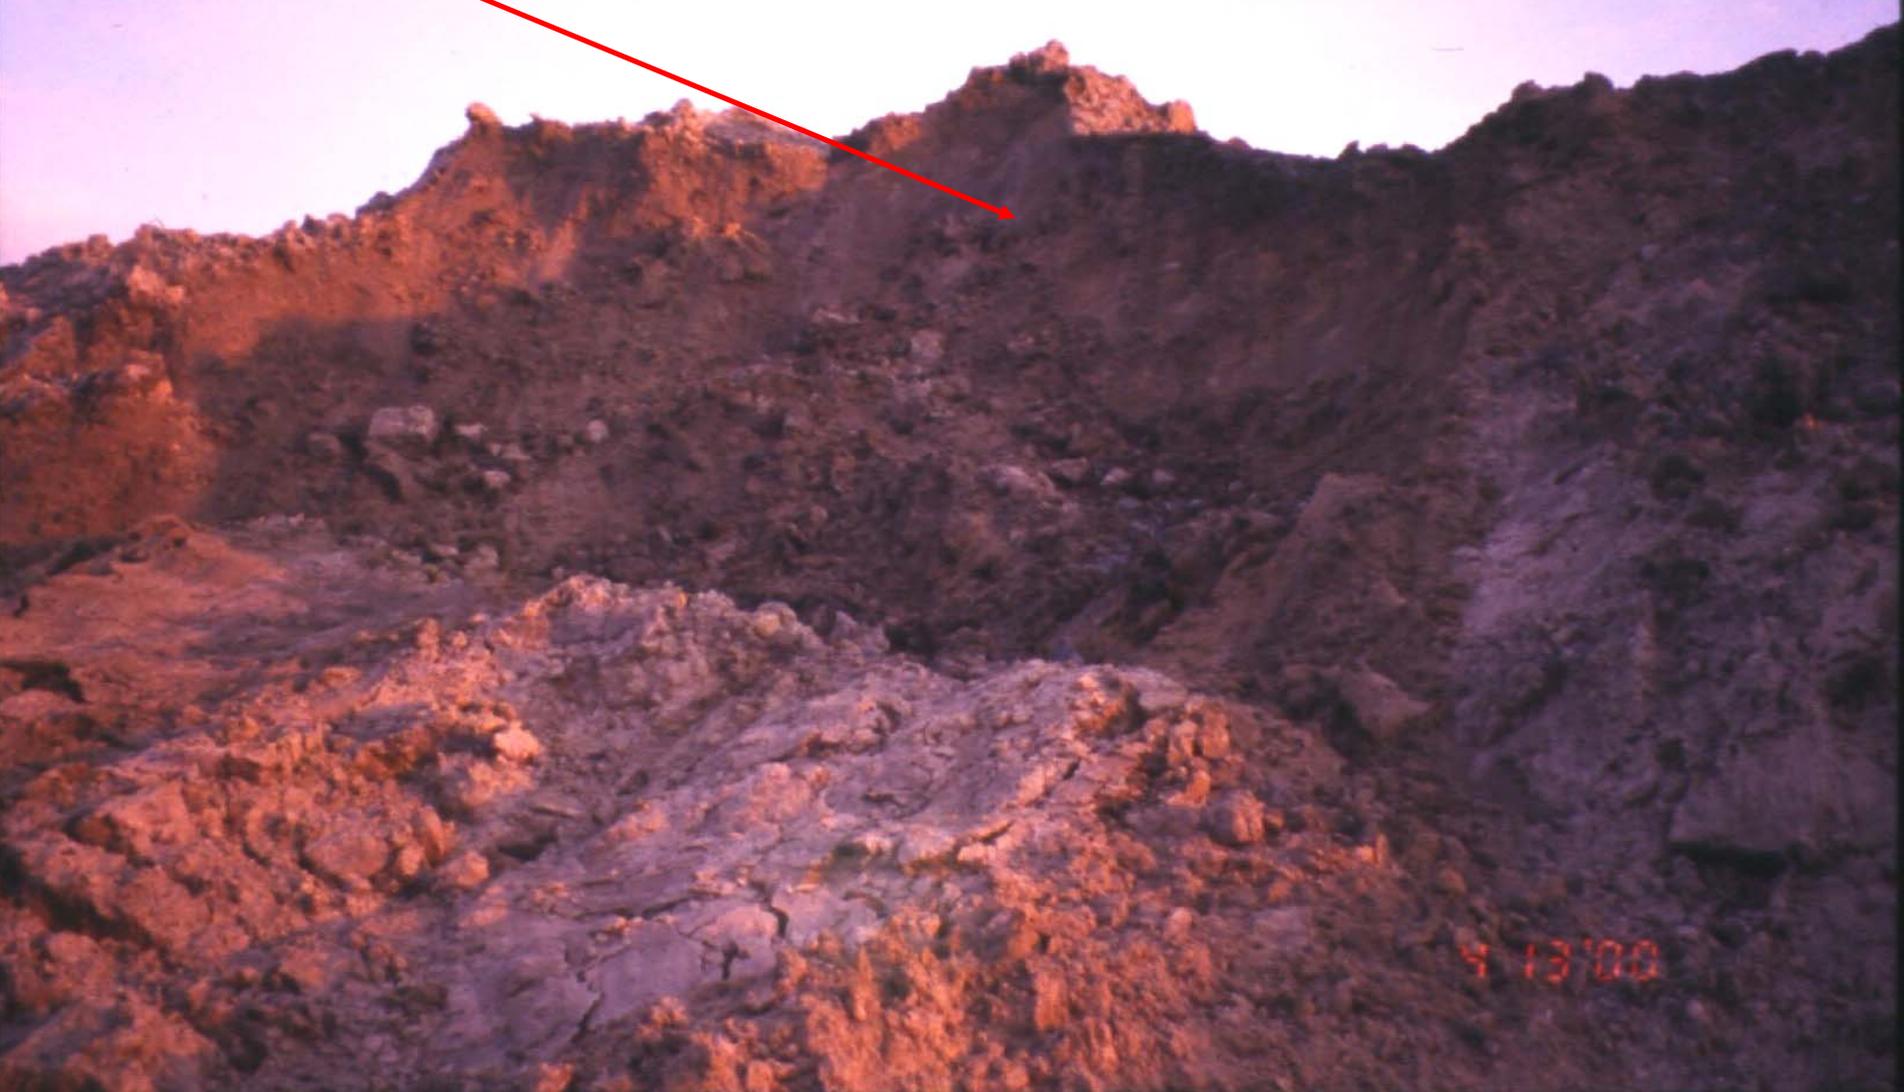
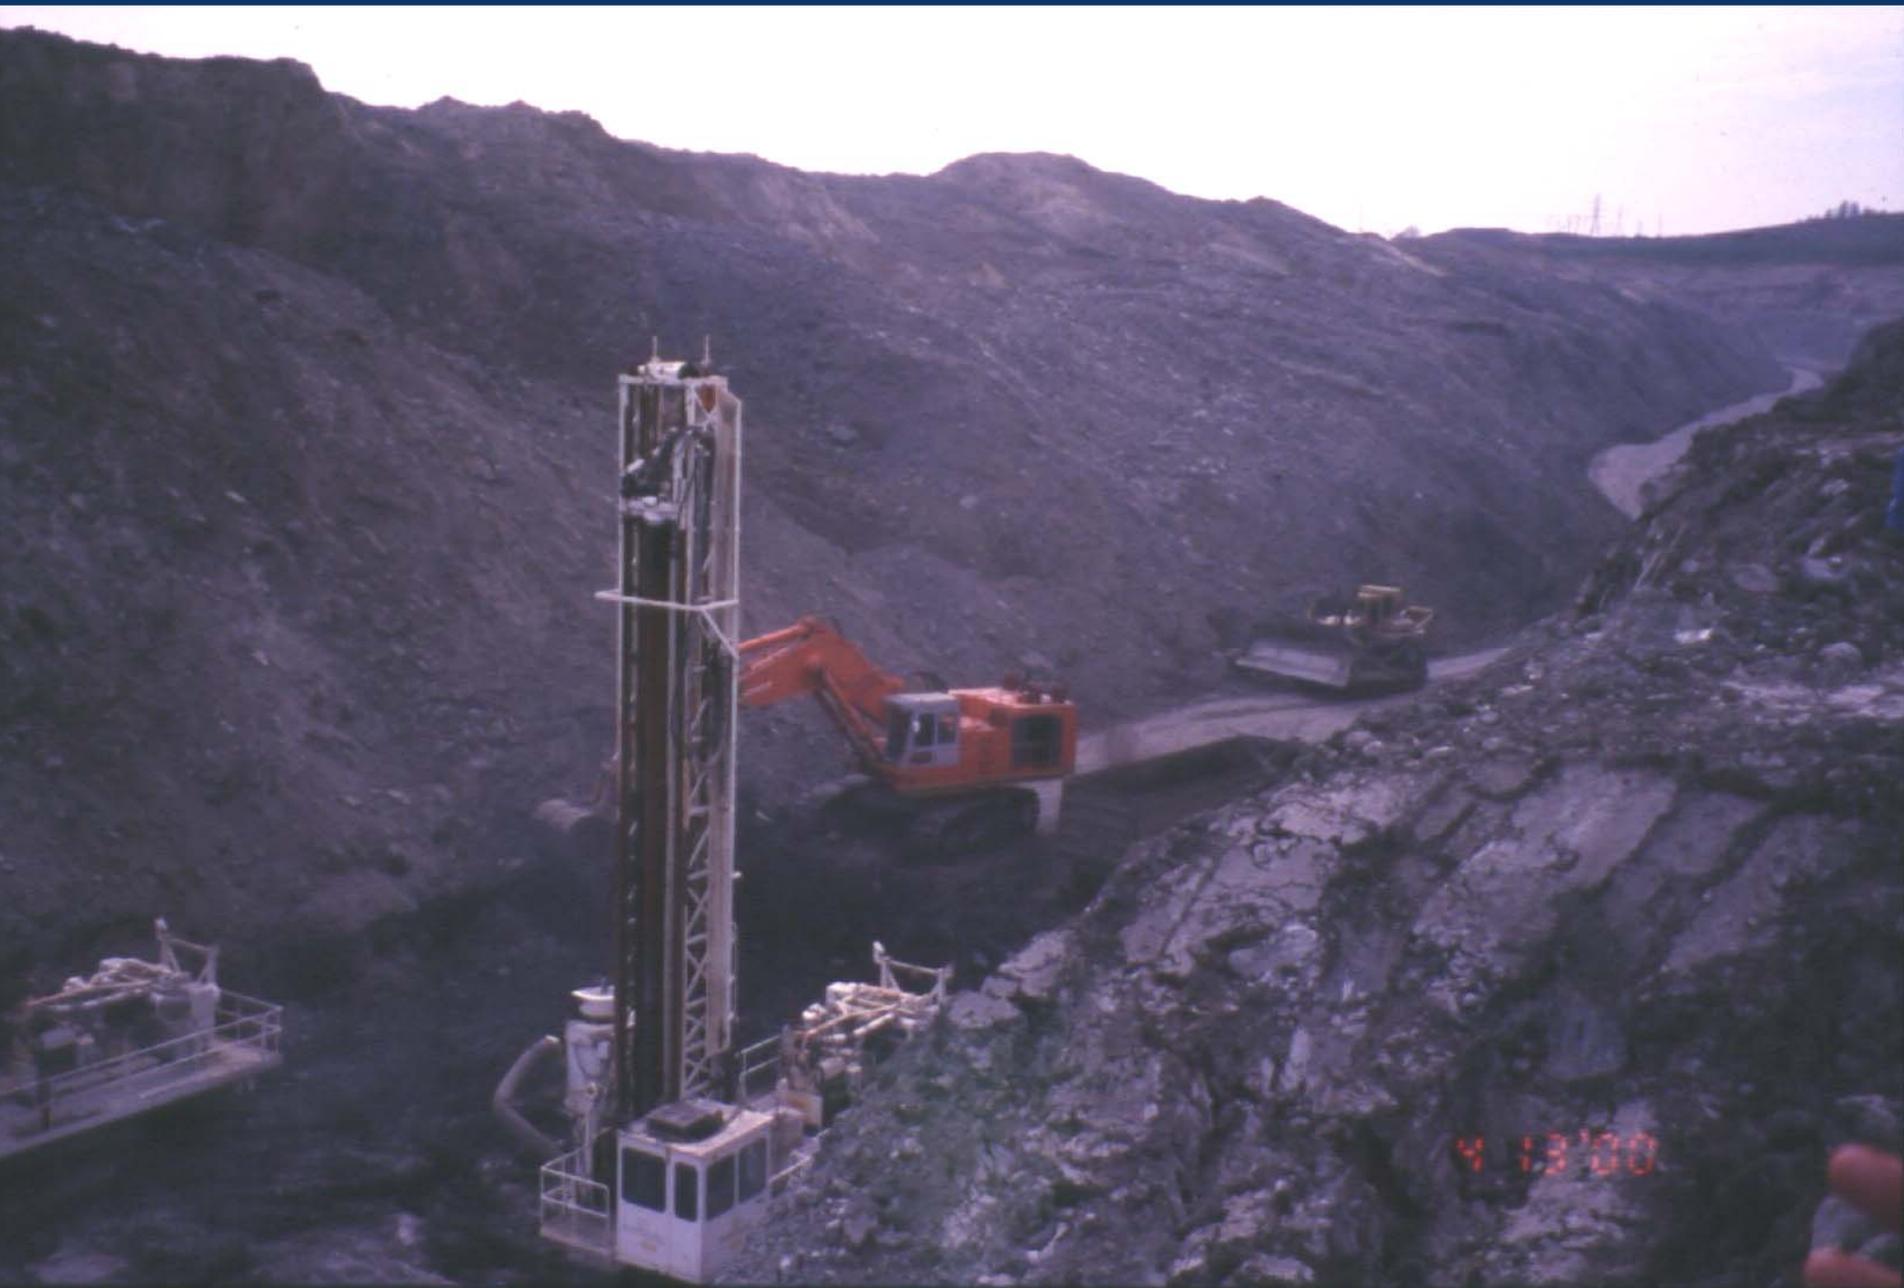
- April 11, 2000, large mass of spoil slid into the active pit
- Failure was preceded by rocks rolling down into the pit; miners were evacuated; then the spoil mass failed within a half-hour later
- Company breached top of spoil buckwall to allow additional soft clay and sand to flow down into the pit.

Back-scarp

- Massive translational and rotational slide
- The spoil mass slid along the fireclay material at the base of the spoil bank, and there was also a deep-seated rotational slide within the spoil itself
- Top of slide mass was about 50 ft above the top of the buckwall, and left a 15- to 35-foot-high back-scarp
- Lateral extent of slide was 600-700 feet
- Buckwall reposed to about 33.5 degrees
- January 2000: 10-15 ft of water accumulated in pit bottom after heavy rainfall and sat there for several months. This most likely softened the fireclay and led to the failure

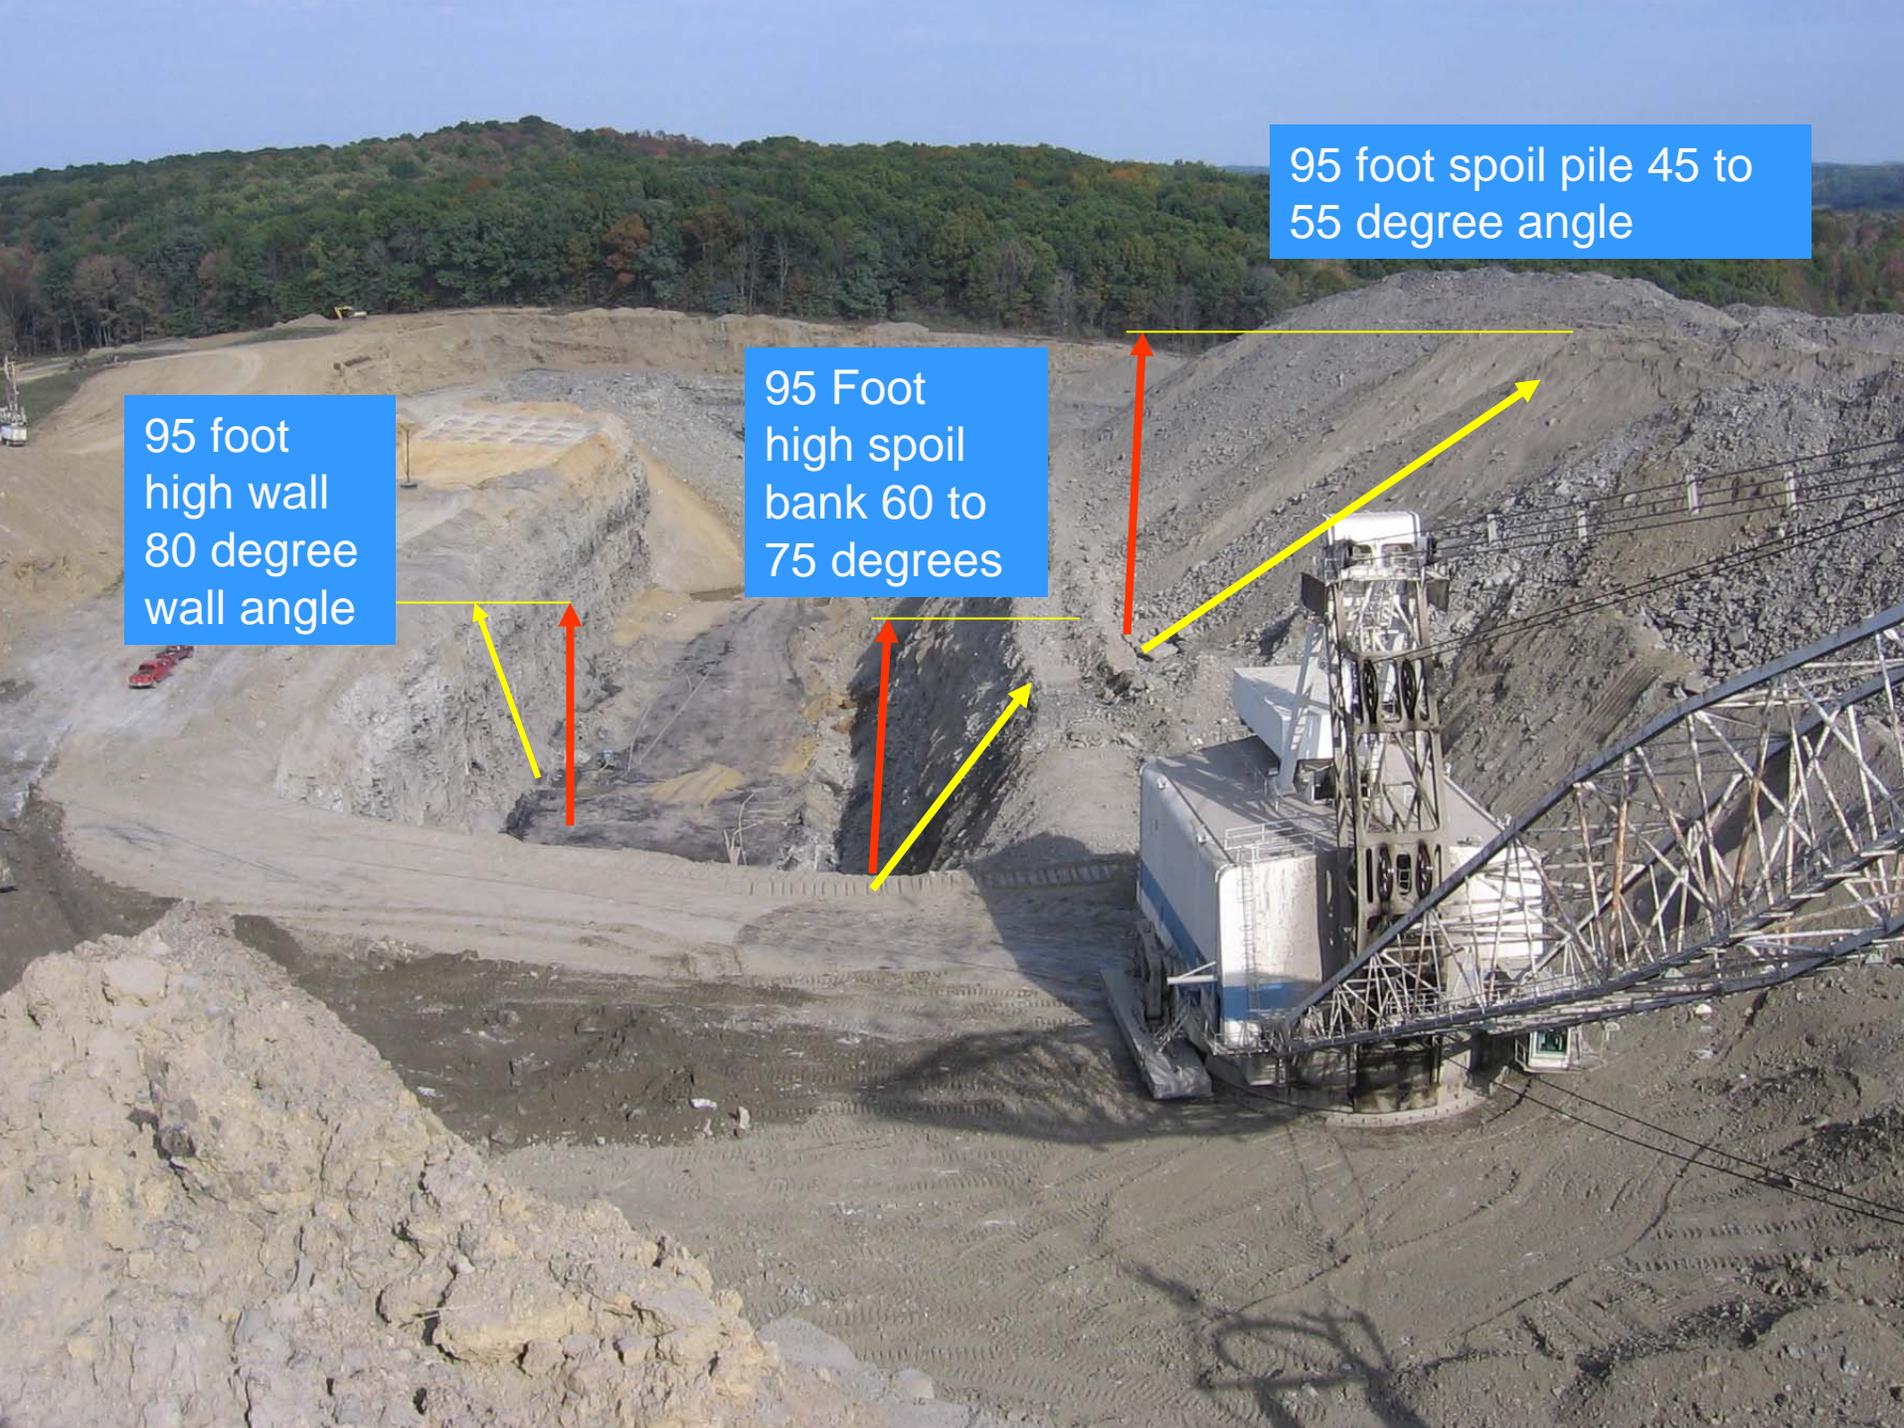
95 foot spoil pile 45 to 55 degree angle

95 foot high wall 80 degree wall angle

95 Foot high spoil bank 60 to 75 degrees

Best visual look at height of spoil pile.

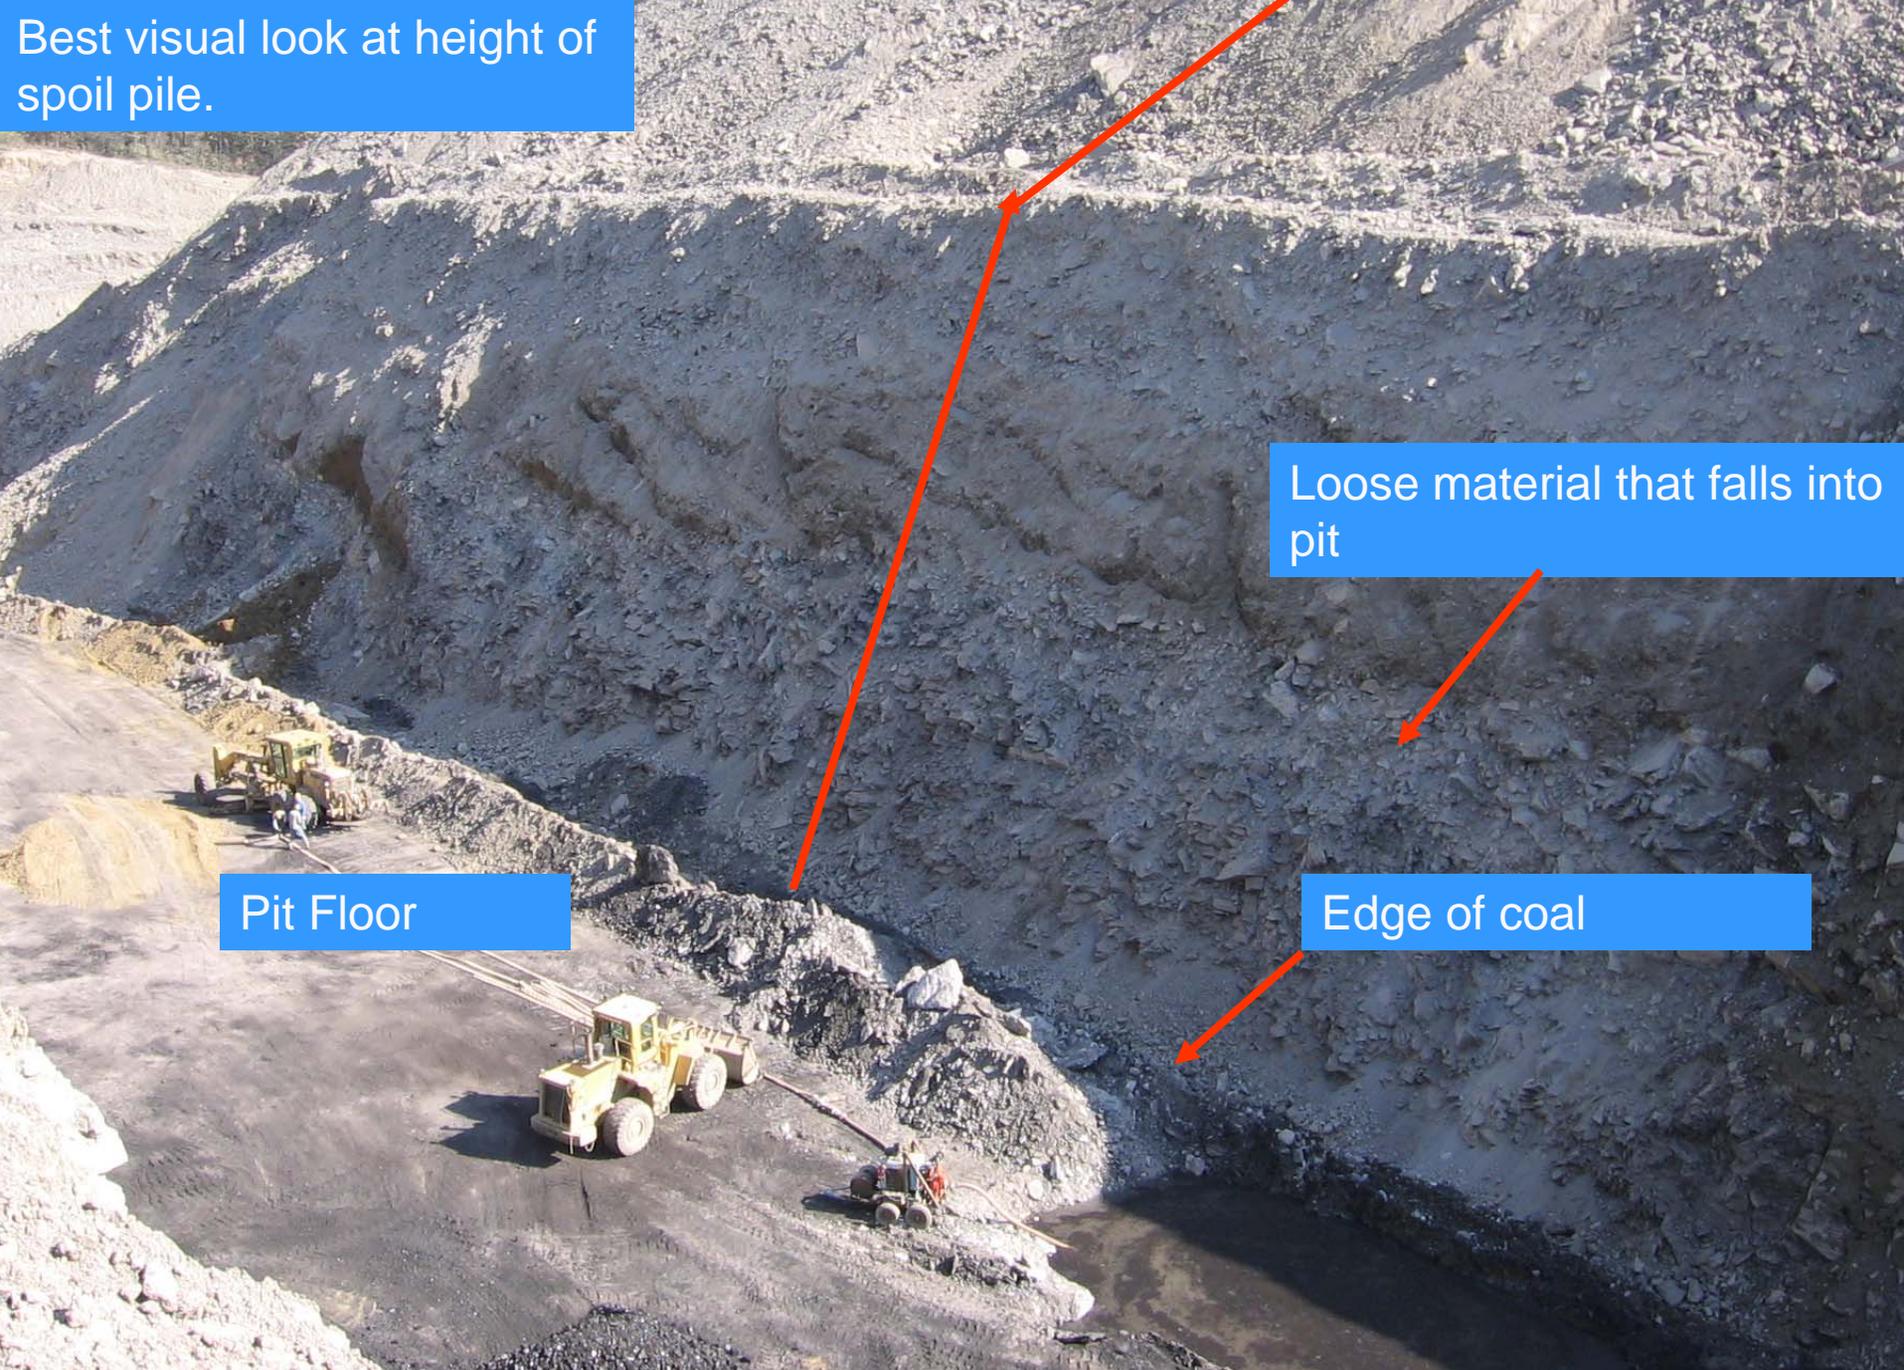
Loose material that falls into pit

Pit Floor

Edge of coal

Top half of 190 foot  
spoil pile
