# **Ground Control at Surface Mines**

## **Spoil Pile Safety**

**Mine Waste and Geotechnical Engineering Division**  
**Pittsburgh Safety and Health Technology Center**  
**Directorate of Technical Support**  
**Mine Safety and Health Administration, USDOL**

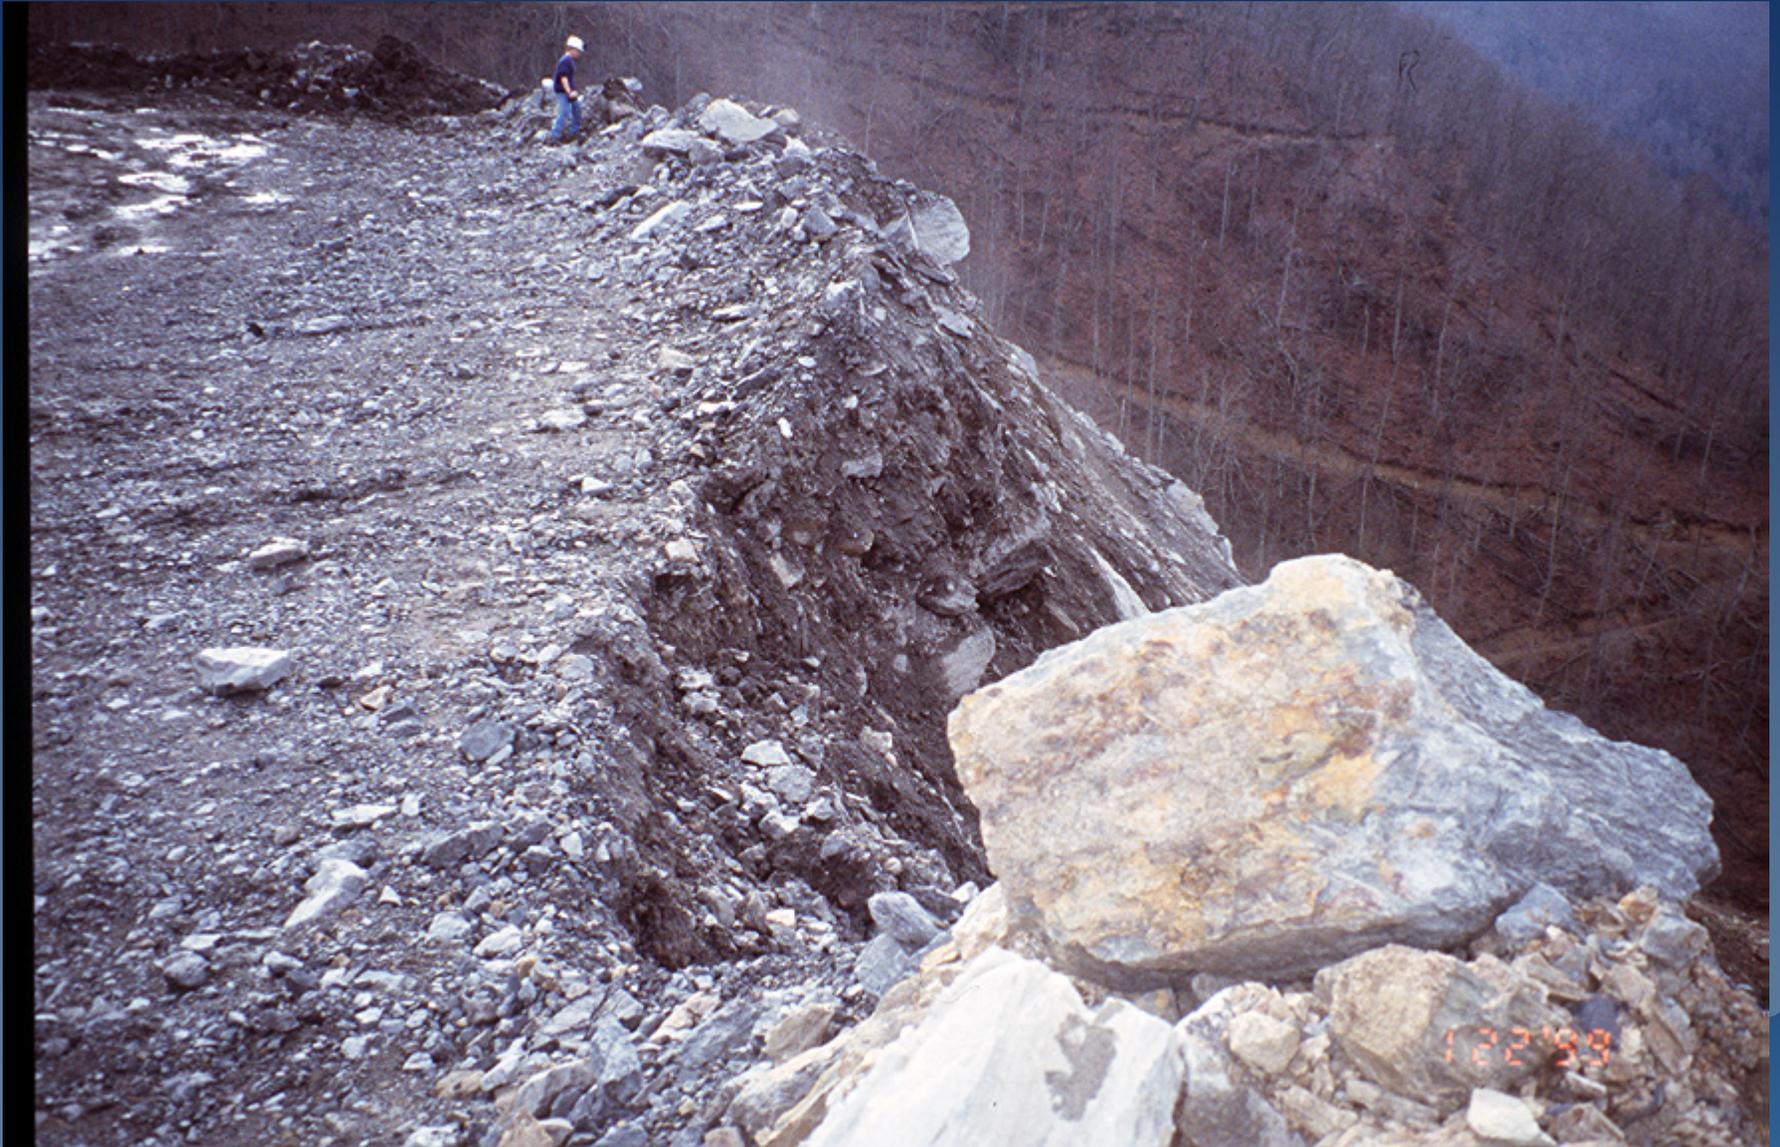
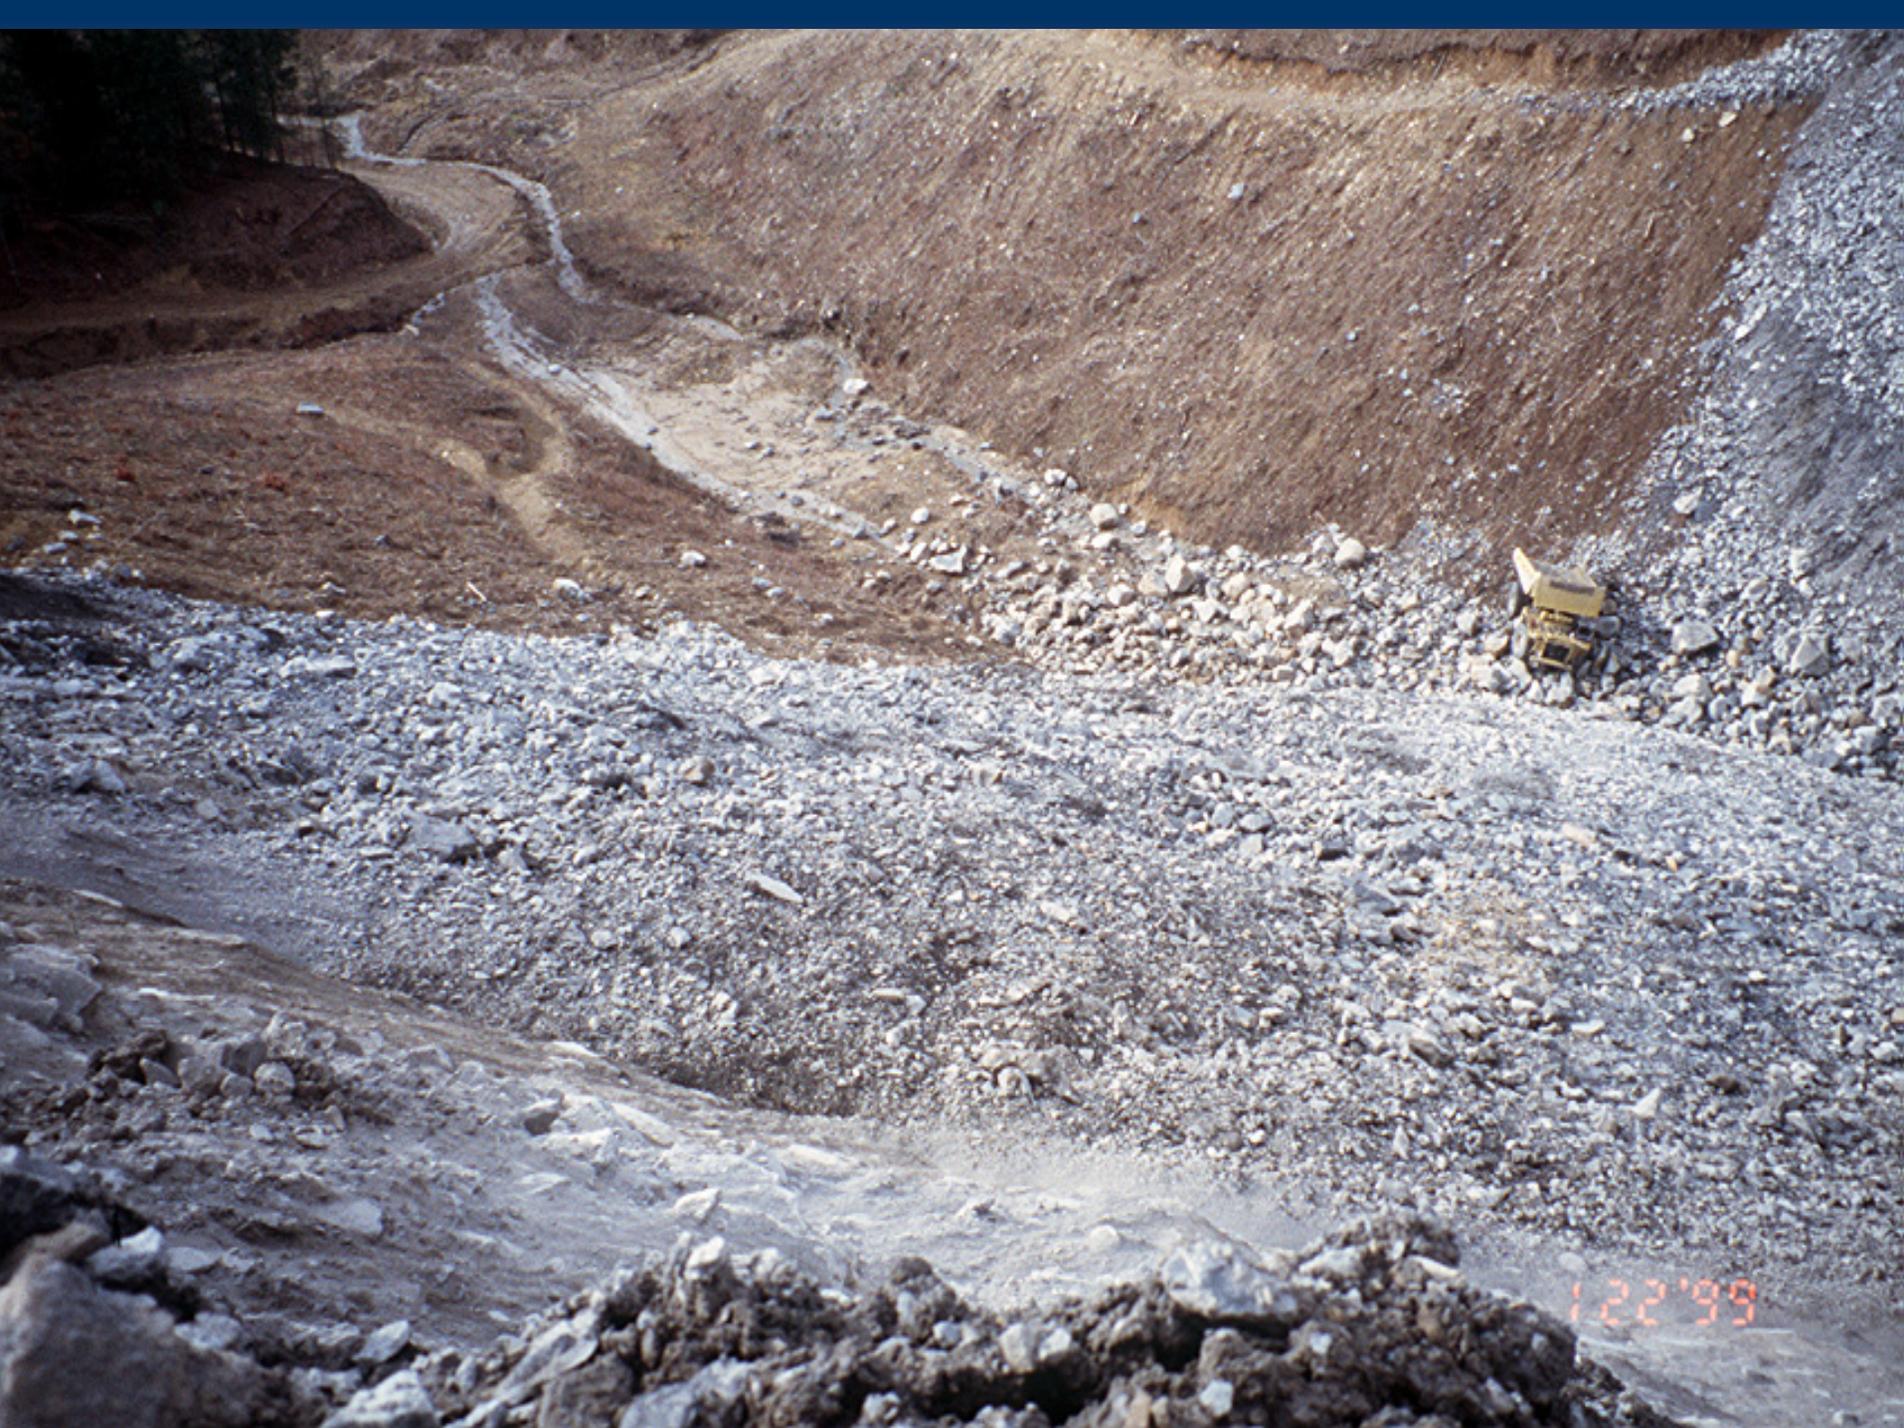
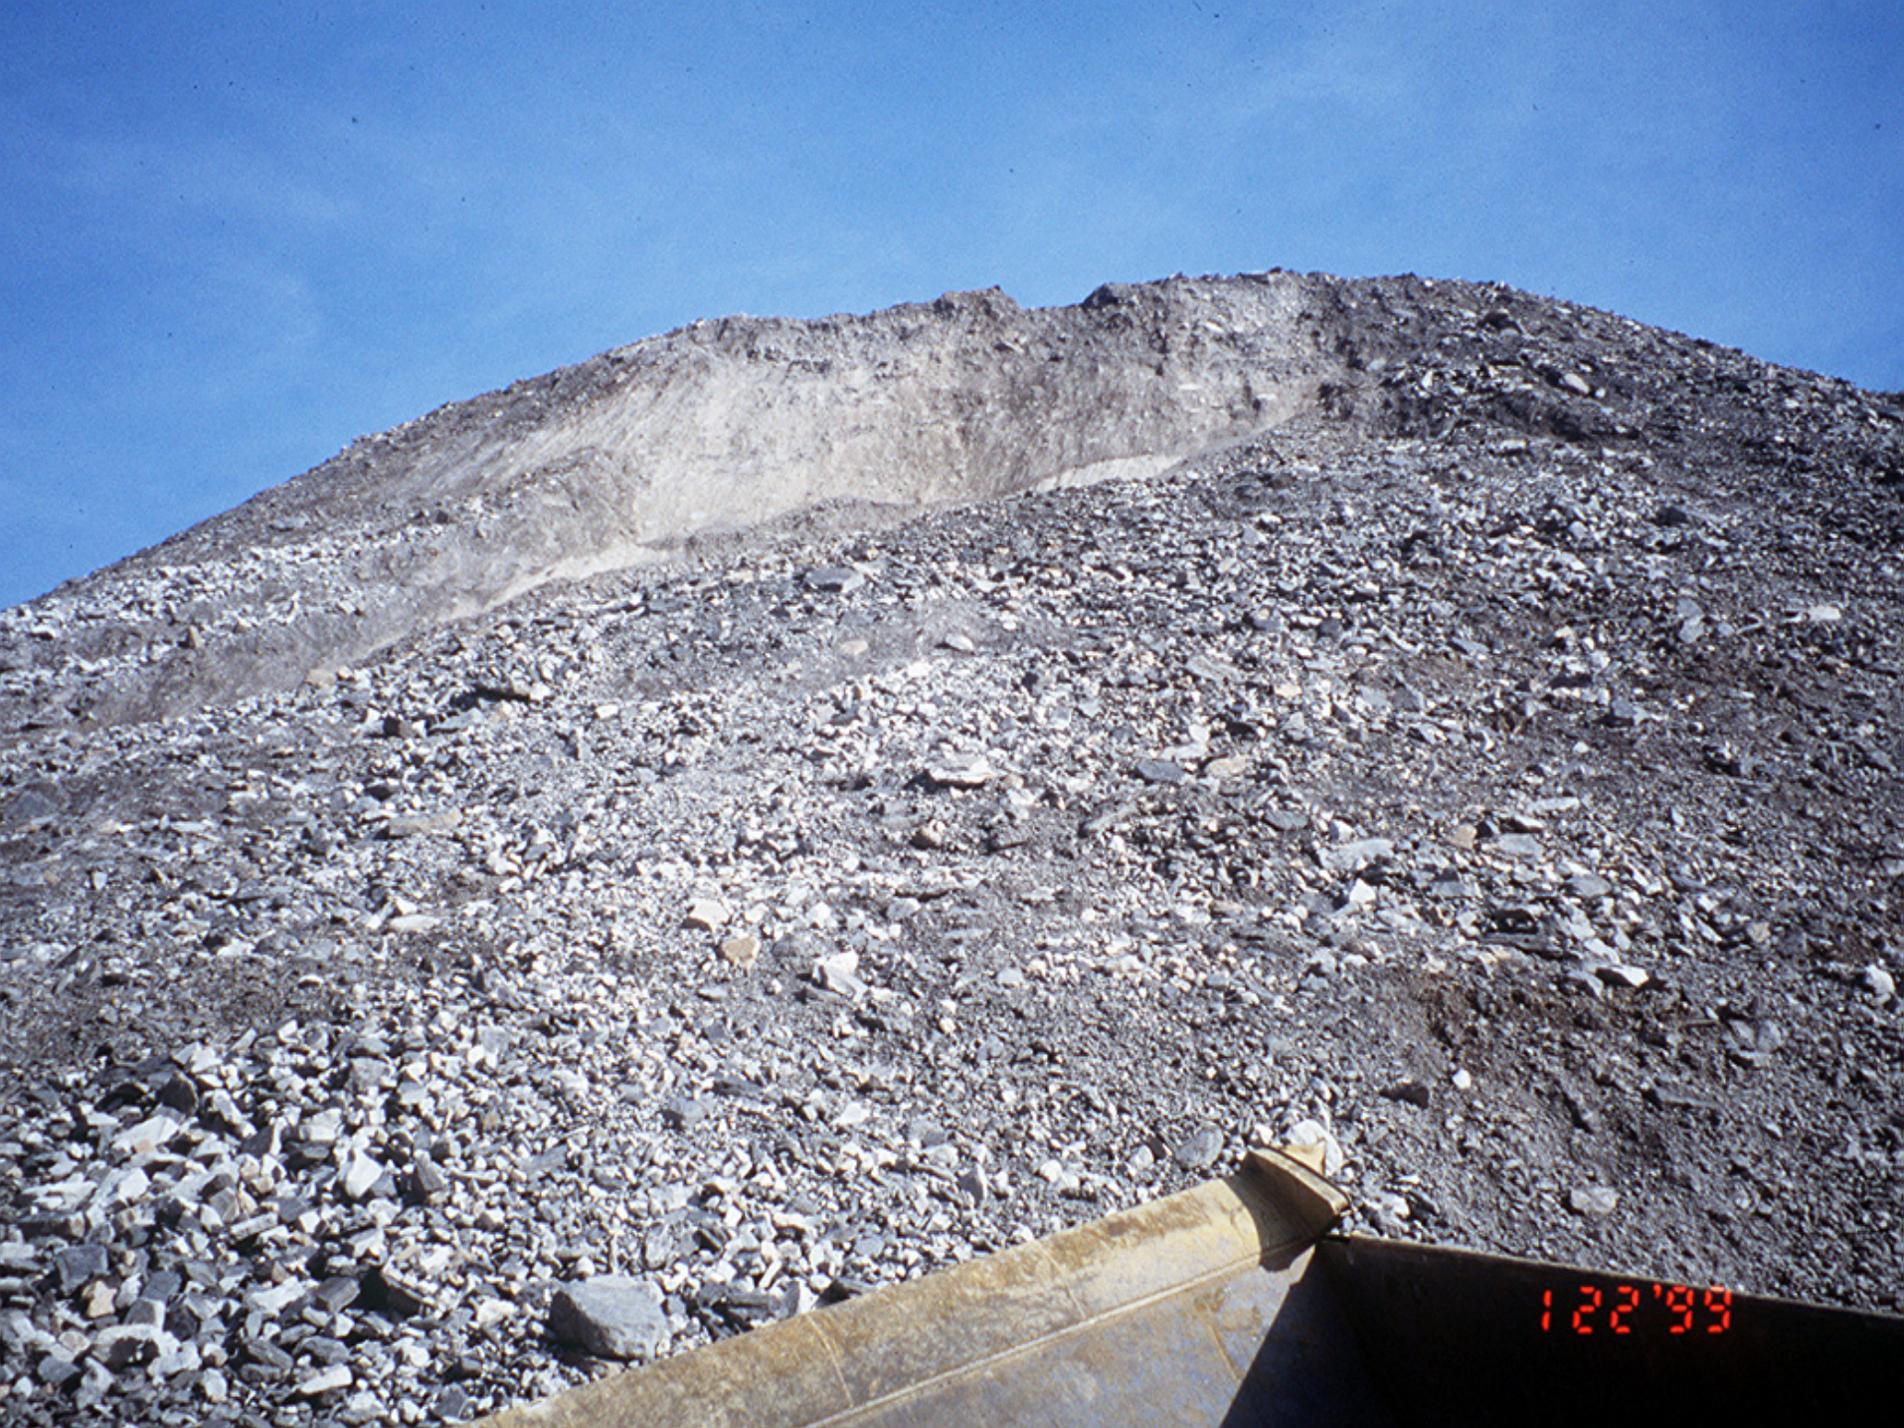
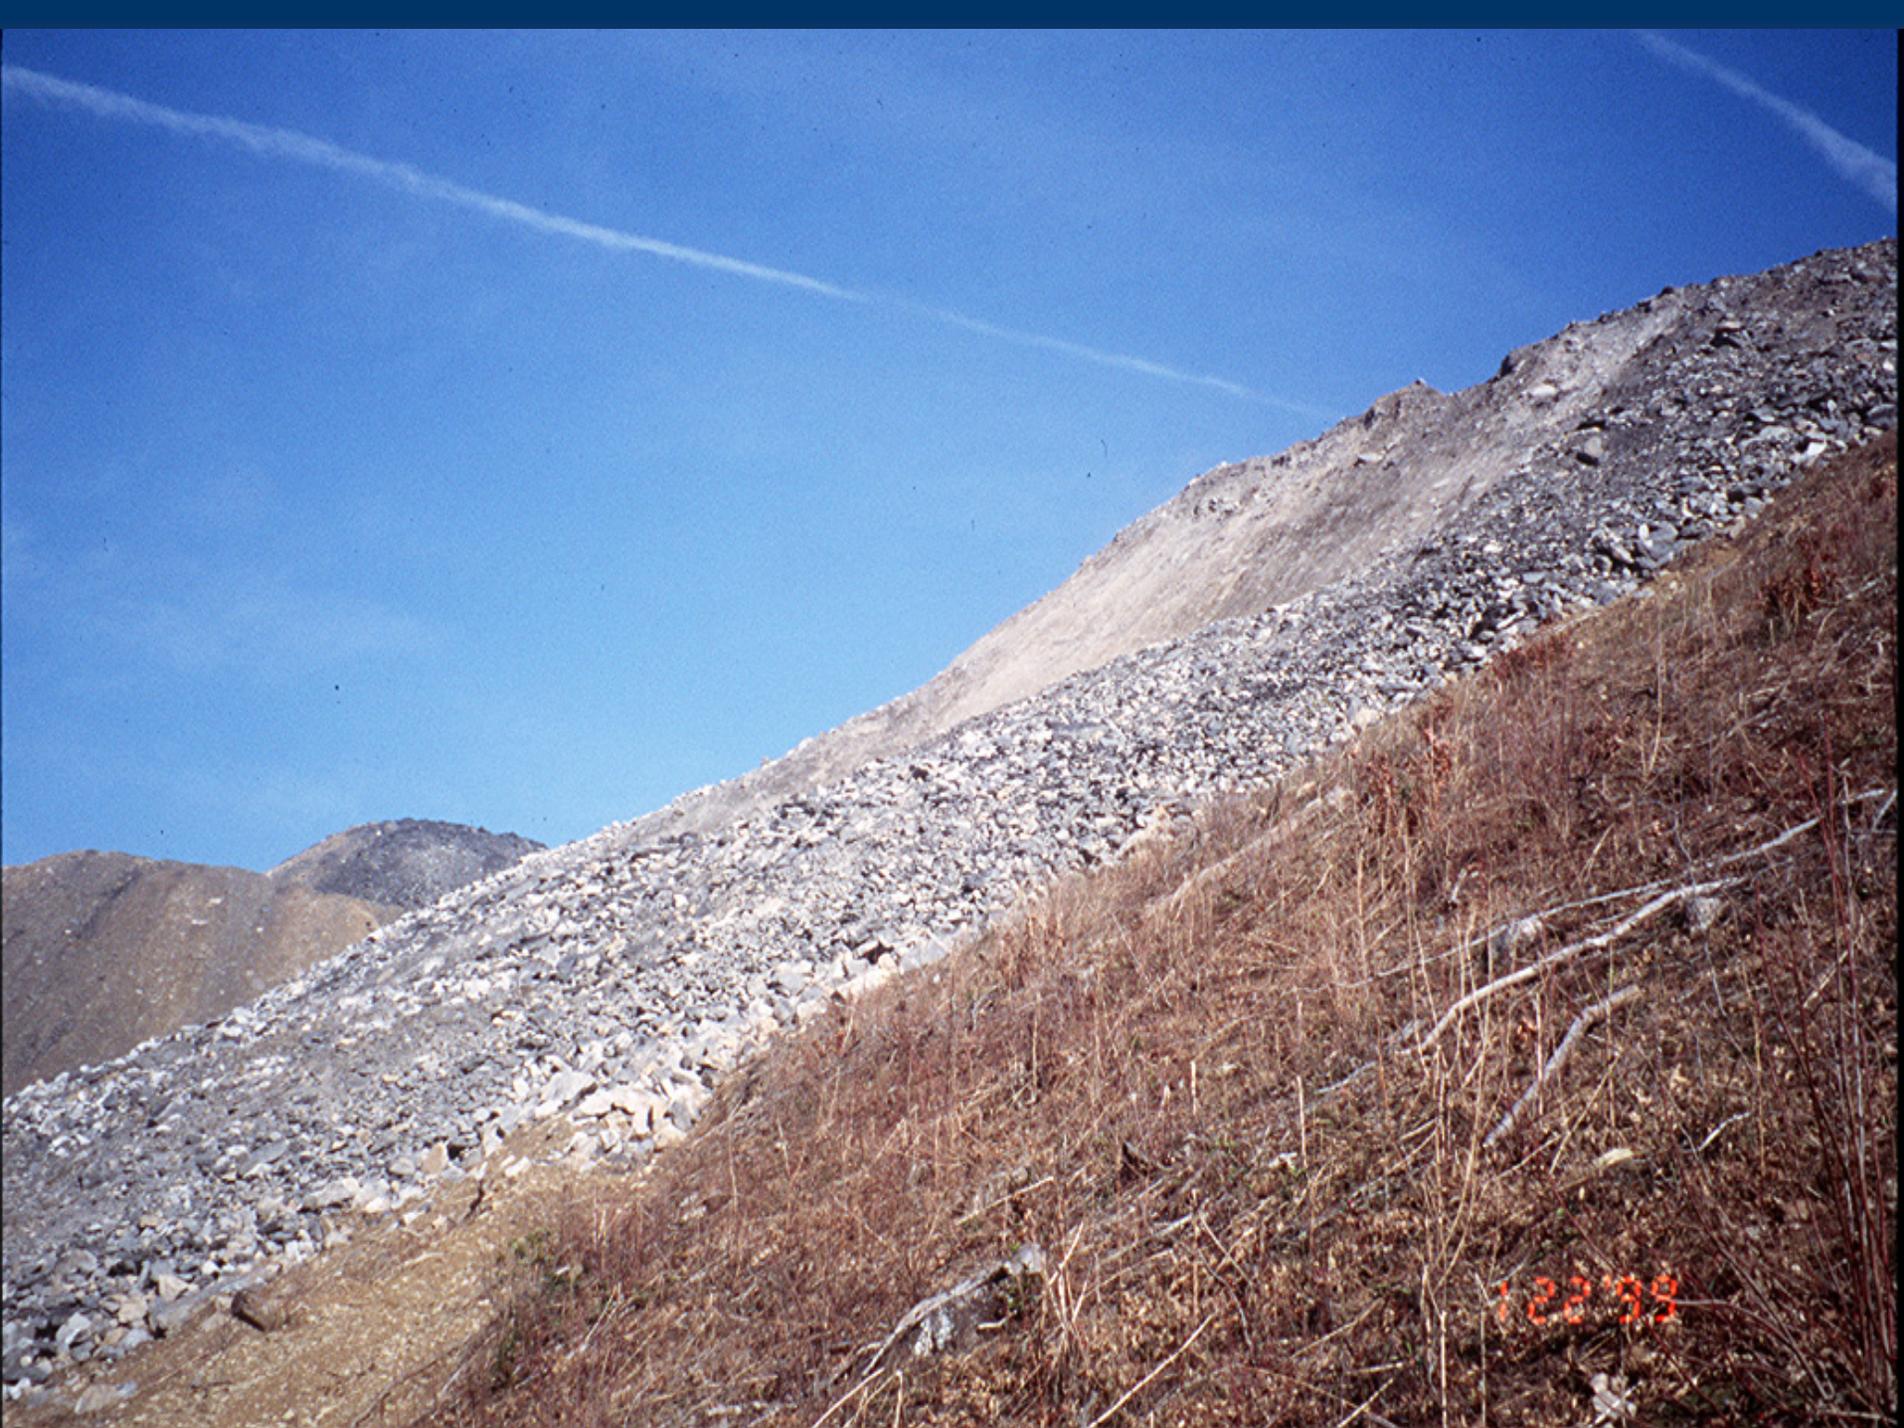
Sliding along weak soil layer in the foundation of the spoil bank
