# **Ground Control at Surface Mines**

## **Spoil Pile Safety**

**Mine Waste and Geotechnical Engineering Division**  
**Pittsburgh Safety and Health Technology Center**  
**Directorate of Technical Support**  
**Mine Safety and Health Administration, USDOL**

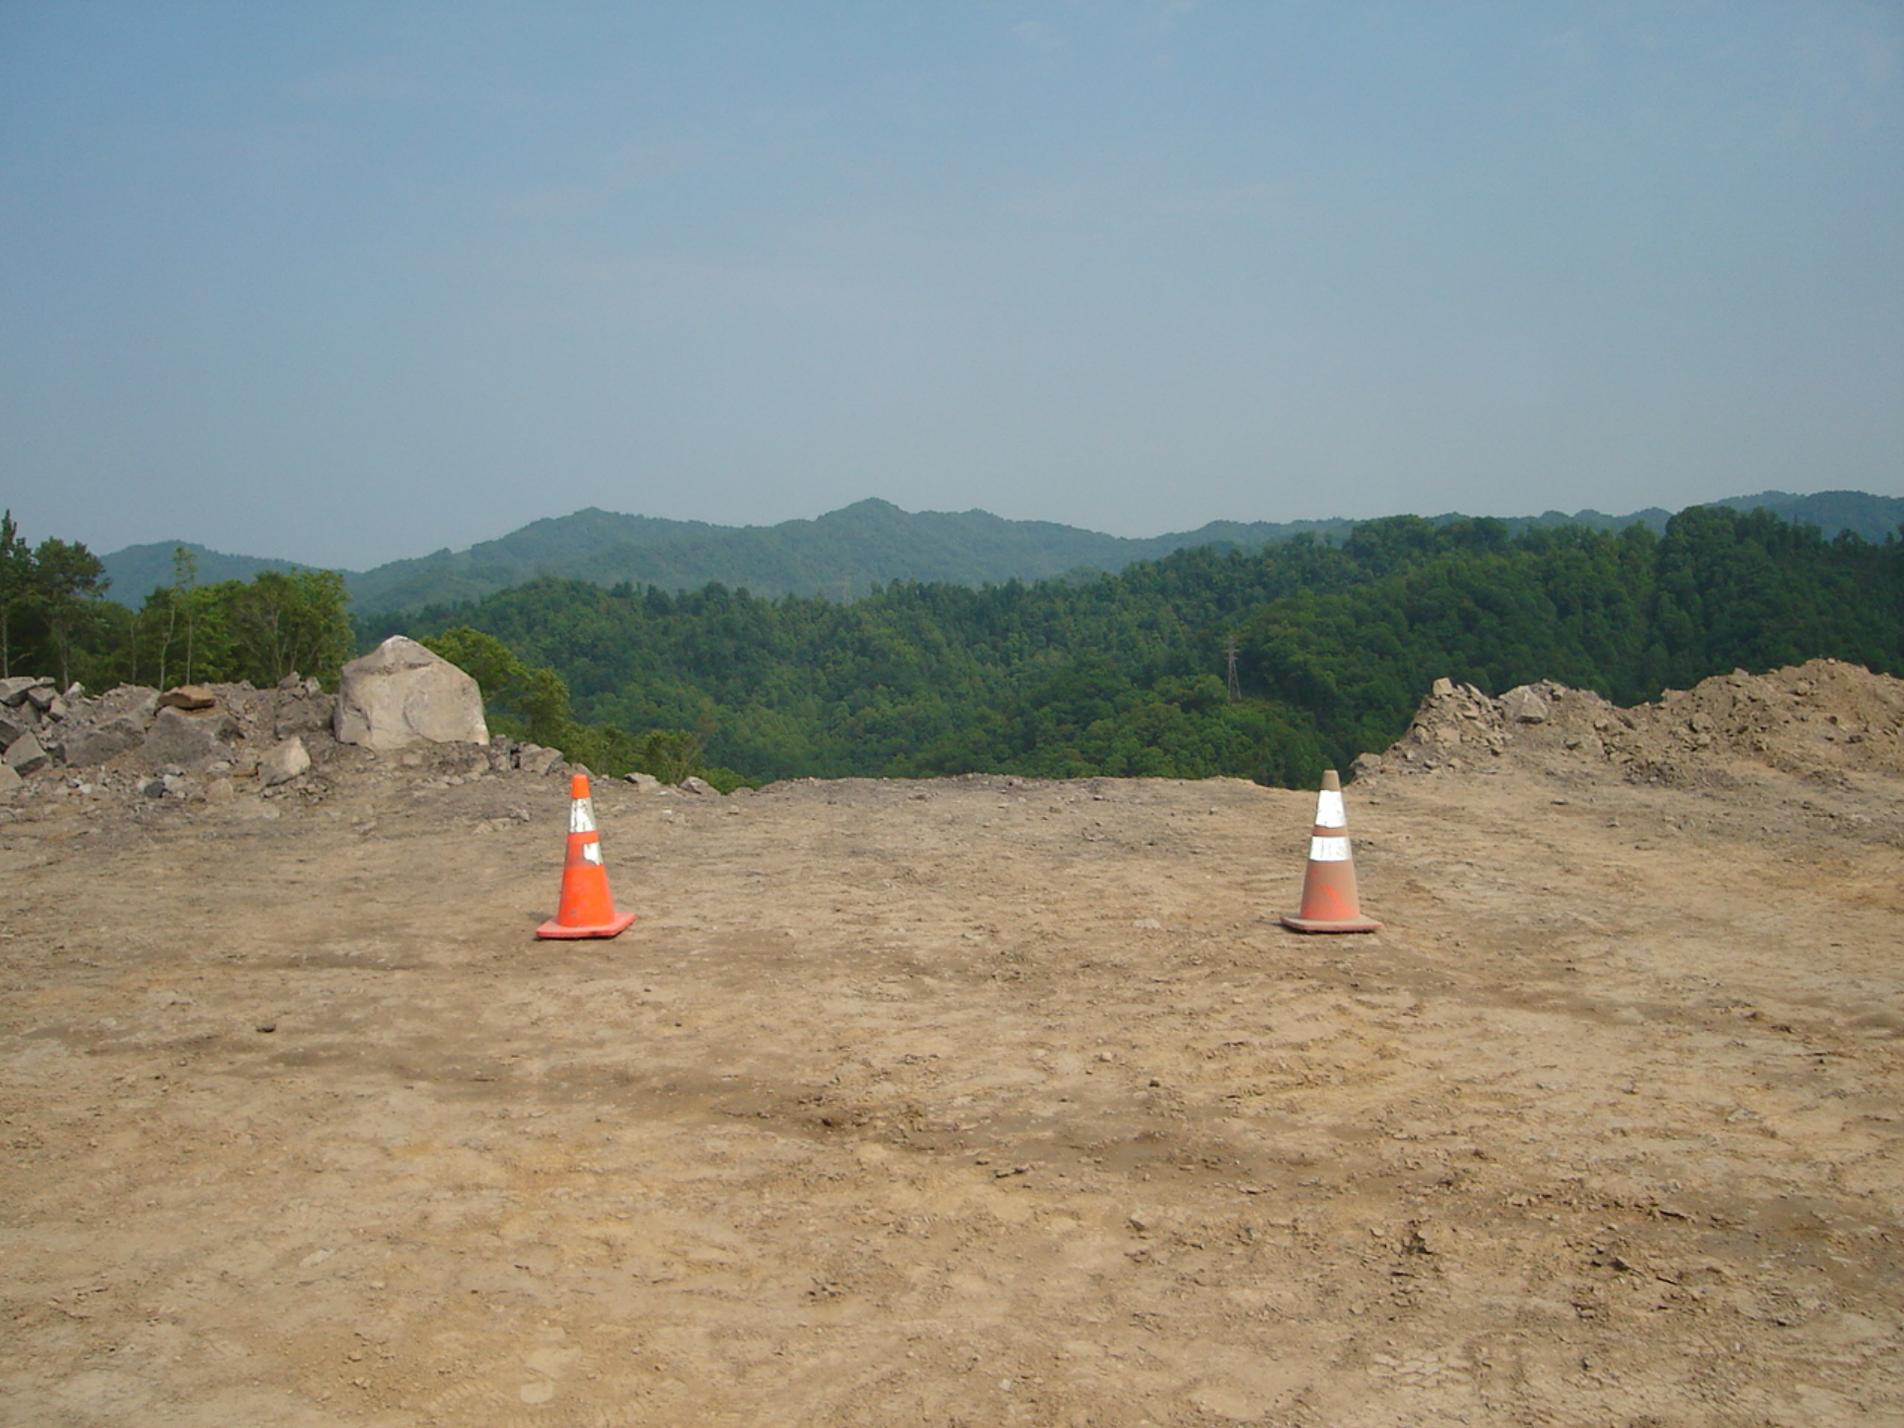
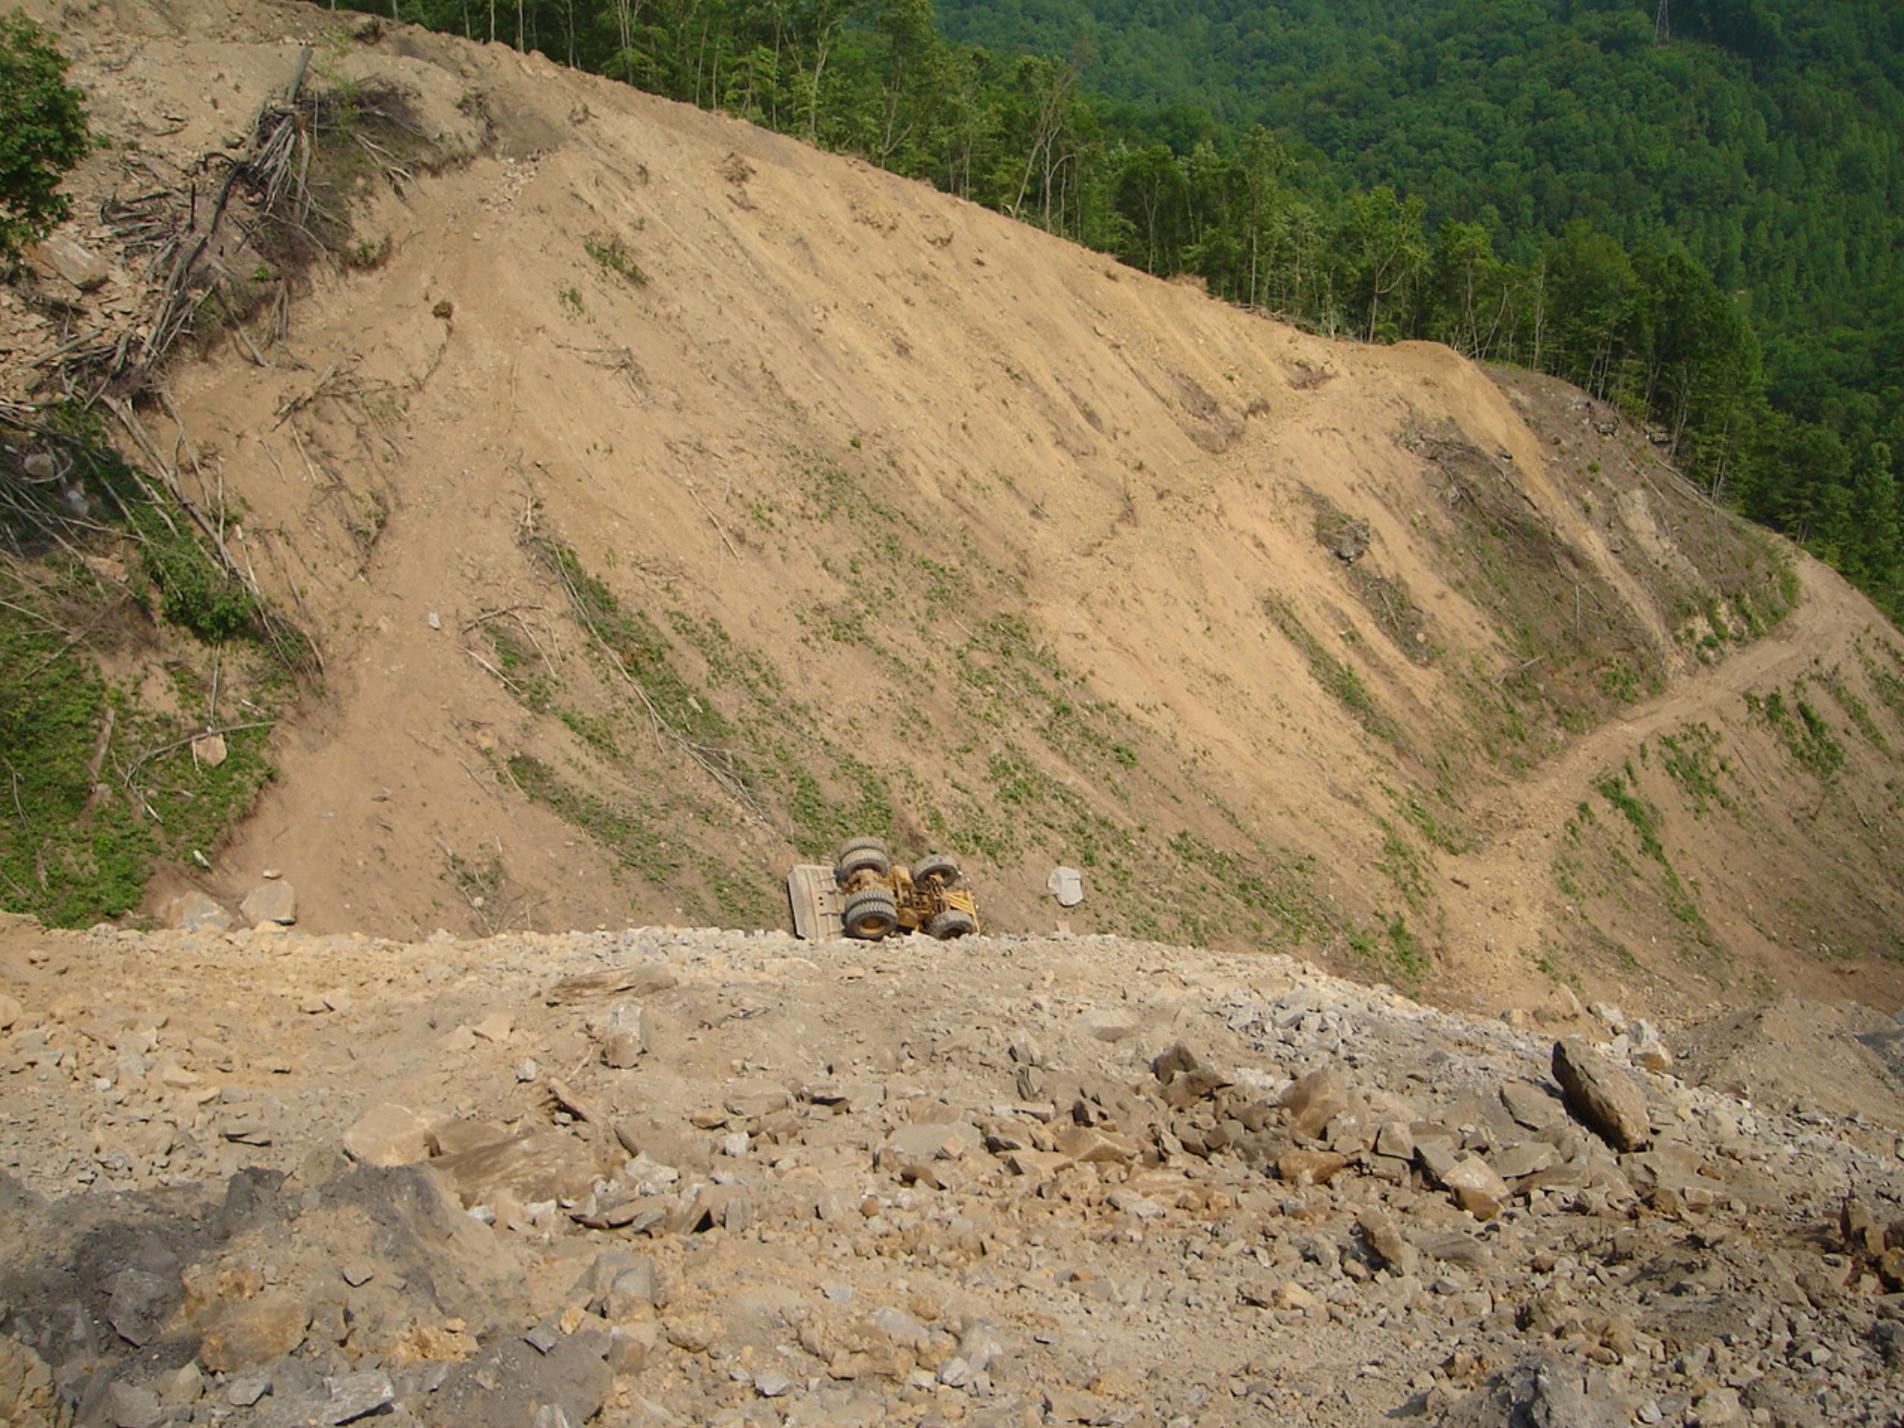
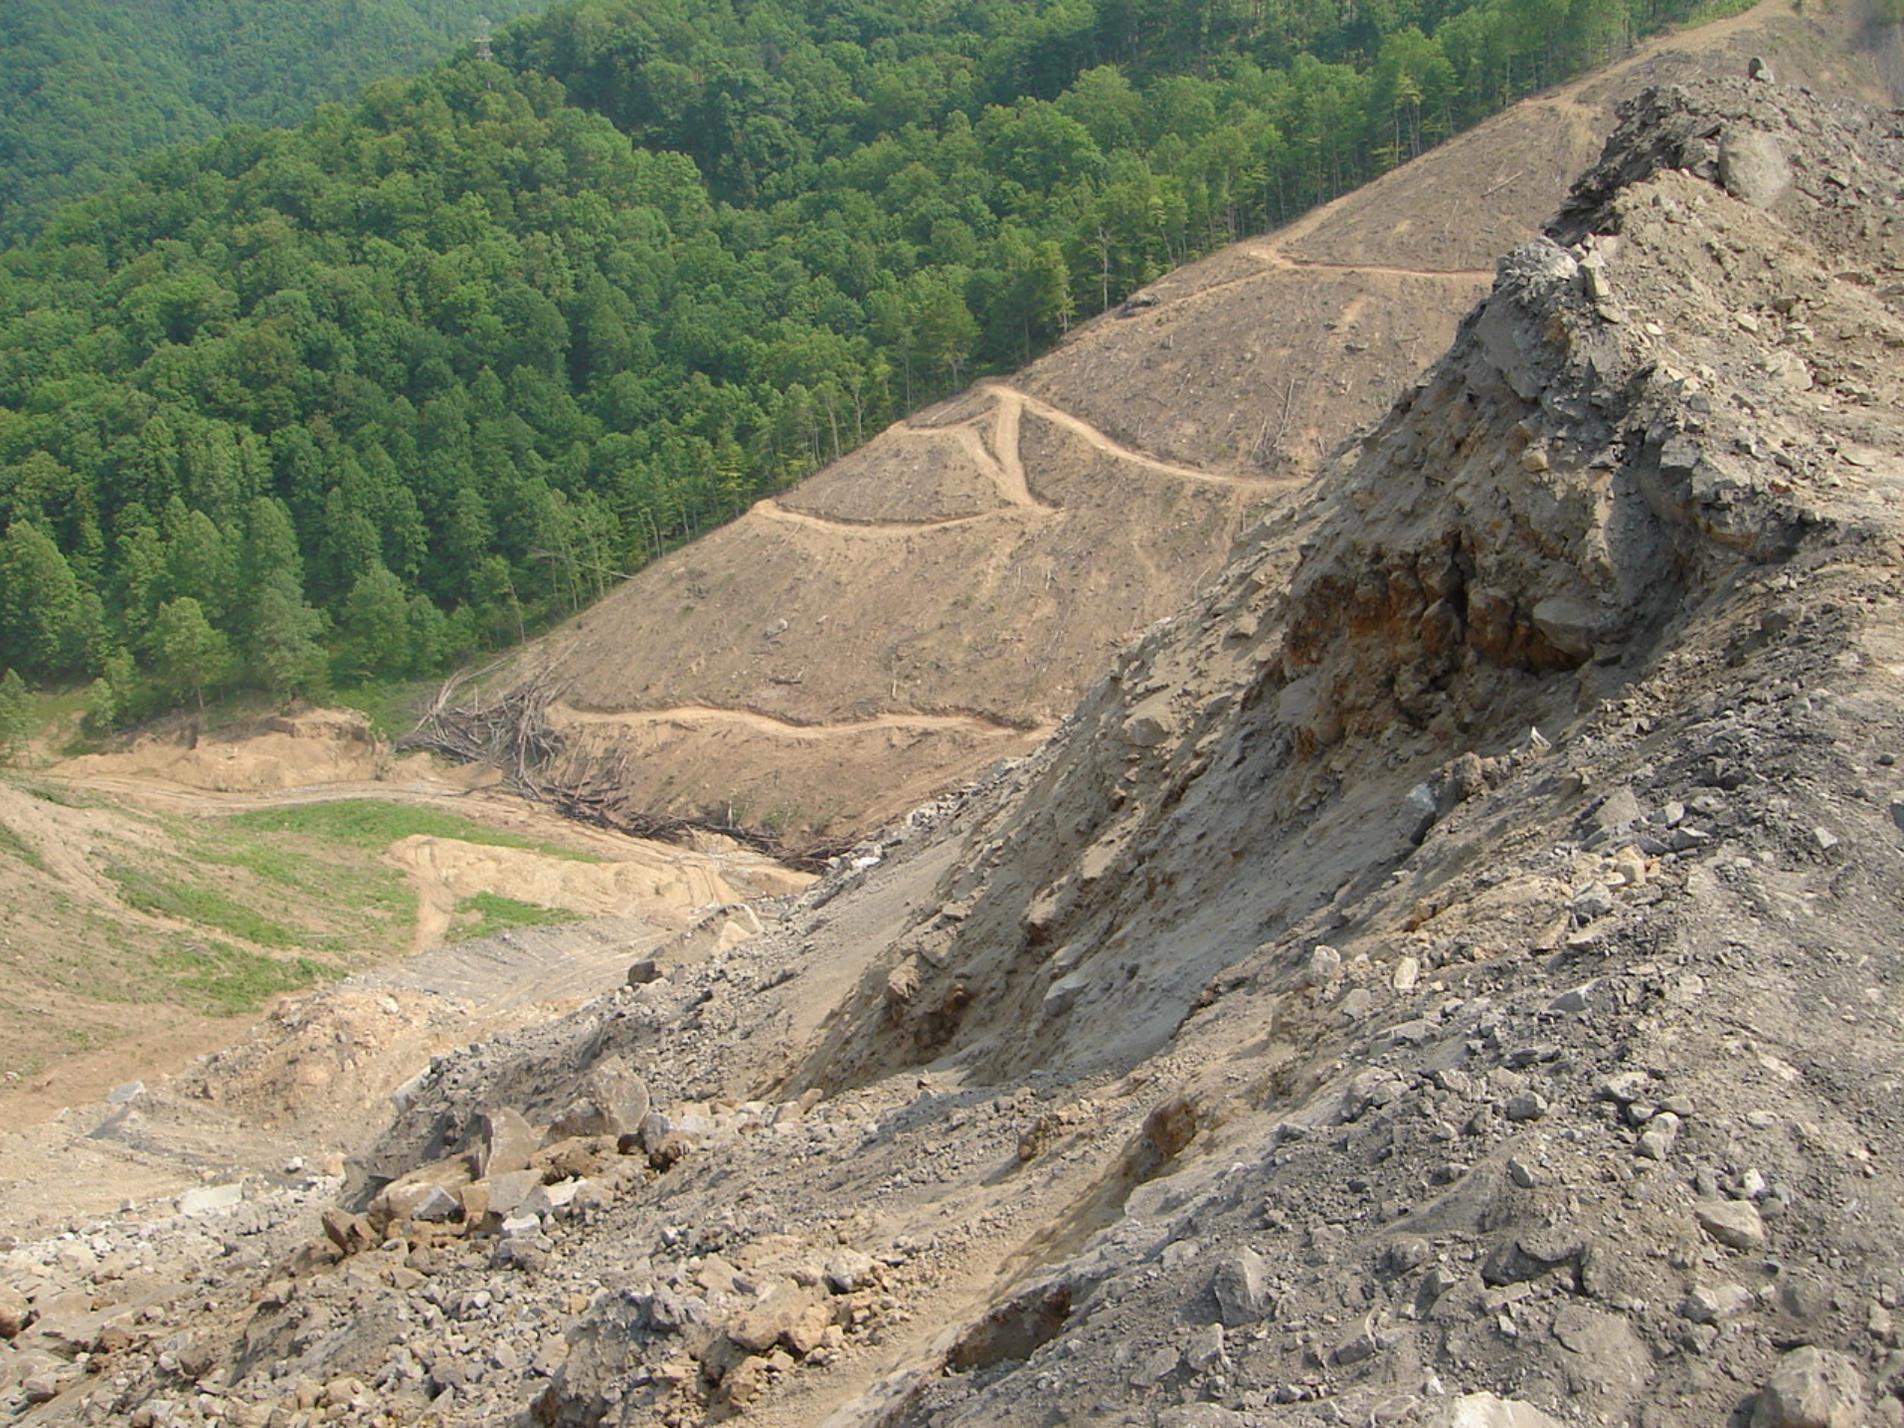
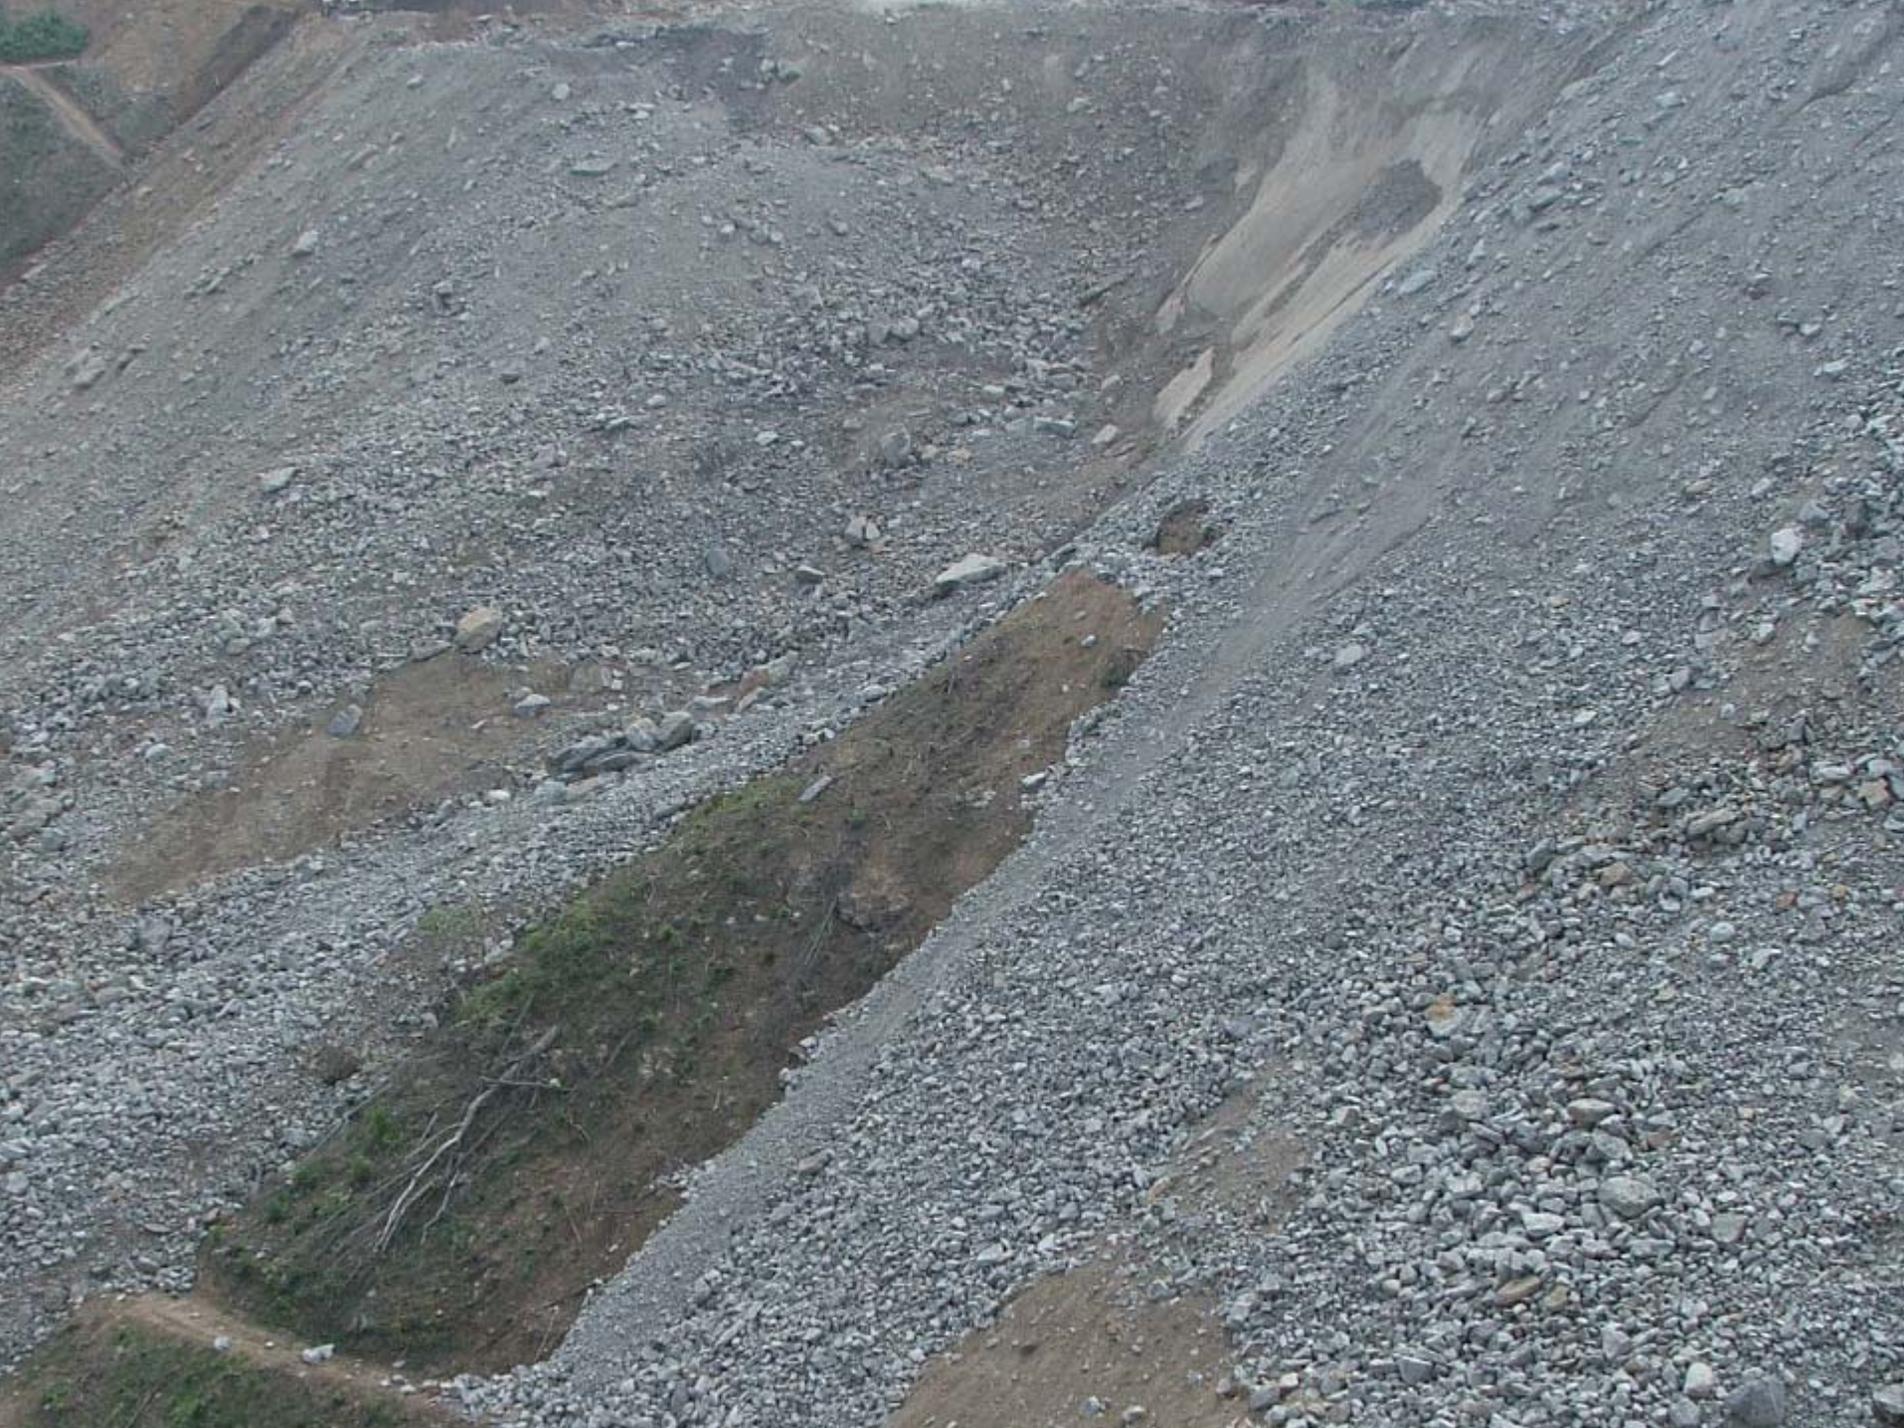
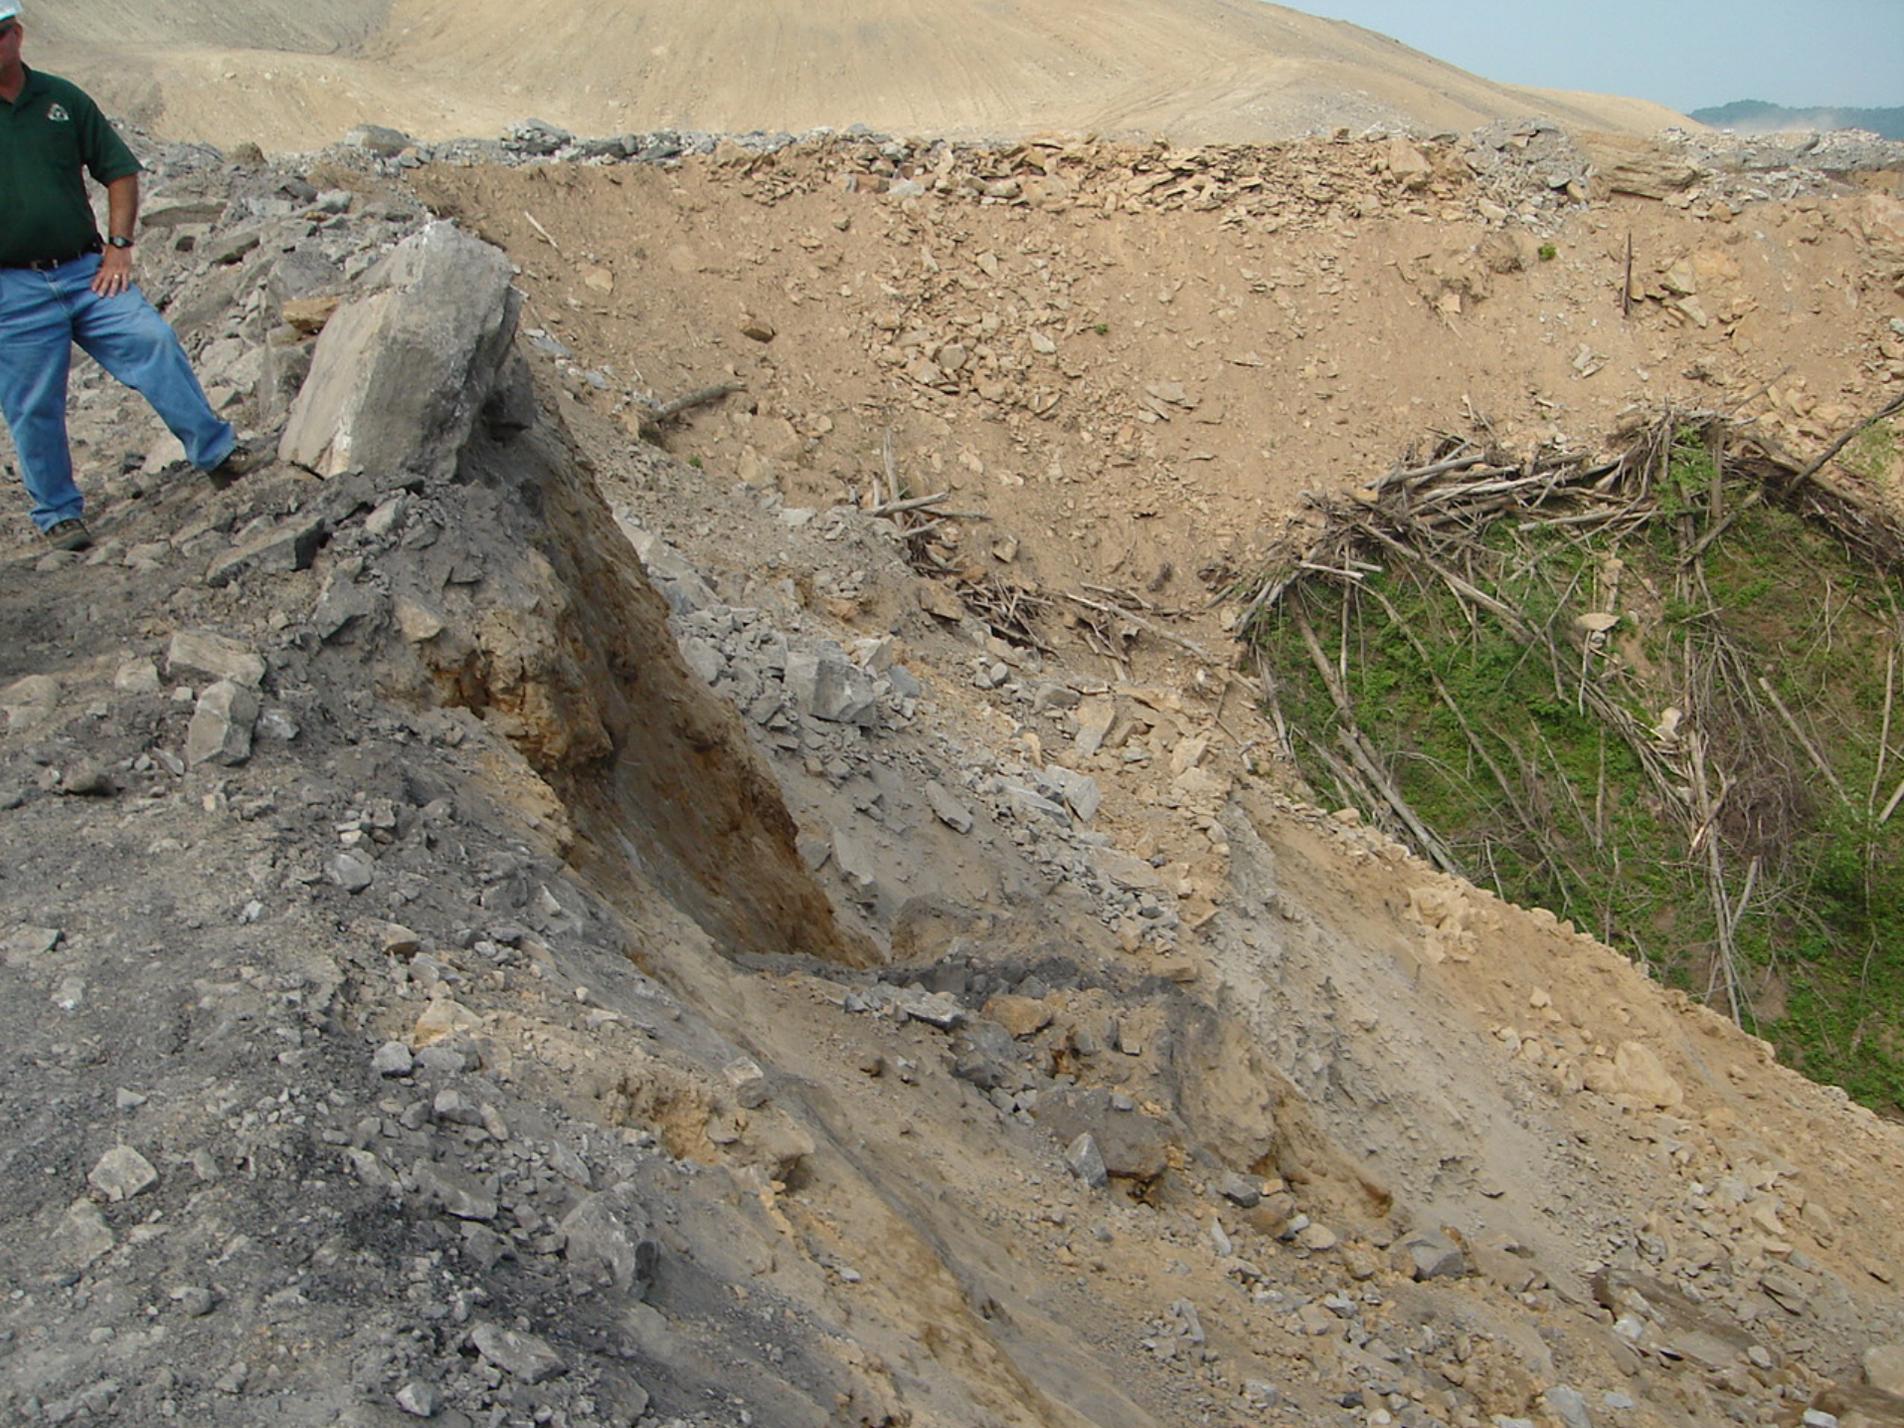
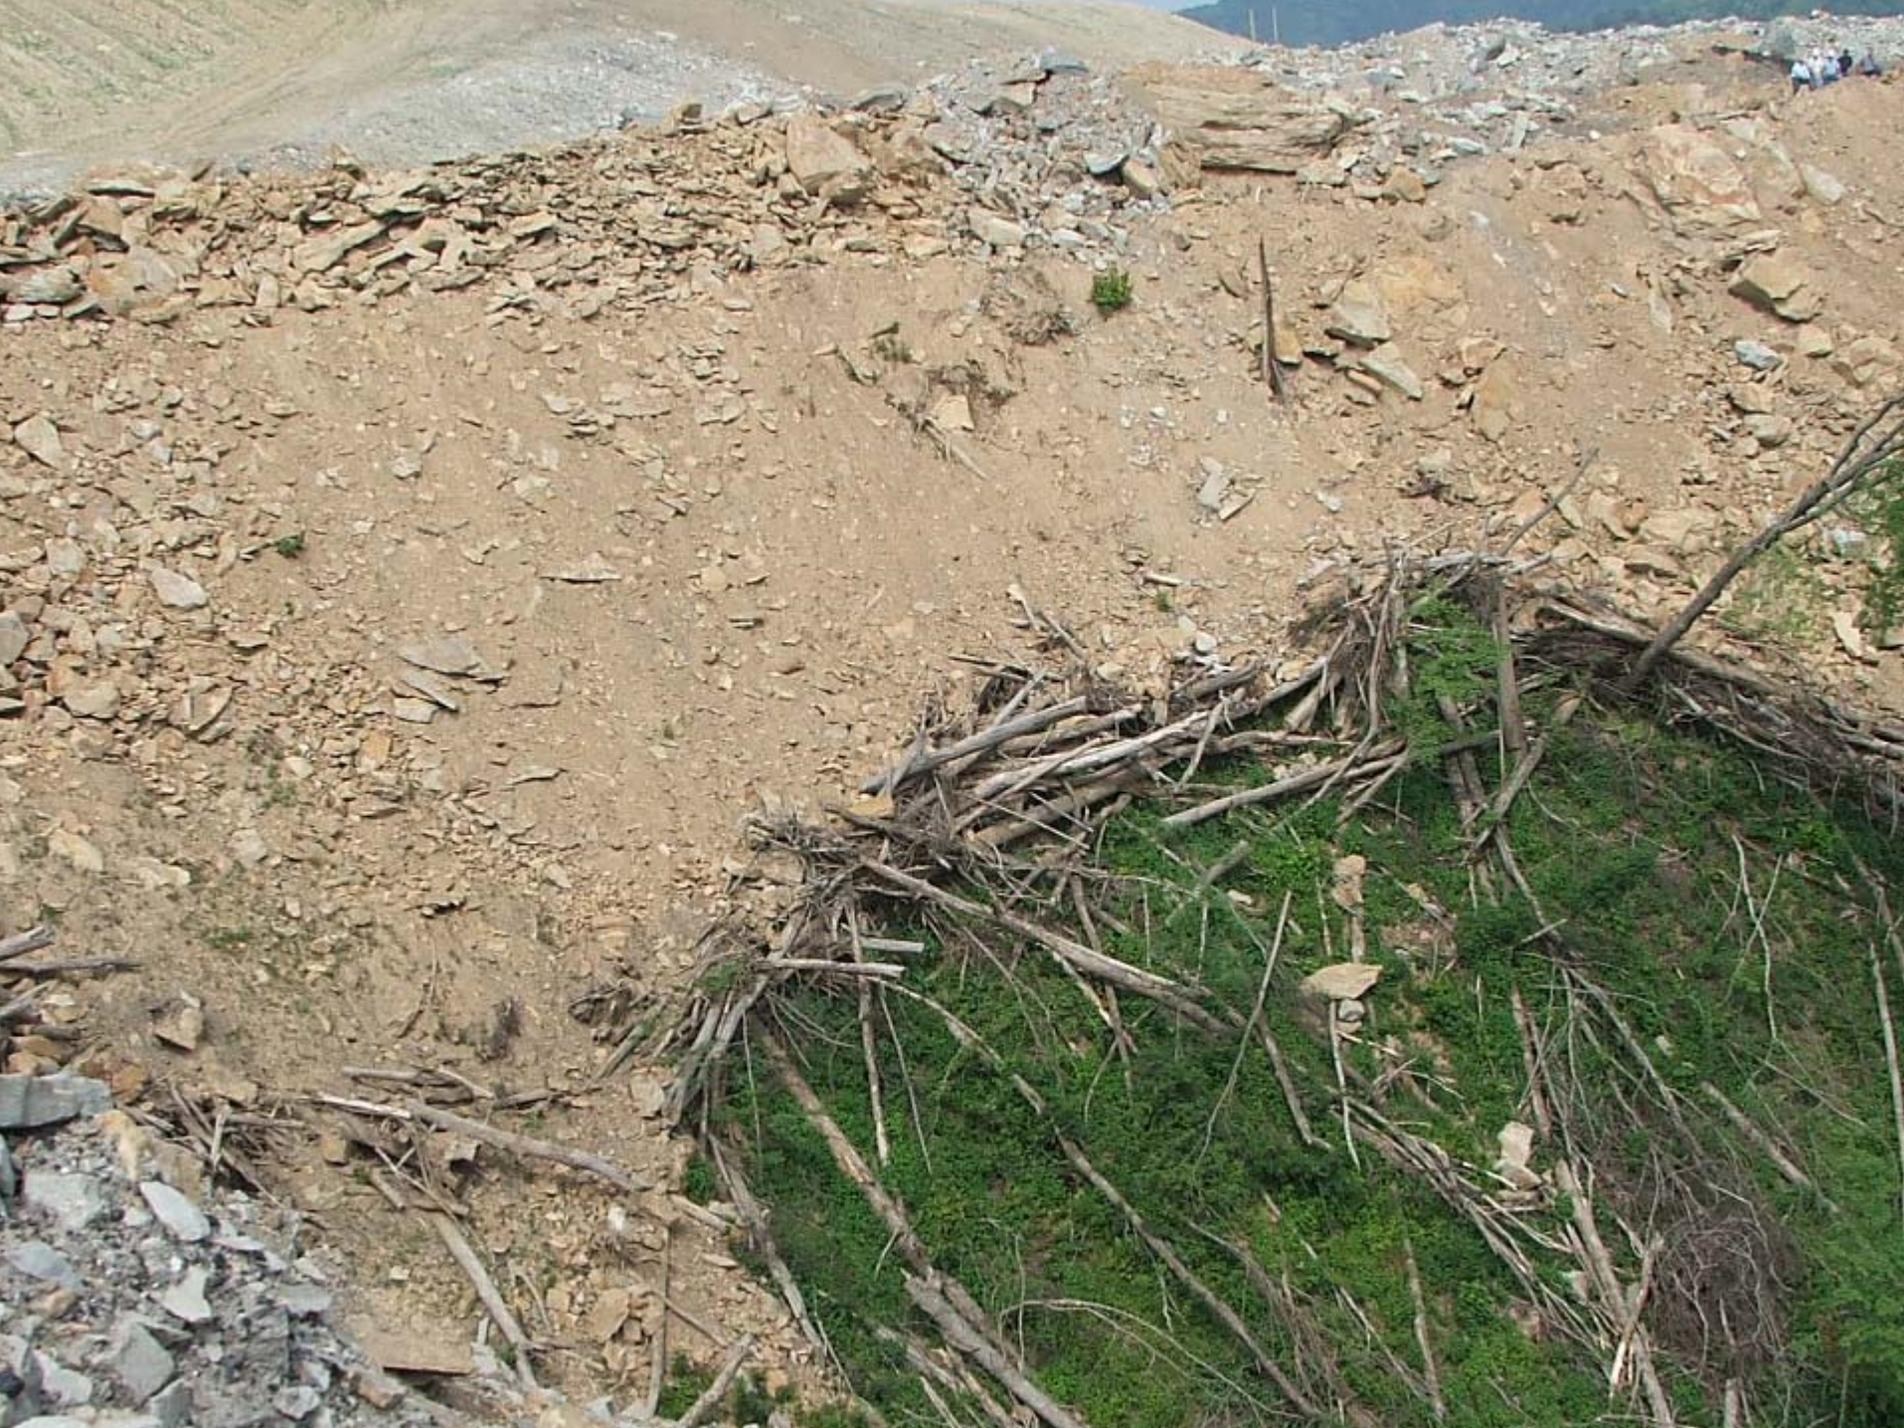
**Example 5**  
**Mountaintop Mining in Southern**  
**West Virginia**  
**May 23, 2007**

Sliding along weak soil  
layer in the foundation  
of the spoil bank and  
Trees / Vegetation in  
the toe area
