## MSHA's Accident Prevention Program Safety Idea

### Conveyor Cleanup

Tag # **AP2002-S025**

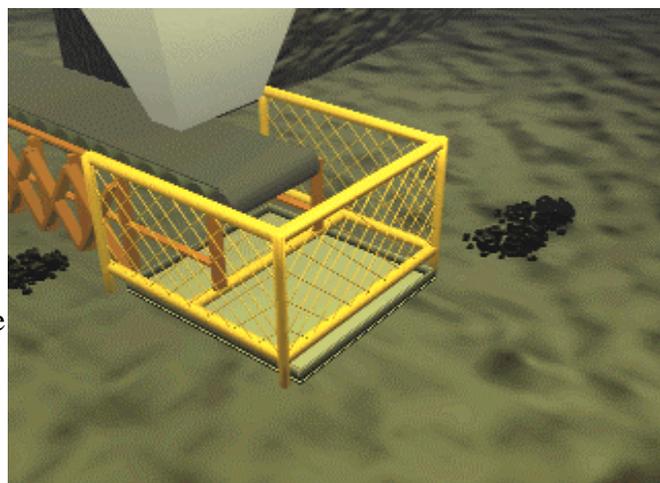
Conveyor accidents occur all too frequently in the mining industry every year. Clean up around and under belt drives, take-ups and tail pulleys is inconvenient and hazardous due to the confined space and running belt. This kind of maintenance is generally neglected until the spillage actually interferes with and fouls the operation of the belt. There is a very simple and cost effective solution to this problem which can reduce unnecessary exposure of workers to the inherent hazards of belt maintenance. The solution is very similar to the crumb tray on a toaster or a drip pan under a kitchen range. A pan is fabricated from lightweight stainless steel with rolled edges to prevent injury from sharp edges and corners. The pan can be fitted with handles or ropes and could include wheels or rollers if desired. This pan is strategically placed under the point where spillage occurs (drives, take-ups, tail pulleys and transfer points). A hinged door could be cut out of the guarding or cage which would permit access to slide the drip pan out periodically so that the spillage can be safely removed.
