METAL / NONMETAL

Serious Injury Accident

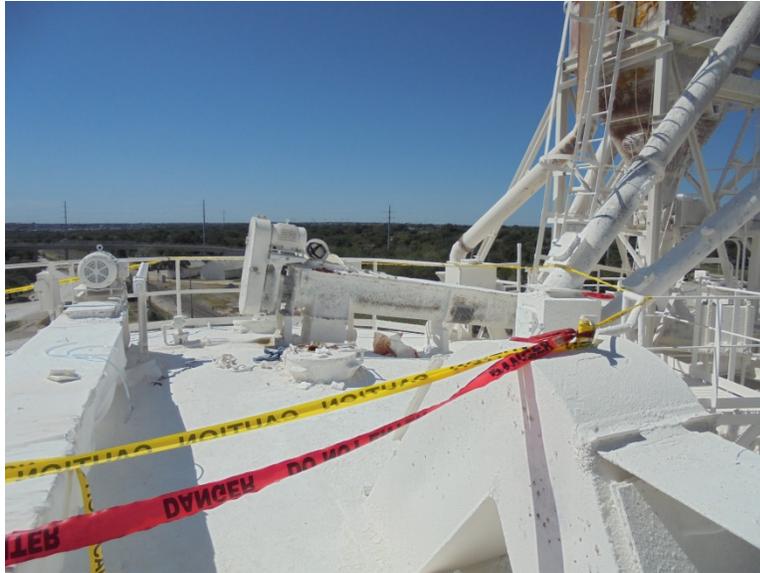
Surface Lime Mine – A miner was attempting to unclog a screw conveyor with a 3/8” poker rod while the screw conveyor was still in operation. During the process, the miner lost an arm when it became entangled in the screw conveyor.

- Do not attempt to clear a jammed conveyor until power has been LOCKED OUT.
- Do not poke or prod material into the conveyor with a bar or stick inserted through the openings.
- Establish and discuss safe work procedures.
- Examine work areas and identify and control all hazards before starting any work.
- Do not place yourself in a position that will expose you to hazards while performing a task.
- Monitor personnel routinely to determine that safe work procedures are followed.
