DISTRICT 2 – CLOSE CALL MATERIAL HANDLING

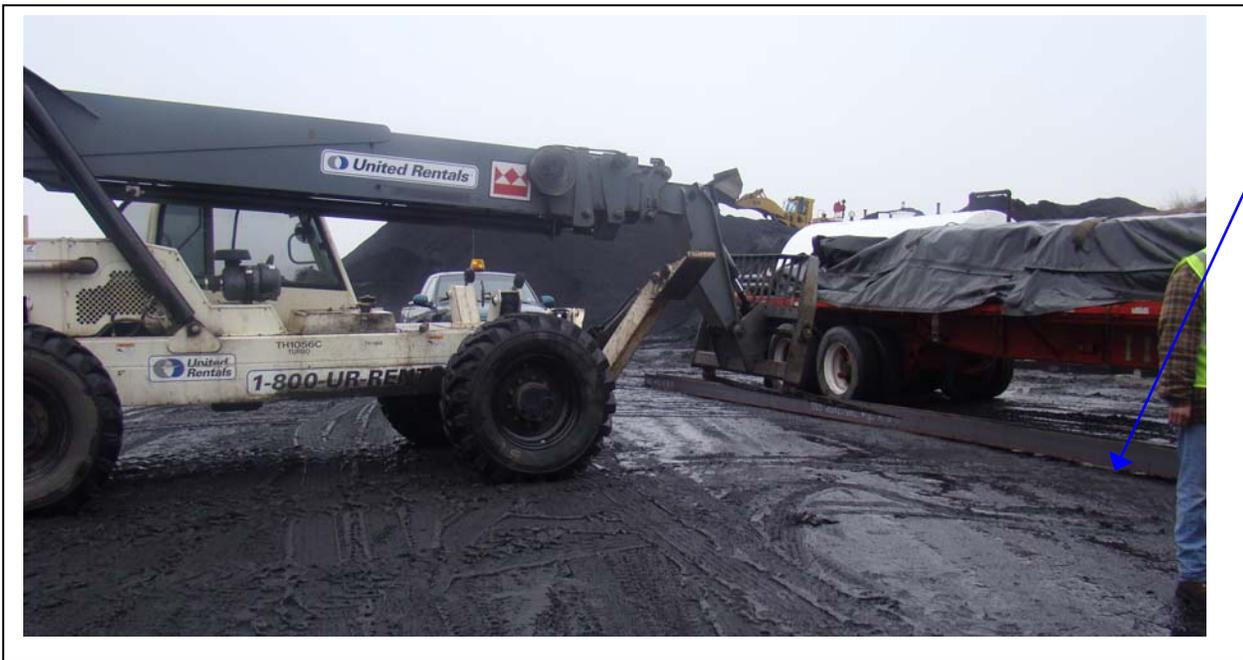
Victim
Location

On March 23, 2011 an accident occurred at the Cambria Fuel Preparation Plant, (36-0330). While unloading a 40 foot steel I-beam off of a delivery truck, the beam slid off the end of the forks of the forklift, pinning the delivery truck driver under the beam. He sustained a broken hip, a fractured femur, and facial lacerations and lost some teeth.

- Establish safe work procedures, do not walk under suspended loads, use taglines to stay clear of suspended loads, and ensure all personnel involved communicate clearly with each other.
- Never work in a location where co-workers cannot see you during loading or unloading of materials.
- Ensure that workers are not positioned near hazards from falling loads.
