DISTRICT 2 – COAL MINE NEAR MISS

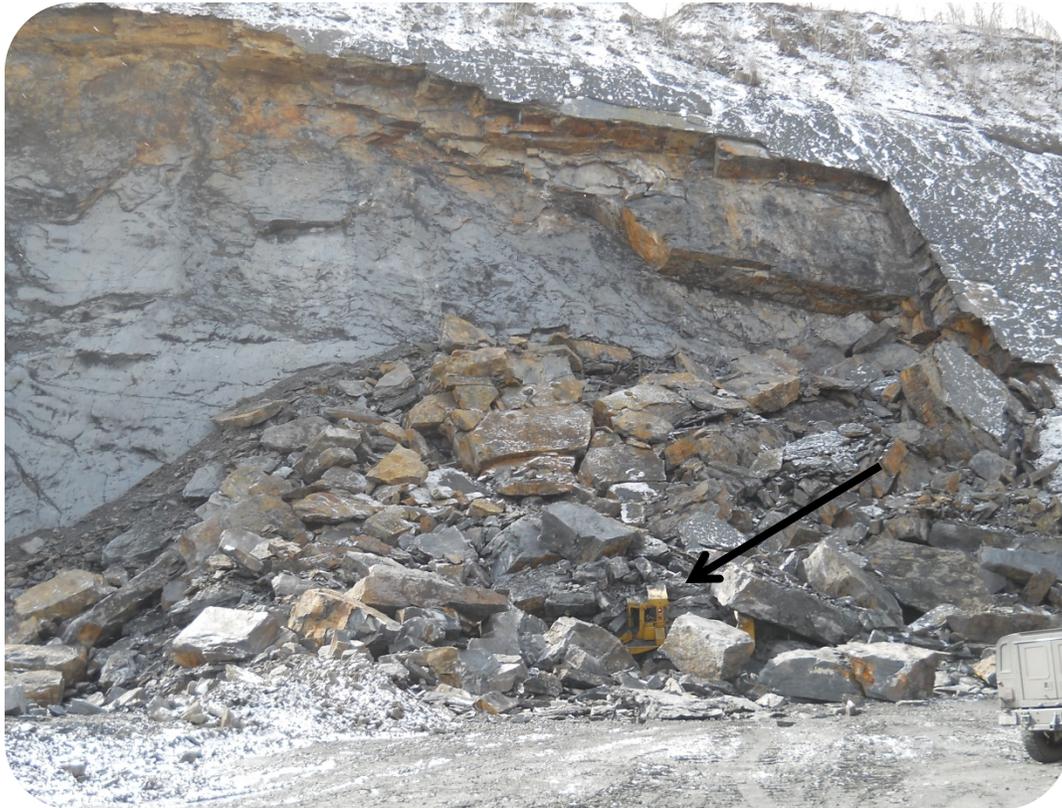
On March 28, 2015 a highwall failure nearly covered a D-11N Caterpillar bulldozer that was pushing coal from the toe of the highwall. There were no injuries.

- Train all employees in highwall hazard recognition.
- Look, Listen and evaluate your highwall and pit conditions daily, especially after each rain, freeze, or thaw.
- Observe and communicate highwall hazards immediately.
- Insure appropriate action is taken to remove the hazards associated with any anomaly that may appear in the highwall or pit.
- Ensure that personnel's work or travel areas and mining systems or equipment are operating are a safe distance from the toe of the highwall.
- Keep the highwall dry; divert water from running down the highwall.
