District 2 – Coal Mine Near Miss

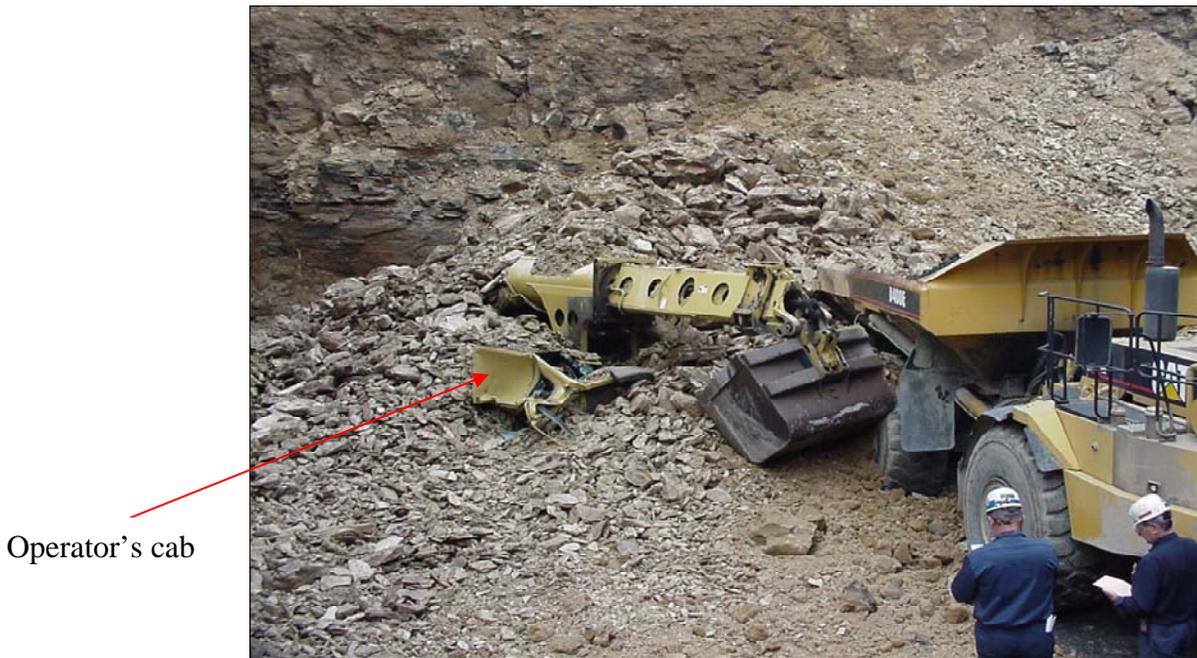
On July 21, 2004, a loader operator , began his shift at 0600 hours and made final preparations to begin loading coal from the 026 pit. The employee then began loading coal using a Gradall XL5200L into a Caterpillar D400E haulage truck operated by his supervisor. At approximately 11:30 AM, the truck operator noticed some material beginning to dribble from the highwall and radioed the loader operator to get out of the pit. The loader operator rotated the bucket and operator's compartment approximately 180 degrees and was attempting to exit the pit when the highwall collapsed covering the Gradall and the back end of the haulage truck. The truck operator radioed the scale house for help and then assisted in getting the loader operator out of the cab of the Gradall. He was then transported to the hospital via ambulance. The loader operator received several minor cuts and a sprained ankle.

- Train all employees in highwall hazard recognition.
- Conduct examinations prior to beginning work around highwalls, and as frequent as necessary to ensure safety, especially during periods of changing weather conditions. Inspect the top and bottom of the highwall for cracking, spalling, sloughage, loose ground, and large rocks that could be hazardous.
- Ensure loose material is scaled prior to performing work. To safely scale using the shovel, maintain the highwall height within the reach of the bucket.
- Position the shovel and trucks so that the shovel cab swings away from the highwall when loading.
