MNMM Fatal 2005-29

- Powered Haulage
- October 18, 2005 (New Mexico)
- Underground Potash Mine
- Utility Worker
- 36 years old
- 2 year, 48 weeks mining experience

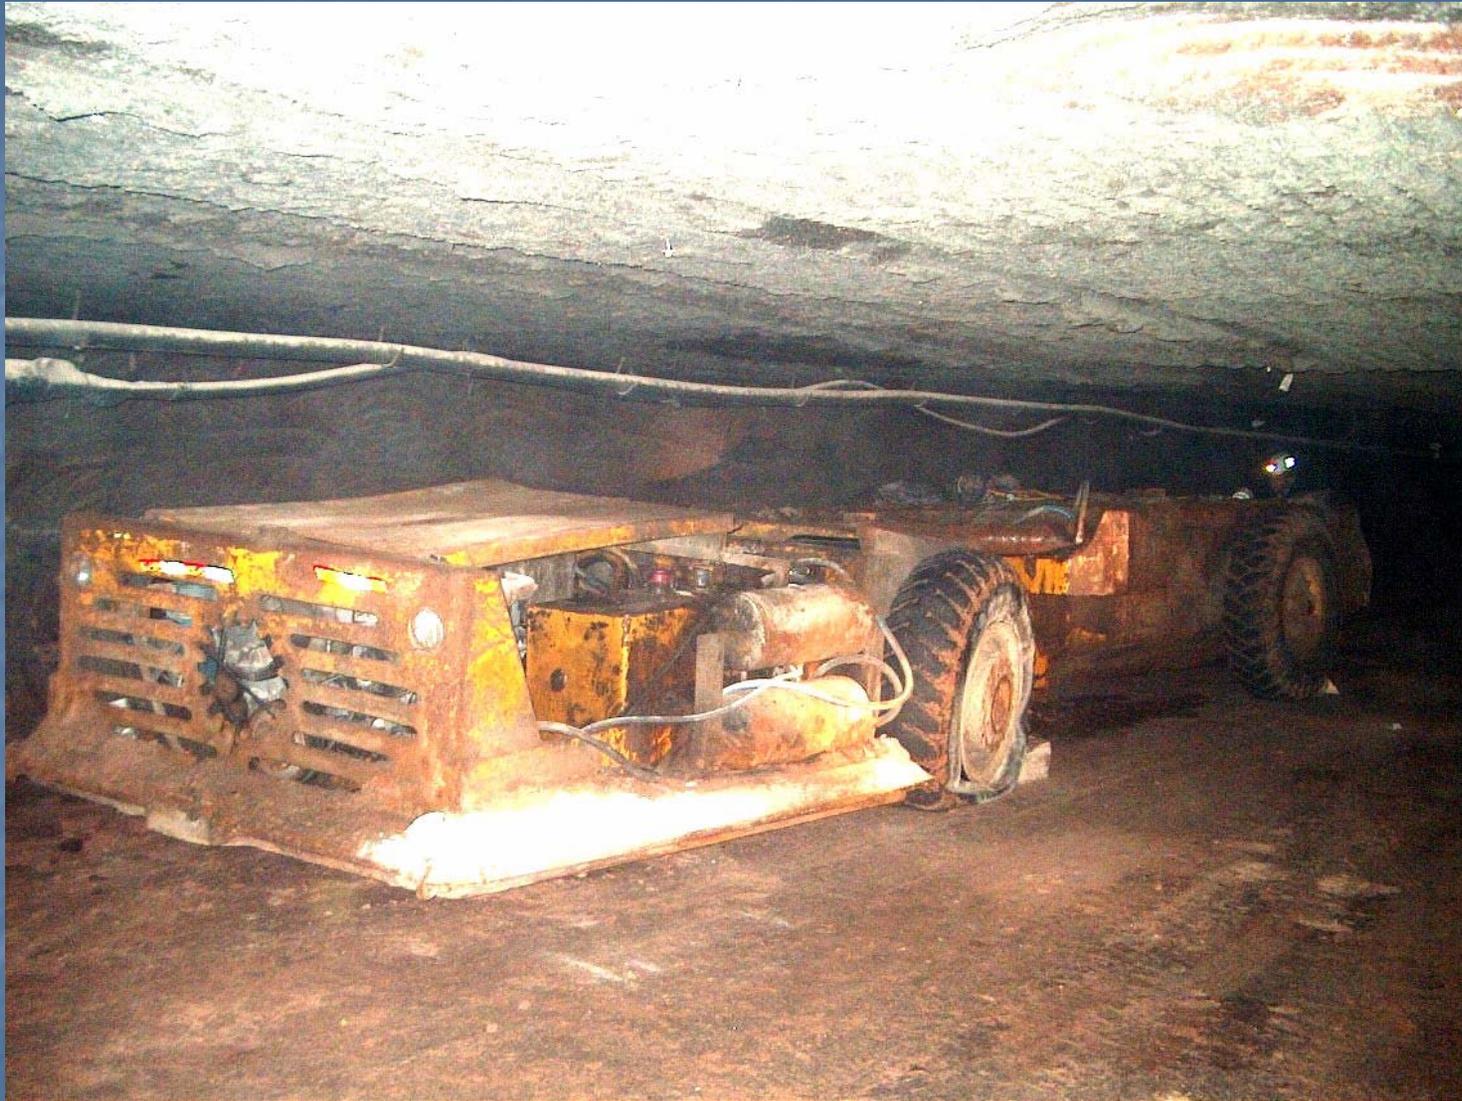
The victim was fatally injured when a utility water truck rolled onto him. He parked the truck on a grade and went to connect a pump cable.

Apparently the truck began to drift and the victim attempted to stop it but was pinned beneath one of the wheels.

- Administrative controls needed improvement. The victim left the water truck unattended and failed to set the parking brake. The truck was parked on a grade and the wheels were not chocked or turned into the rib.

- Stop, Look, Analyze, and Manage (SLAM) each task to identify all potential hazards.
- Set the parking brake before exiting mobile equipment.
- Do not attempt to stop moving equipment after you have exited the vehicle.
- When parking mobile equipment on a grade, chock the wheels or turn them into a rib.
