Fatality #17 – August 10, 2005
Victim Died November 15, 2005
Fall of Roof or Back - Underground - AL
Drummond Company, Inc. - Shoal Creek Mine

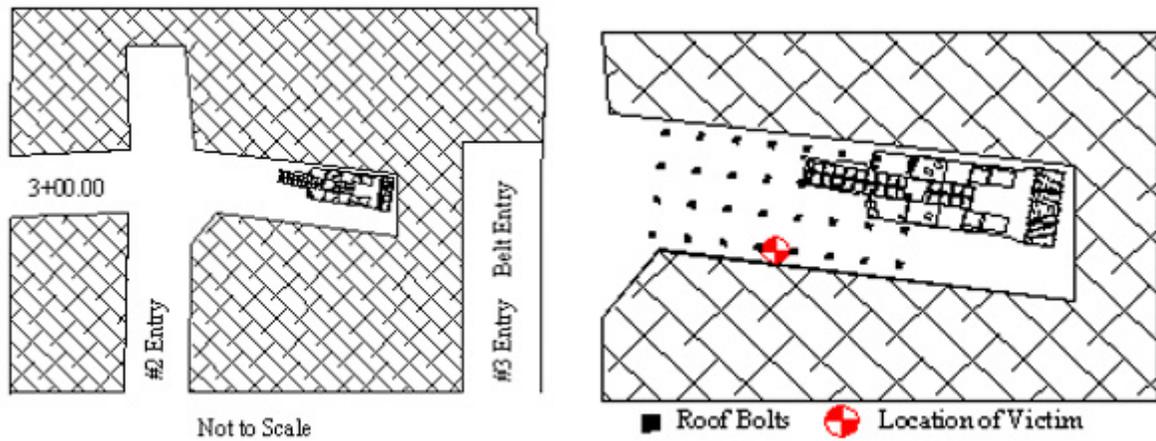
COAL MINE FATALITY - On August 10, 2005, a 54-year old continuous mining machine operator, with 15 months of experience in this occupation, was injured when he was struck by a 30" x 30" x 6" piece of draw rock that fell from between the rib and roof bolts. He was operating the continuous mining machine by remote-control while standing along the right rib when the accident occurred. The mine opening was 11'-4" high at the accident site. The victim died of his injuries on November 15, 2005.

- Train all miners on the importance of continual roof, face, and rib evaluations and the need to take corrective action as necessary.
- Conduct a thorough visual examination of the roof, face, and ribs immediately before any work is started, and thereafter as conditions warrant.
- Position yourself in a safe area.
- Be alert to changing roof conditions at all times.
- Scale down or support loose material.
- Use supplemental support for immediate roof control such as screen or larger roof bolt plates.
