MNMM Fatal 2006-05

- Powered Haulage
- April 4, 2006 (Michigan)
- Sand & Gravel Operation
- Plant Operator
- 23 years old
- 4 weeks mining experience

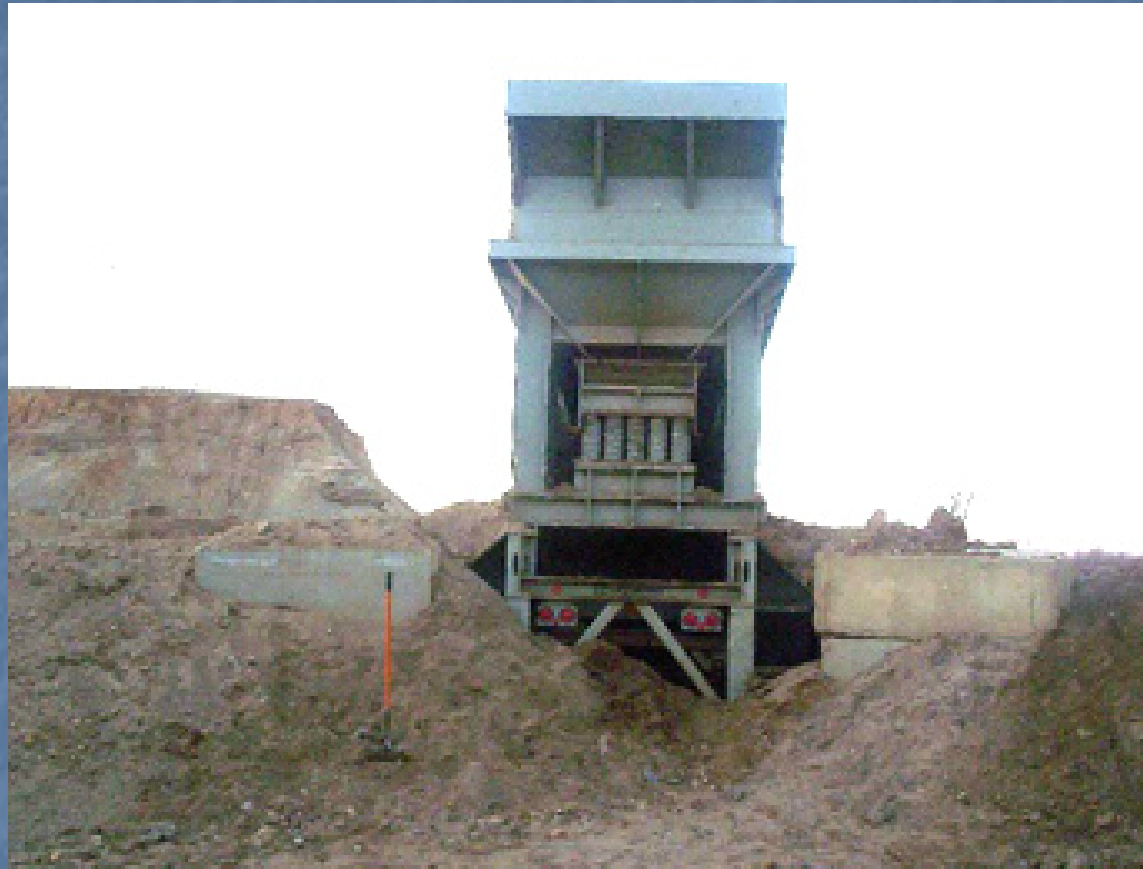
The victim was fatally injured when he became entangled in a conveyor belt tail pulley at the portable crushing plant. He had entered the area under the crusher from the back end and traveled to the back side of the pulley. The accident occurred because management failed to establish procedures to ensure that employees could safely remove spillage near moving conveyors. The conveyor was not de-energized and blocked against motion prior to persons entering the area. The victim failed to recognize the hazard of performing work near moving machine parts.

Operating procedures and controls were inadequate and failed to ensure that persons could safely remove spillage around moving conveyor belts.

- Establish policies that ensure employees are trained on required procedures to safely remove spillage near moving conveyor belts.
- Before assigning miners to clean up spillage, have them identify hazards and demonstrate how they would safely complete the tasks.

- Stop, Look, Analyze, Manage (SLAM)
- Ensure that conveyor belts are de-energized and blocked against motion before positioning yourself near the drive, head, tail, and take-up pulleys.
