MNM Fatal 2006-06

- Powered Haulage
- April 11, 2006 (Texas)
- Dimension Stone Operation
- Rock Handler
- 22 years old
- 39 weeks mining experience

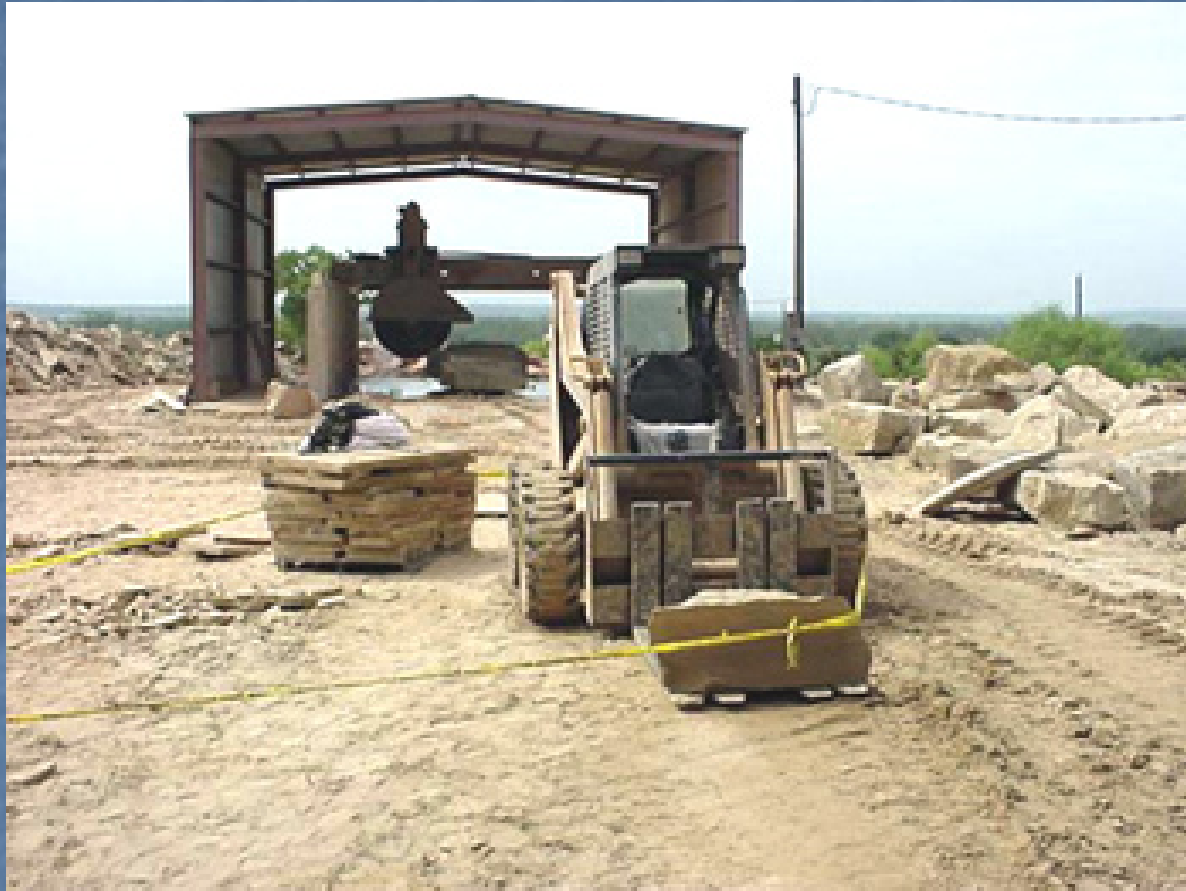
The victim was fatally injured when a skid steer loader backed over him. He was tightening field fence wire with pliers to secure stone to a pallet, when the skid steer loader backed over him.

- Operating procedures were inadequate and did not ensure that pallets were placed away from the established haulage roadway so miners could safely work on them. A risk assessment to identify and eliminate all possible hazards was not conducted before starting the task.

- Provide a location for stacking and binding stones to pallets that minimizes the exposure of miners to the travel of mobile equipment.
- Discuss work procedures and identify all hazards associated with the work to be performed along with the methods to protect personnel. Stop, Look, Analyze, Manage (SLAM)
- Ensure all miners are trained to recognize work place hazards, specifically the hazard of mobile equipment traveling nearby.
- Before moving mobile equipment, look in the direction of travel, be certain no one is in the intended path, sound the horn to warn unseen persons, and wait a few moments to give them time to get to a safe location.
