MNM Fatal 2006-09

- Powered Haulage
- May 3, 2006 (Utah)
- Sand & Gravel Operation
- Laborer
- 19 years old
- 4 weeks mining experience

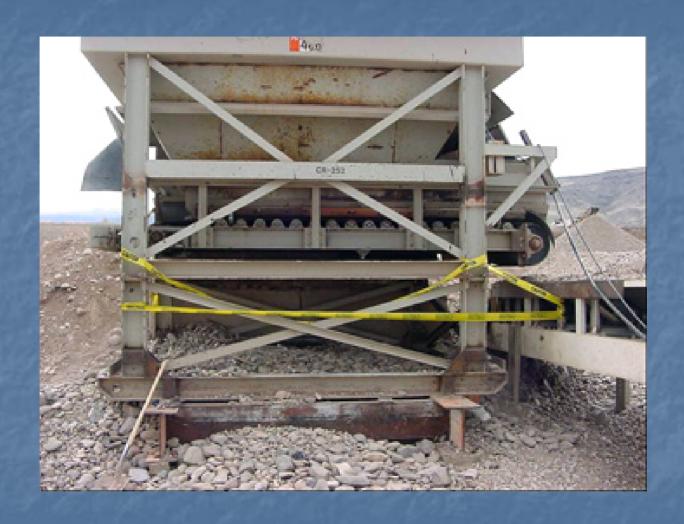
The victim was fatally injured when became entangled between a conveyor belt and a return roller. He was underneath the feed conveyor belt adjusting a return roller while the belt was in motion.

• Management policies and controls were inadequate. Task training was not completed for the miner assigned to adjust the tracking on the conveyor belt. Procedures and controls were not established to ensure that the miner could safely complete the task he was assigned.

- Ensure that miners are properly task trained in procedures to safely adjust conveyor belts that are in operation. A competent person should closely observe the miner while he performs the task to ensure they are protected from hazardous motion of the conveyor.
- Before assigning miners to adjust belts, have them identify hazards and demonstrate how they would safely complete the task. Stop, Look, Analyze, Manage (SLAM).
- Keep all guards securely in place except when testing or making adjustments.
- Install local stop switches at all conveyor locations and ensure start up warning alarms are operational where visual observation of the entire conveyor is not possible from the start up control.
