MNM Fatal 2012-04

- Fall of Rib Accident
- March 20, 2012 (Montana)
- Underground Gemstone Mine
- Mine Owner
- 54 years old
- 25 years of experience

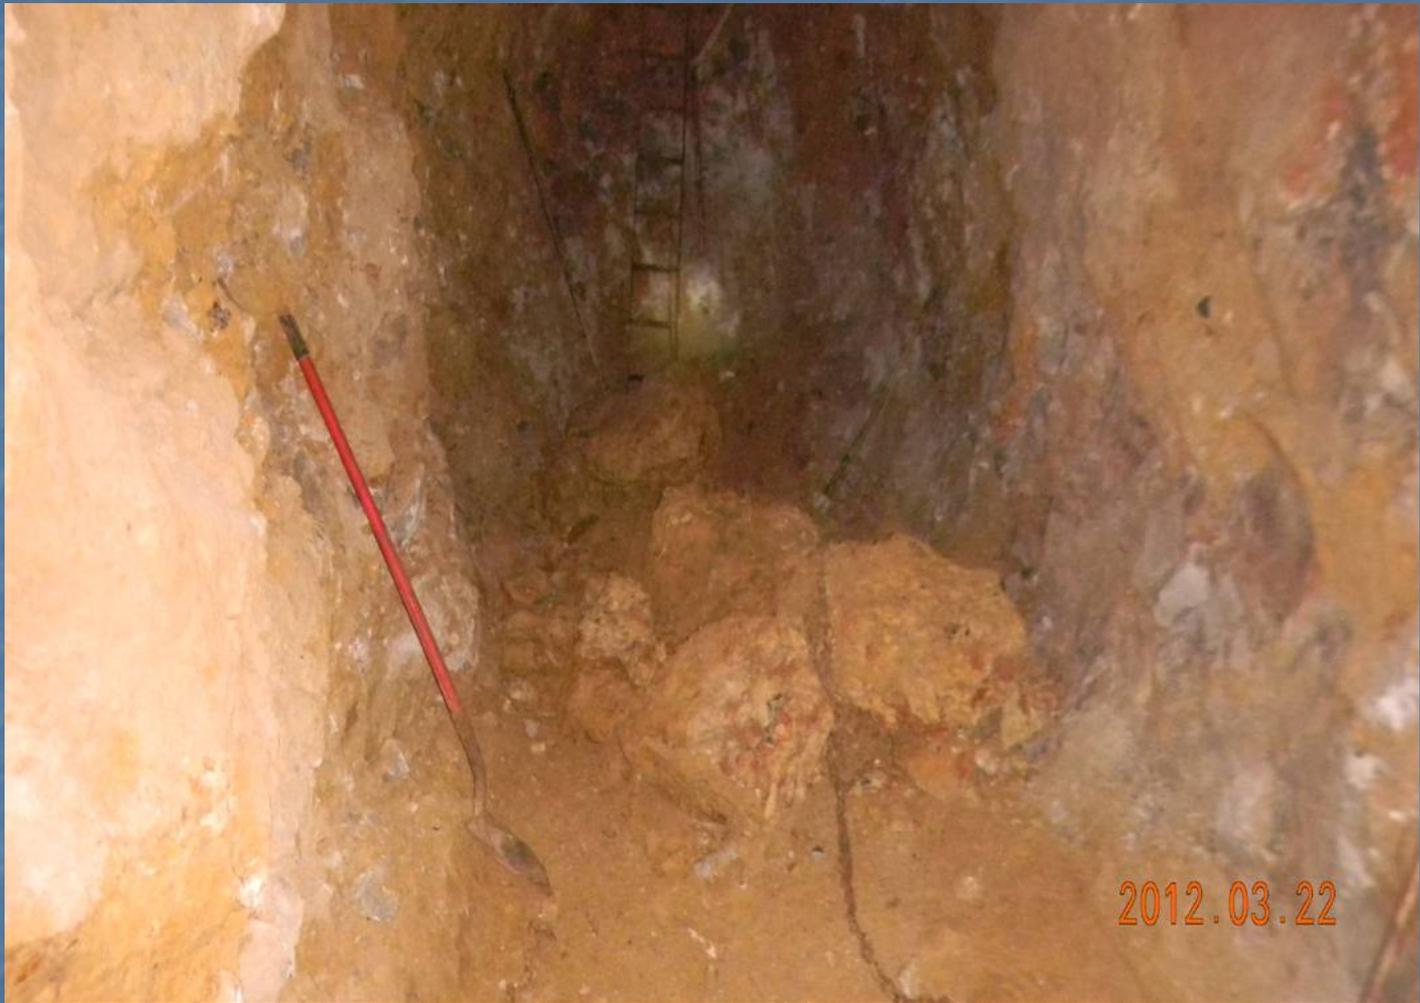
The victim was killed while cleaning fine ore with a shovel and loading it in the bucket of a front-end loader. A rock, about 20 feet high, fell from the top left rib striking him.

The accident occurred due to management's failure to ensure examinations and tests for loose ground conditions are conducted after blasting. Ground conditions that created a hazard were not taken down or supported.

Root Cause: Management failed to establish procedures requiring experienced persons to examine and test ground conditions prior to commencing work after blasting. Management failed to established procedures to correct hazardous conditions or provide ground support where ground conditions indicate it is necessary.

Corrective Actions: The mine owner was killed in the accident and the mine is currently not in production status. No corrective action has been taken. However, before mining operations commence, the mine operator will comply with the requirements of 30 CFR.
