Re: Proposed Rule; Proximity Detection Systems for Continuous Mining Machines in  
Underground Coal Mines; RIN 1219-AB65

United Mine Workers of America  
Comments on the  
Proposed Rule for Proximity Detection Systems for Continuous Mining  
Machines in Underground Coal Mines  
November 14, 2011

# Recommendations for Evaluating and Implementing Proximity Warning Systems on Surface Mining Equipment

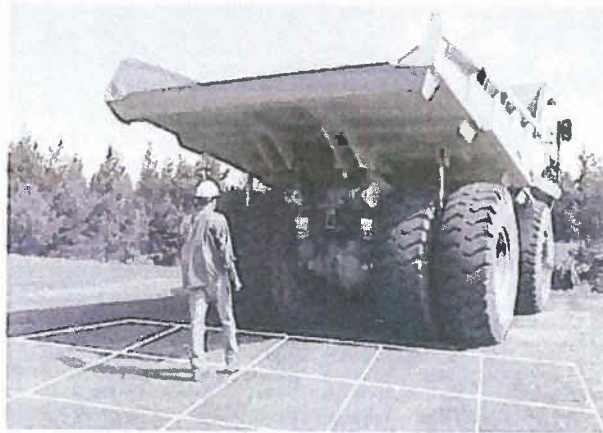
Figure 4. Preliminary tests conducted using a 50-ton-capacity off-highway dump truck.

Preliminary evaluations of systems that showed potential for use on mining equipment were conducted at the NIOSH Spokane Research Laboratory using a 50-ton-capacity, rigid frame, off-highway dump truck (fig. 4). While smaller than trucks typically used at surface mining operations, the 50-ton truck provided a test bed that allowed researchers to determine important parameters for each system.

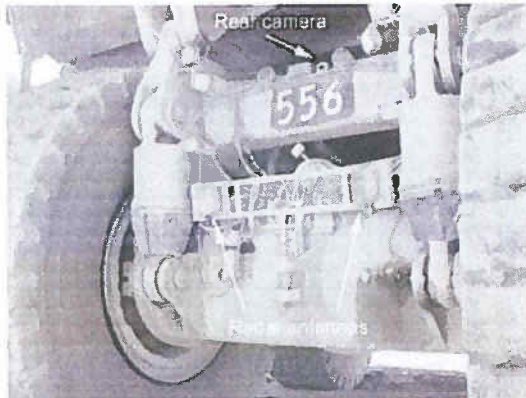
Figure 5. Preco radar antennas and Vision Techniques camera mounted on the rear of a haul truck.

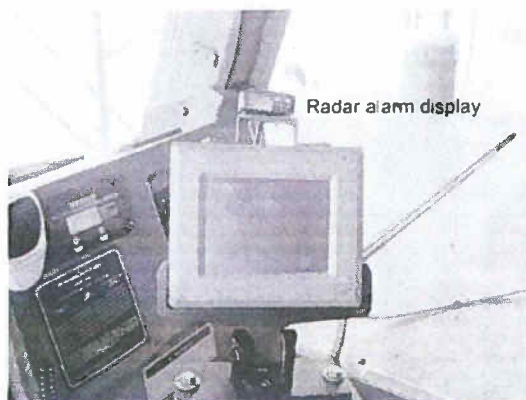
Figure 7. Preco radar alarm display mounted in truck cab.

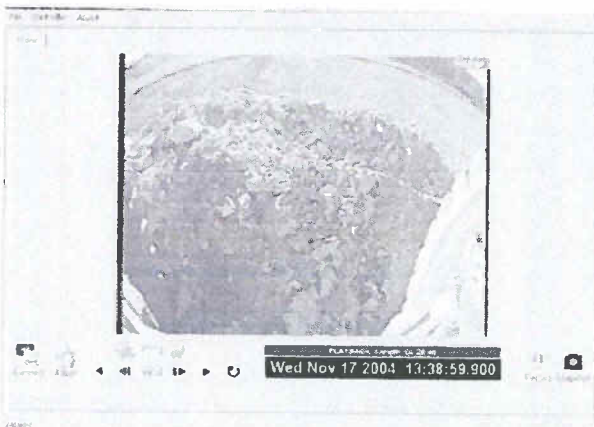
Figure 10. Screen shot of video viewing software showing berm and radar alarm indicator (upper right).

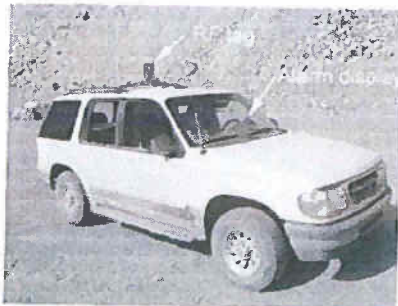
Figure 15. AMT RF tag mounted on a passenger vehicle.

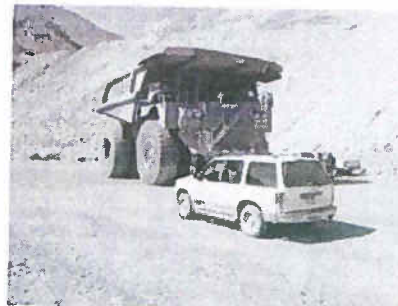
Figure 16. Tests to determine the detection characteristics of the AMT CAS-CAM/RF system.

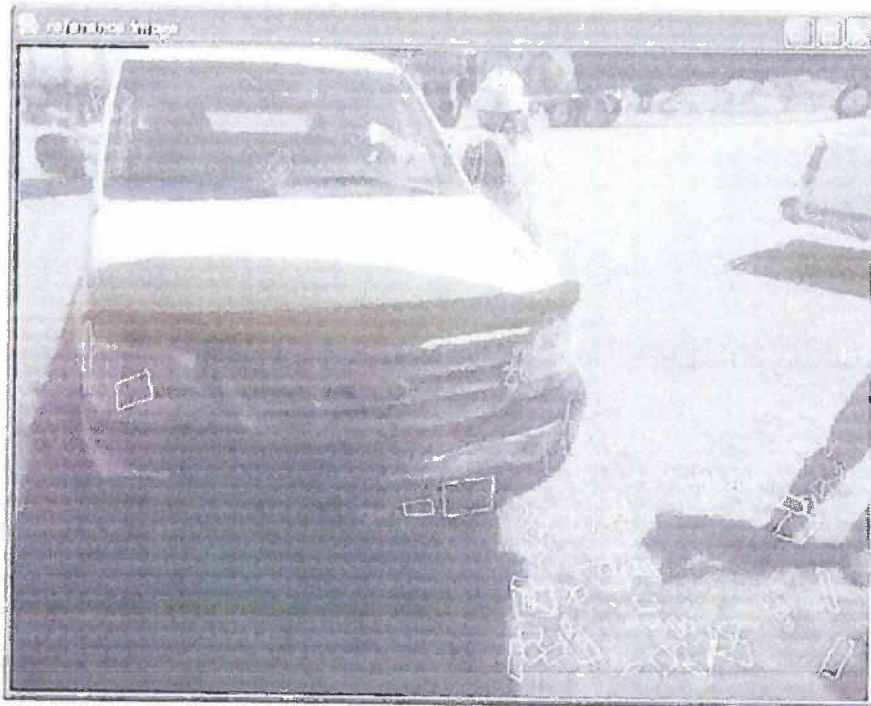
Figure 24. Captured image from one camera with ground and alarm areas identified by boxes.

The stereo cameras were mounted on the rear of an off-highway dump truck while image pairs were collected for various obstacles. Figure 24 shows one of the stereo images captured during a test at a quarry. The light-colored boxes represent areas identified on the ground. The darker boxes represent items that stood out from the ground and would cause an alarm. The pickup truck, people, and car in the background were correctly identified as objects that would cause an alarm. Other tests were conducted to

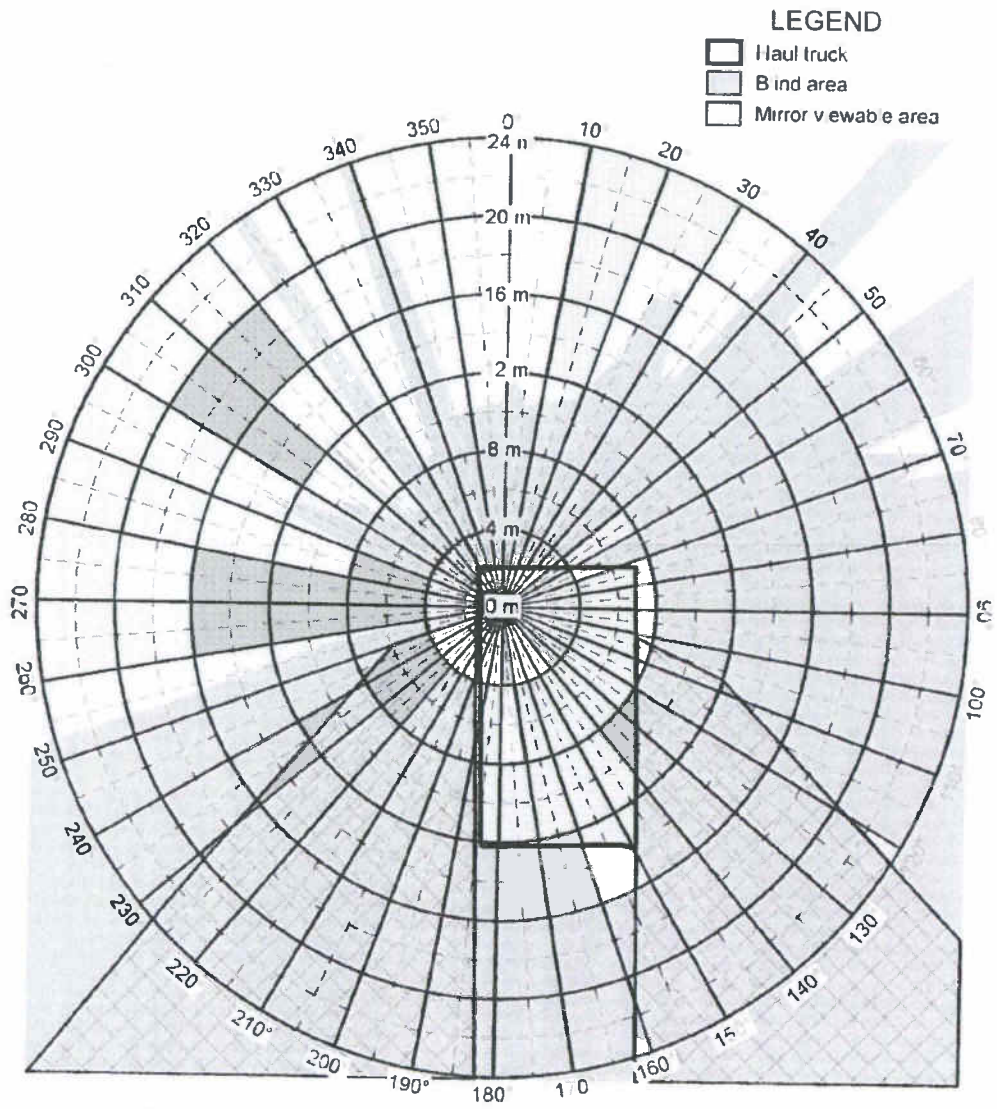
Figure A.3. Blind area diagram for a Euclid EH4500 280-ton-capacity haul truck (1.5 meter plane).

These blind area plots can be used as a guide to determine the effective placement of monitoring devices. For instance, the most significant blind areas on a haul truck (figs. A1, A2, A3) are to the front, the right side, and to the rear. Cameras or proximity warning sensors should monitor these areas. On a front-end loader (figs. A4, A5, A6) the rear blind area is a concern, but a raised bucket can also cause a significant blind area to the front. Large excavators (figs. A7, A8, A9) have extensive blind areas on the side opposite the cab and to the rear. These machines tram slowly, but the primary concern is an object or person within the swing radius. A tracked dozer (figs. A10, A11, A12) has significant blind areas to the rear and to the front when the blade is raised. Side blind areas are a concern too, because tracked or skid-steer machines can rotate quickly around the machine's center point. A large motor grader (figs. A13, A14, A15) has fairly good visibility if mirrors are used, but the front and rear blind areas are still of concern. Visualizing the extent of the blind areas can be an effective tool in reminding workers of the dangers of approaching equipment while on foot or in a smaller vehicle. Blind areas for many other types of smaller equipment used in mining and construction can be found in Hefner, 2003.
