Fatality #16 - December 15, 2011

**Machinery - Pennsylvania - Crushed, Broken Stone NEC
Damascus 535 Crushing - Damascus 535 Crushing**

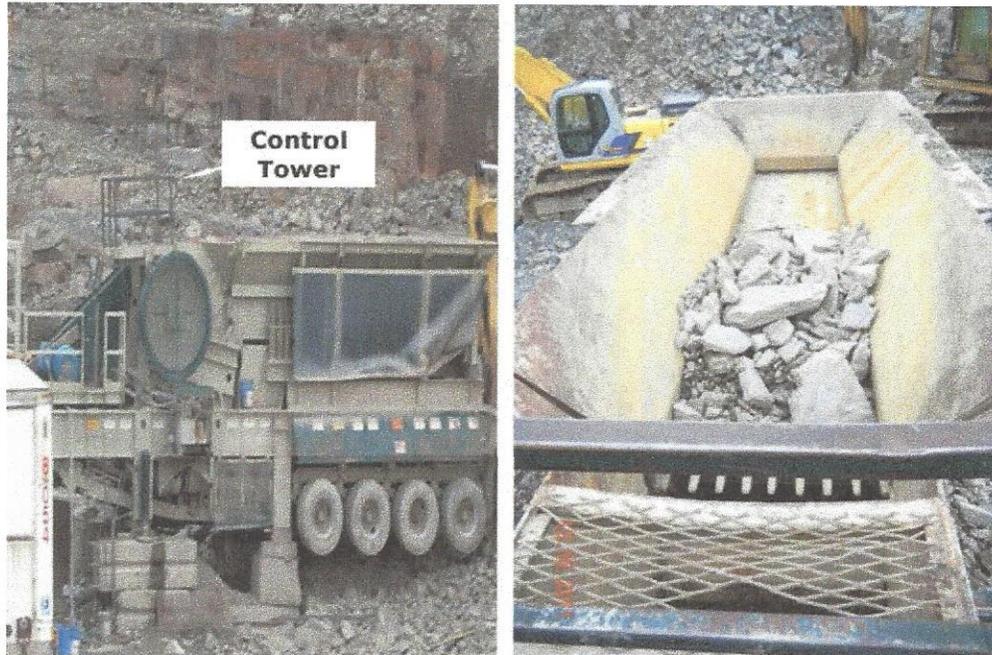
METAL/NONMETAL MINE FATALITY - On December 15, 2011, a 22 year-old laborer with 3 months of experience was killed at a surface stone operation. The victim, who was last seen on a control tower, fell into an operating jaw crusher.

- Always use fall protection when working where a fall hazard exists.
- Establish policies and procedures for safely clearing plugged material in a jaw crusher.
- Ensure that persons are task trained and understand the hazards associated with the work being performed.
- Deenergize and Lock-out/tag-out all power sources before working on crushers.
- Do not place yourself in a position that will expose you to hazards.
- Monitor personnel routinely to determine that safe work procedures are followed.

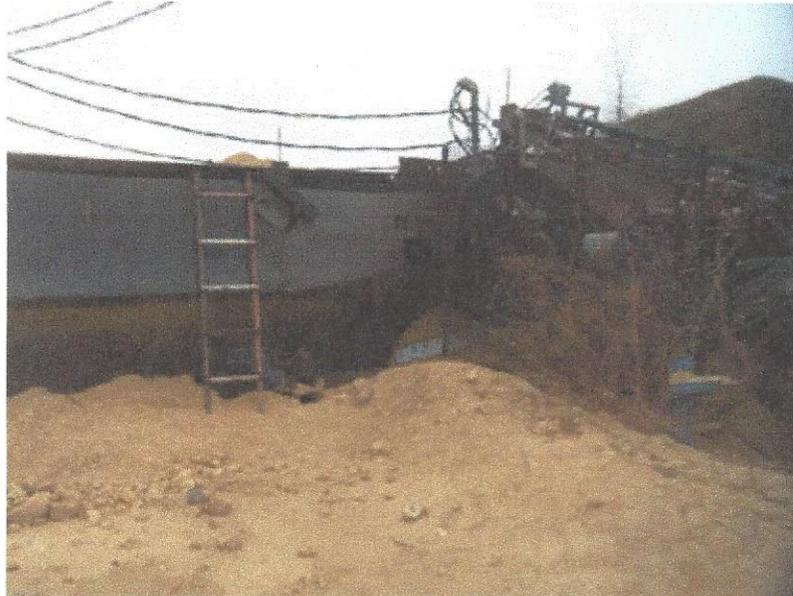
METAL/NONMETAL MINE FATALITY - On November 7, 2011, an 82 year-old owner/crusher operator with 27 years of experience was killed at a surface crushed stone operation. The victim was attempting to dislodge material from the vibrating feed hopper when he slipped or fell into the operating jaw crusher.

- Establish policies and procedures for safely clearing plugged material in a feed hopper. Evaluate design modifications or use auxiliary equipment to reduce the risks associated with clearing an obstruction.
- Ensure that persons are task trained and understand the hazards associated with the work being performed.
- Deenergize and Lock-out/tag-out all power sources before working on crushers.
- Provide and maintain a safe means of access to all working places.

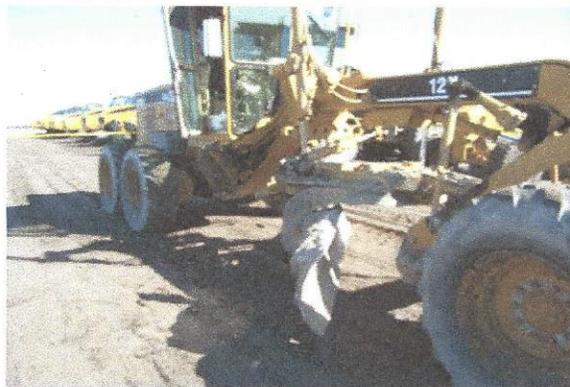
METAL/NONMETAL MINE FATALITY - On February 12, 2011, a 41 year- old grader operator with 15 years of experience was killed at a phosphate rock operation. The victim and a coworker were standing and talking when he was struck by a grader that was backing up. The accident occurred in a staging area where equipment operators were inspecting their equipment before the shift.

- Train all persons to recognize work place hazards and to stay clear of normal paths of travel for mobile equipment.
- Regularly monitor work practices and reinforce their importance. Take immediate action to correct unsafe conditions or work practices.

- Designate a specific area, clear of mobile equipment, where persons can meet before the shift starts.
- Install cameras and collision avoidance systems on mobile equipment to protect persons.

- Ensure that illumination is adequate at the work site.
- Before moving mobile equipment, look in the direction of travel, use all mirrors, cameras, backup alarms, and installed proximity detection devices to ensure no one is in the intended path.

- Sound the horn to warn persons of movement and allow time to move to a safe location.
- Communicate with mobile equipment operators and ensure they acknowledge your presence.

- Wear high visibility clothing when working around mobile equipment.
- Consider use of wearable strobes when near mobile equipment.

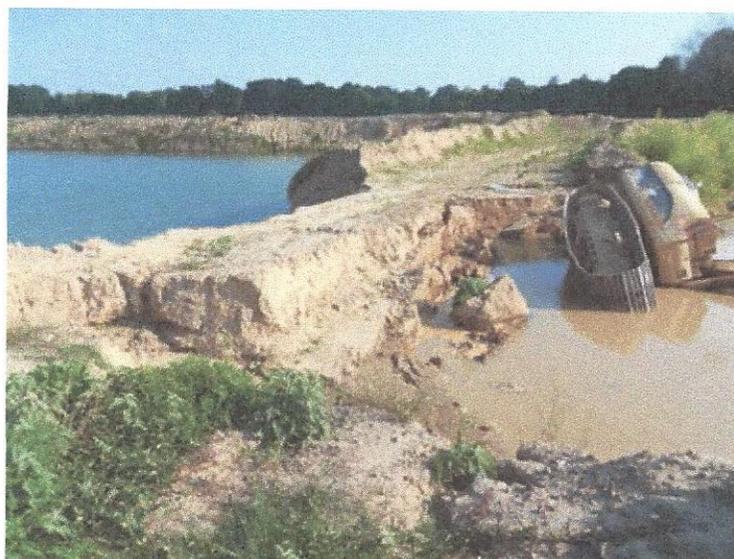
METAL/NONMETAL MINE FATALITY - On May 23, 2012, a 36 year-old foreman with about 9½ years of experience was killed at a sand and gravel operation. He was operating an excavator on a dike separating two ponds. The ground beneath the excavator tracks failed and the excavator toppled into one of the ponds.

- Examine work areas to identify all hazards and remediate before starting any work.
- Evaluate the stability of the ground (slopes and berms) prior to operating equipment near any drop off or edge.
- Always be attentive to changes in ground conditions and visibility when operating machinery.
- Perform the work at a safe distance away from the edge of a pond or where the stability of the ground may be unknown.
- If a potential hazard is present, use long reach equipment to limit exposure and maintain a safe distance away.
- Consider areas that have experienced previous slope failures to be unstable and do not approach until the area is evaluated for stability.
- Wear flotation devices where there is a danger of falling into water.
- Be alert to changes in ground conditions such as cracking, bulging, sloughing, undercutting, and erosion.

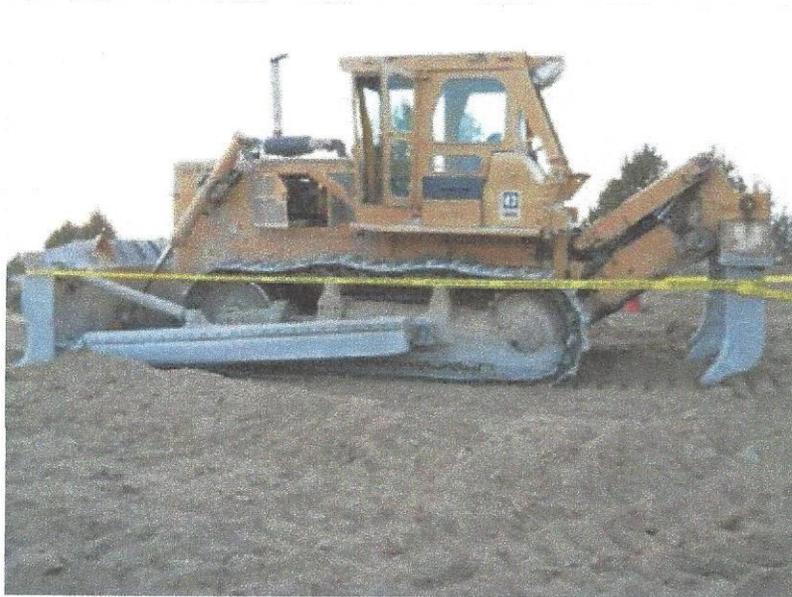
METAL/NONMETAL MINE FATALITY - On September 26, 2012, a 79-year old foreman with 56 years of experience was killed when he was run over by the dozer he had been operating. The victim exited the cab and was positioned on the left track checking the engine throttle linkage when the dozer moved forward.

- Inspect equipment before placing it in operation for the shift.
- Correct safety and operational defects on equipment in a timely manner to prevent the creation of a hazard to persons.

- Establish safe work procedures and identify and remove hazards before beginning a task.
- Prior to beginning work, ensure that persons are task-trained and understand the hazards associated with the work being performed. Know and follow safe work procedures before beginning repairs.

- Block dozer against motion by lowering the blade and ripper to the ground and setting the parking brake. Set the transmission lock lever to ensure the transmission is in neutral.

- Do not place yourself in a position that will expose you to hazards while performing a task.
- Monitor personnel routinely to determine that safe work procedures are followed.

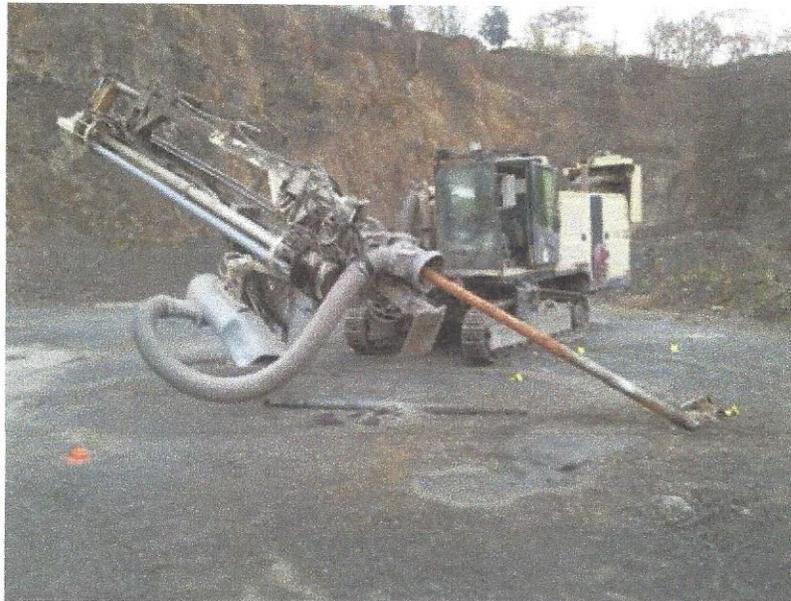
METAL/NONMETAL MINE FATALITY - On November 1, 2012, a 30-year old contract driller with 6 years of experience was killed at a common shale operation. The victim apparently attempted to thread a new drill steel manually, with the use of a strap and the drill head rotating, when the rotating steel entangled him.

- Establish and discuss safe work procedures. Identify and control all hazards. Train all persons to recognize all potential hazards and understand safe job procedures to eliminate all hazards before beginning work.

- Ensure that the manufacturer's procedures are followed when adding drill steels.
- Ensure that emergency stop/shut-off switches, panic bars, dead man devices, tethers, slap bars, rope switches, two handed controls, spring loaded controls, are functional and in easily accessible locations.

- Never manually thread drill steels when the drill head is rotating.
- Drills should be fitted with automated systems for changing rods, or two persons should be present when rods are changed manually.

- Do not wear loose fitting clothing when working around drilling machinery. Avoid using a strap or other objects that could become entangled with or thrown from moving or rotating parts.

- Monitor personnel routinely to ensure procedures are followed.

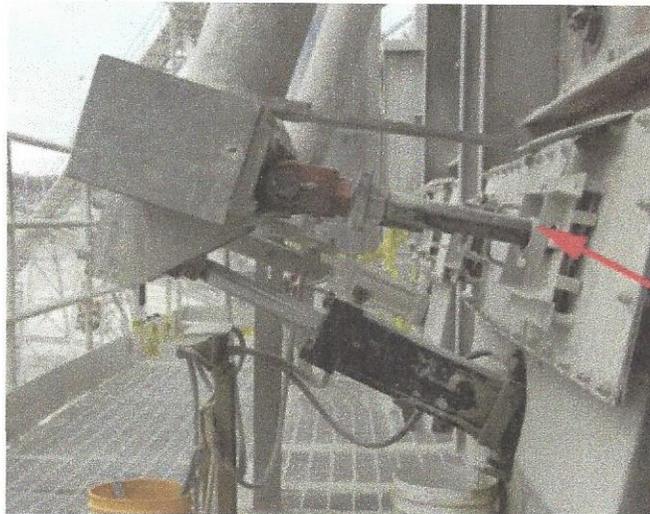
METAL/NONMETAL MINE FATALITY - On January 21, 2013, a 54-year old mechanic with 6 years of experience was killed at a lime operation. The victim went to a kiln pre-heat deck to repair a leaking hydraulic cylinder that activates a pusher arm on the kiln. He was caught between the corner of the angle iron and the plate connecting the push rods.

Victim caught here

- Establish and discuss safe work procedures. Identify and control all hazards associated with the work to be performed along with the methods to properly protect persons.

- Always follow the equipment manufacturer's recommended maintenance procedures when conducting repairs to machinery.
- Task train all persons to recognize all potential hazardous conditions and understand safe job procedures to eliminate all hazards before beginning work.

- Before working on or near equipment, ensure that the equipment power circuits are locked out/tagged out and that the equipment is blocked against hazardous motion.

- Require all persons to be positioned to prevent them from being exposed to any hazards. Monitor personnel to ensure safe work procedures, including lock out/tag out and safe work positioning, are followed.

- Ensure guarding is in place to cover potential pinch points and moving parts in areas routinely accessed by personnel.

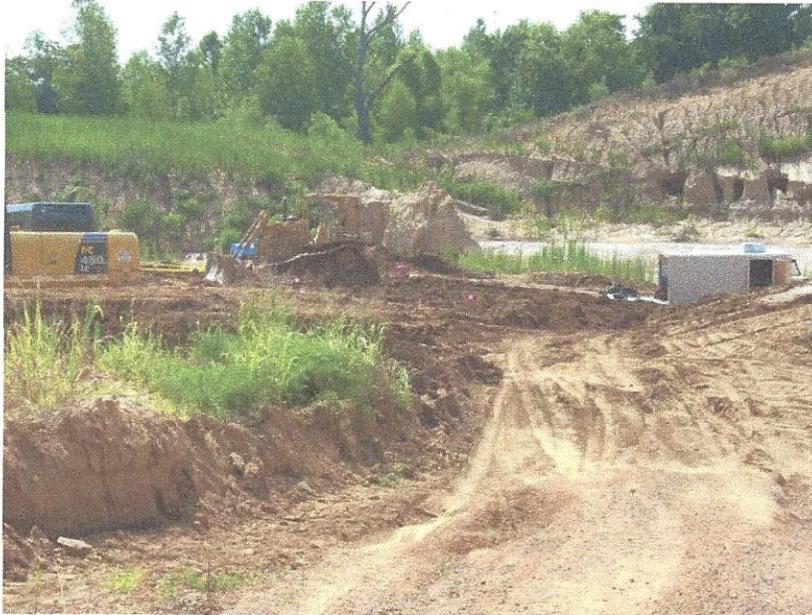
METAL/NONMETAL MINE FATALITY – On July 10, 2013, a 68-year old dozer operator with 23 years of experience was killed at a sand and gravel mine. He was pushing material with a dozer when the machine veered to the right and traveled into a water filled pit.

- Task train all persons to understand the hazards associated with the work being performed.
- Be familiar with your work environment. Before starting to work, thoroughly inspect the area and plan the safest way to move the material and maneuver equipment.
- Maintain control of mobile equipment while it is in motion.
- Always wear a seat belt when operating mobile equipment.
- Monitor persons routinely to determine safe work procedures are followed.

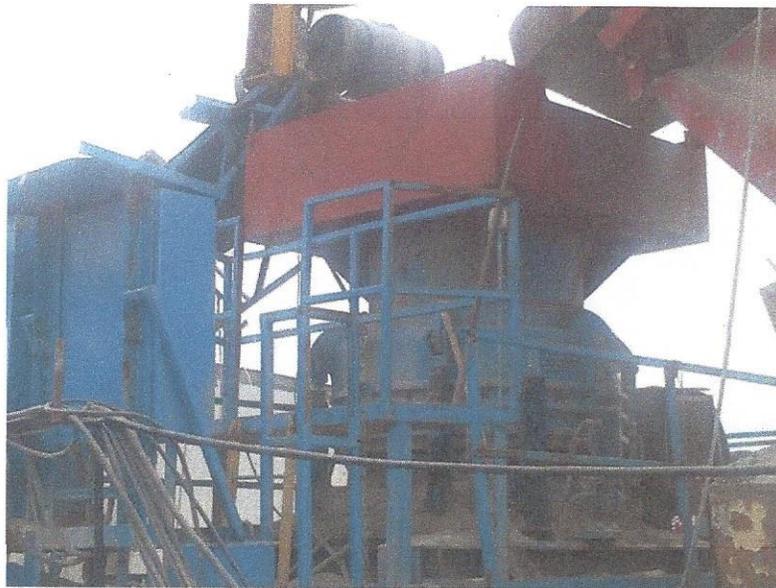
METAL/NONMETAL MINE FATALITY – On August 5, 2013, a 55-year old plant manager with 5 years of experience was killed at a crushed stone operation. The victim looked into an operating crusher and a tooth, that broke free from an excavator bucket, was ejected from the crusher and struck him.

- Establish and discuss policies and procedures for safely clearing a cone crusher. Consider a mechanical method for clearing material to minimize exposure to persons performing the work.

- Task train persons to recognize all potential hazardous conditions and to understand safe job procedures for elimination of the hazards before beginning work.

- Before working on or near equipment, ensure the equipment power is off and locked out/tagged out. Ensure the equipment has been securely blocked against hazardous motion to ensure energy cannot be released while performing work.

- Always maintain equipment in a safe operating condition.
- Provide a safe means of access for persons required to maintain a cone crusher.
- Provide guards, shields, or other devices to protect persons from the hazard of flying or falling materials generated from the operation of screens, crushers, or conveyors.

- Implement measures to ensure persons are properly positioned and protected from hazards while performing a task.

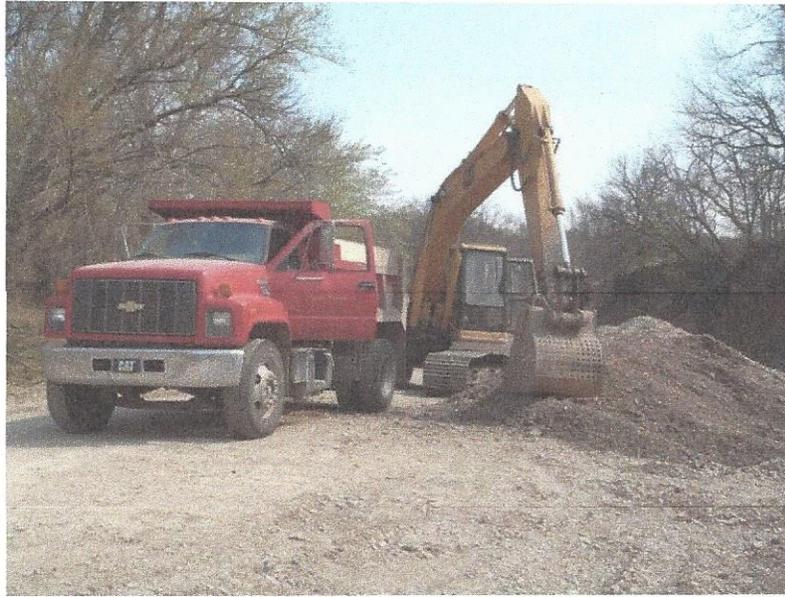
METAL/NONMETAL MINE FATALITY – On April 17, 2014, a 58-year-old truck driver with 3½ years of experience was killed at a sand and gravel mine. An excavator was loading material in a haul truck parked at the pit. When the victim exited the truck, he was struck by the excavator bucket and pinned against the truck.

- Establish and discuss safe work procedures before beginning work. Identify and control all hazards associated with the work to be performed and use methods to properly protect persons.

- Task train all persons to recognize all potential hazardous conditions and to understand safe job procedures for elimination of the hazards before beginning work.

- Ensure that haul truck operators remain in their trucks when being loaded.
- Communicate with mobile equipment operators and ensure they acknowledge your presence. Stay in the line of sight with mobile equipment operators.

- Ensure that you make eye contact with mobile equipment operators before approaching their work areas. Never assume the equipment operator sees you.
- Never place yourself in a location where equipment operators can't see you.

- Before operating equipment, always ensure other miners are clear and safely positioned.
- Monitor persons routinely to determine safe work procedures are followed.

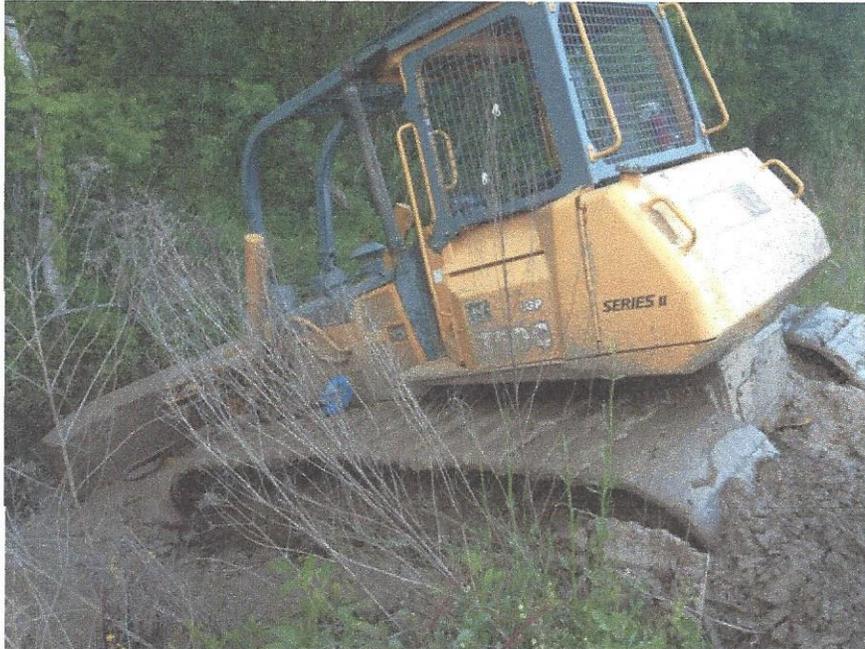
METAL/NONMETAL MINE FATALITY – On April 24, 2014, a 50-year-old contract dozer operator with 23 years of experience was killed at a fire clay mine. He had been operating a dozer pushing clay in the pit and was found lying five feet behind the dozer.

- Ensure that persons are trained, including task-training, to understand the hazards associated with the work being performed.
- Establish and discuss safe work procedures before beginning work. Identify and control all hazards associated with the work to be performed and use methods to properly protect persons.
- Do not place yourself in a position that will expose you to hazards while performing a task.
- Maintain control of mobile equipment while it is in motion.
- Set the parking brake and lower the bull dozer blade to the ground before dismounting equipment.
- Never jump from mobile equipment.
- Always wear a seat belt when operating mobile equipment.
- Monitor persons routinely to determine safe work procedures are followed.

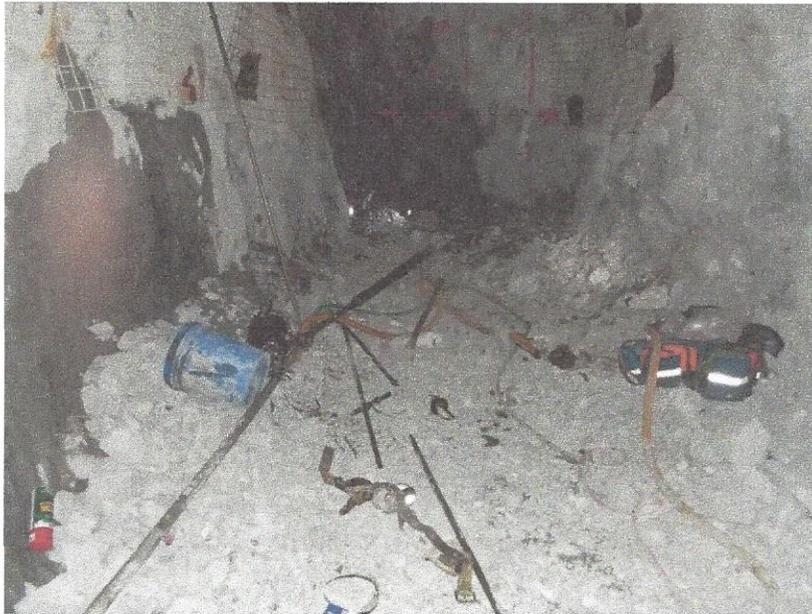
METAL/NONMETAL MINE FATALITY – On April 28, 2014, a 53-year-old miner with 32 years of experience was killed at an underground gold mine. The victim was drilling with a jackleg drill when his clothing became entangled in the drill steel of the machine.

- Ensure that persons are trained, including task-training, to understand the hazards associated with the work being performed.
- Establish and discuss safe work procedures before beginning work. Identify and control all hazards associated with the work to be performed and use methods to properly protect persons.
- Conduct work place examinations before beginning any work.
- Do not place yourself in a position that will expose you to hazards while performing a task.
- Stop the drill rotation when performing tasks near the rotating steel.
- Provide safe routing of hoses and cables so they are not close to the rotation of the drill.
- Do not assign a person to work alone in areas where hazardous conditions exist that would endanger his or her safety.
- Do not wear loose fitting clothing when working around drilling machinery.
- Keep work areas clean and free of tripping hazards.

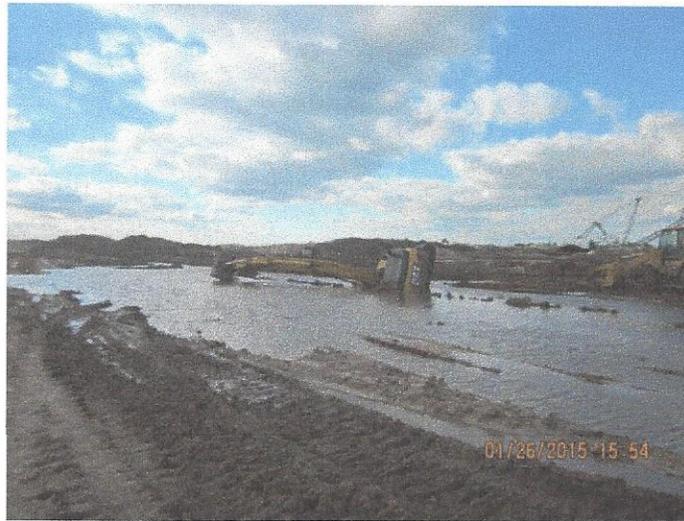
METAL/NONMETAL MINE FATALITY – On January 26, 2015, a 57-year old heavy equipment operator with 36 years of experience was seriously injured at a phosphate mine. He was operating an excavator near a water filled ditch when the excavator tipped forward and went in the water, submerging the cab. The victim was removed from the cab and transported to a hospital where he died later that day.

- Task train all persons to recognize all potential hazardous conditions and safe job procedures to identify and eliminate all hazards before beginning work, specifically the limited visibility of large equipment.

- Discuss safe work procedures before beginning work. Identify and control all hazards associated with the work to be performed and the methods to properly protect miners.

- Provide traffic patterns and roads that minimize the danger of machines traveling near bodies of water.
- Conduct examinations of travelways to evaluate hazards.

- Install barriers, markers, or other warning devices to aid equipment operators where travelways are not recognizable or hazards are not apparent. Limit travel of mobile equipment and inform mobile equipment operators of hazards.

- Do not travel into areas where ground conditions can't be verified. If necessary, use the bucket of the machine to probe the travel/work area to check the ground conditions.

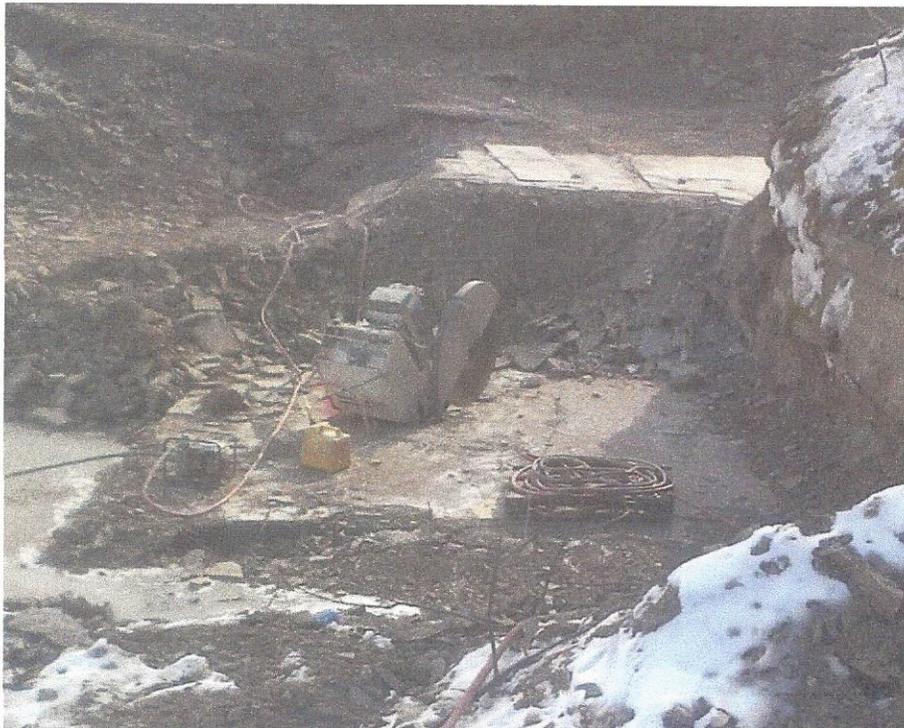
METAL/NONMETAL MINE FATALITY – On March 23, 2015, a 48-year old mine operator with 20 years of experience was killed at a dimension stone operation. The victim was operating a walk-behind masonry saw, positioned between the saw and a ledge, when he tripped and fell. The victim and the saw went over the 4½-foot ledge, resulting in the saw falling on him.

- Identify all hazards and use appropriate controls to protect miners prior to conducting any work.
- Ensure that operators are in a safe position and have control of their equipment at all times.
- Keep workplaces free of tripping hazards.
- Use barricades or railings at edges of drop-offs where persons are in danger of falling.
- Equip walk behind masonry saws with automatic shut off devices to stop the engine if the operator cannot maintain control of the equipment.
- Design bench top stone cutting patterns to ensure the saw operator is not positioned between the saw and the drop off edge.

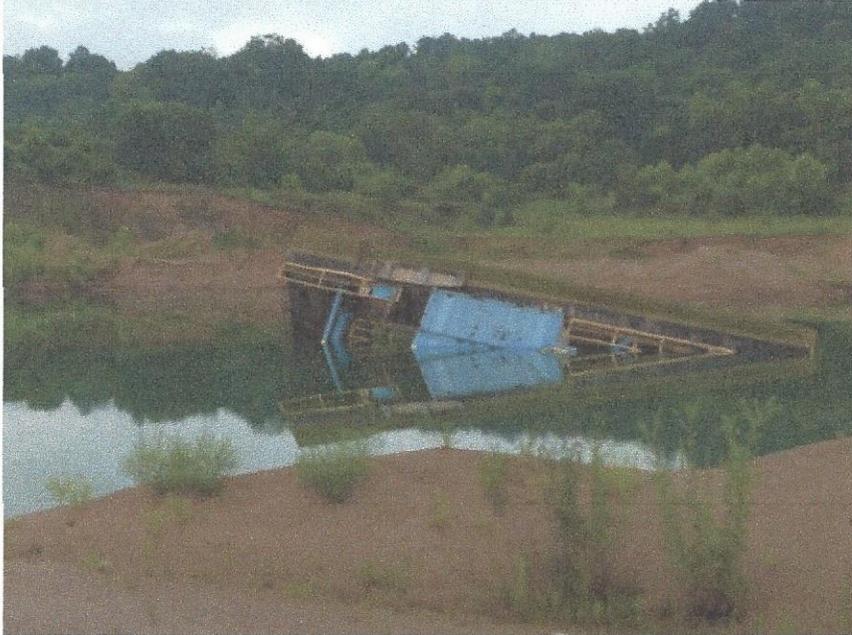
METAL/NONMETAL MINE FATALITY – On July 10, 2015, a 50-year old Superintendent with 26 years of experience was killed at a sand and gravel dredge operation. Two miners were attempting to dislodge the clam shell bucket from the bottom of the pond when the dredge capsized. One miner was injured but was able to swim to shore and summon assistance. The victim was recovered eight days later.

- Always wear a life jacket where there is a danger of falling into the water.
- Ensure that machinery components are blocked against hazardous stored energy prior to performing maintenance or repairs.
- Task train all persons to recognize all potential hazardous conditions and ensure they understand safe job procedures for elimination of the hazards before beginning work.
- Examine and test all safety devices on a regular basis and ensure that they are operating properly.
- When non-routine tasks or problems occur, conduct a risk analysis before starting the task to ensure that all hazards are evaluated and eliminated.

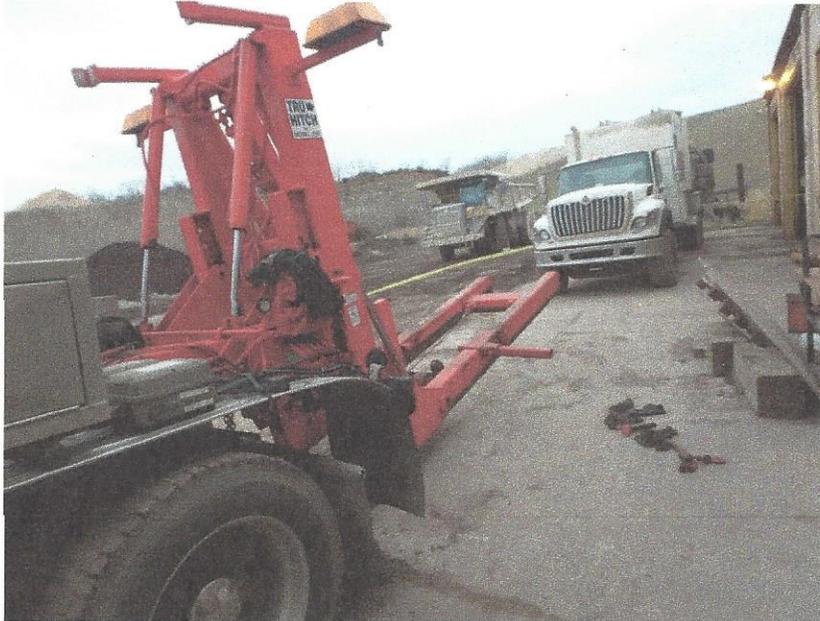
METAL/NONMETAL MINE FATALITY – On December 15, 2015, a 75-year old tow truck laborer was killed at a cement plant. As the tow truck operator was lowering the truck's boom it struck the victim. The victim suffered a severe head wound but was conscious when transported to a local hospital but later died of his injuries.

- Position yourself only in areas where you will not be exposed to hazards resulting from a sudden release of energy. Be aware of your location in relation to machine parts that can move.
- Establish communications between equipment operators and machine helpers. Make sure those around you know your intentions.
- Positively block machine parts (including hydraulic boom lifts) and suspended loads from motion prior to entering areas underneath them.
- Ensure that persons are properly task trained regarding safe operating procedures before allowing them to operate mobile equipment and monitor work to ensure procedures are followed.
- Ensure that all operating systems and safety features on mobile equipment are maintained and functional at all times.
- Operate all machinery in accordance with manufacturers operating guidelines.
- Wear all appropriate personal protective equipment.
