Southern WV Accident Alert

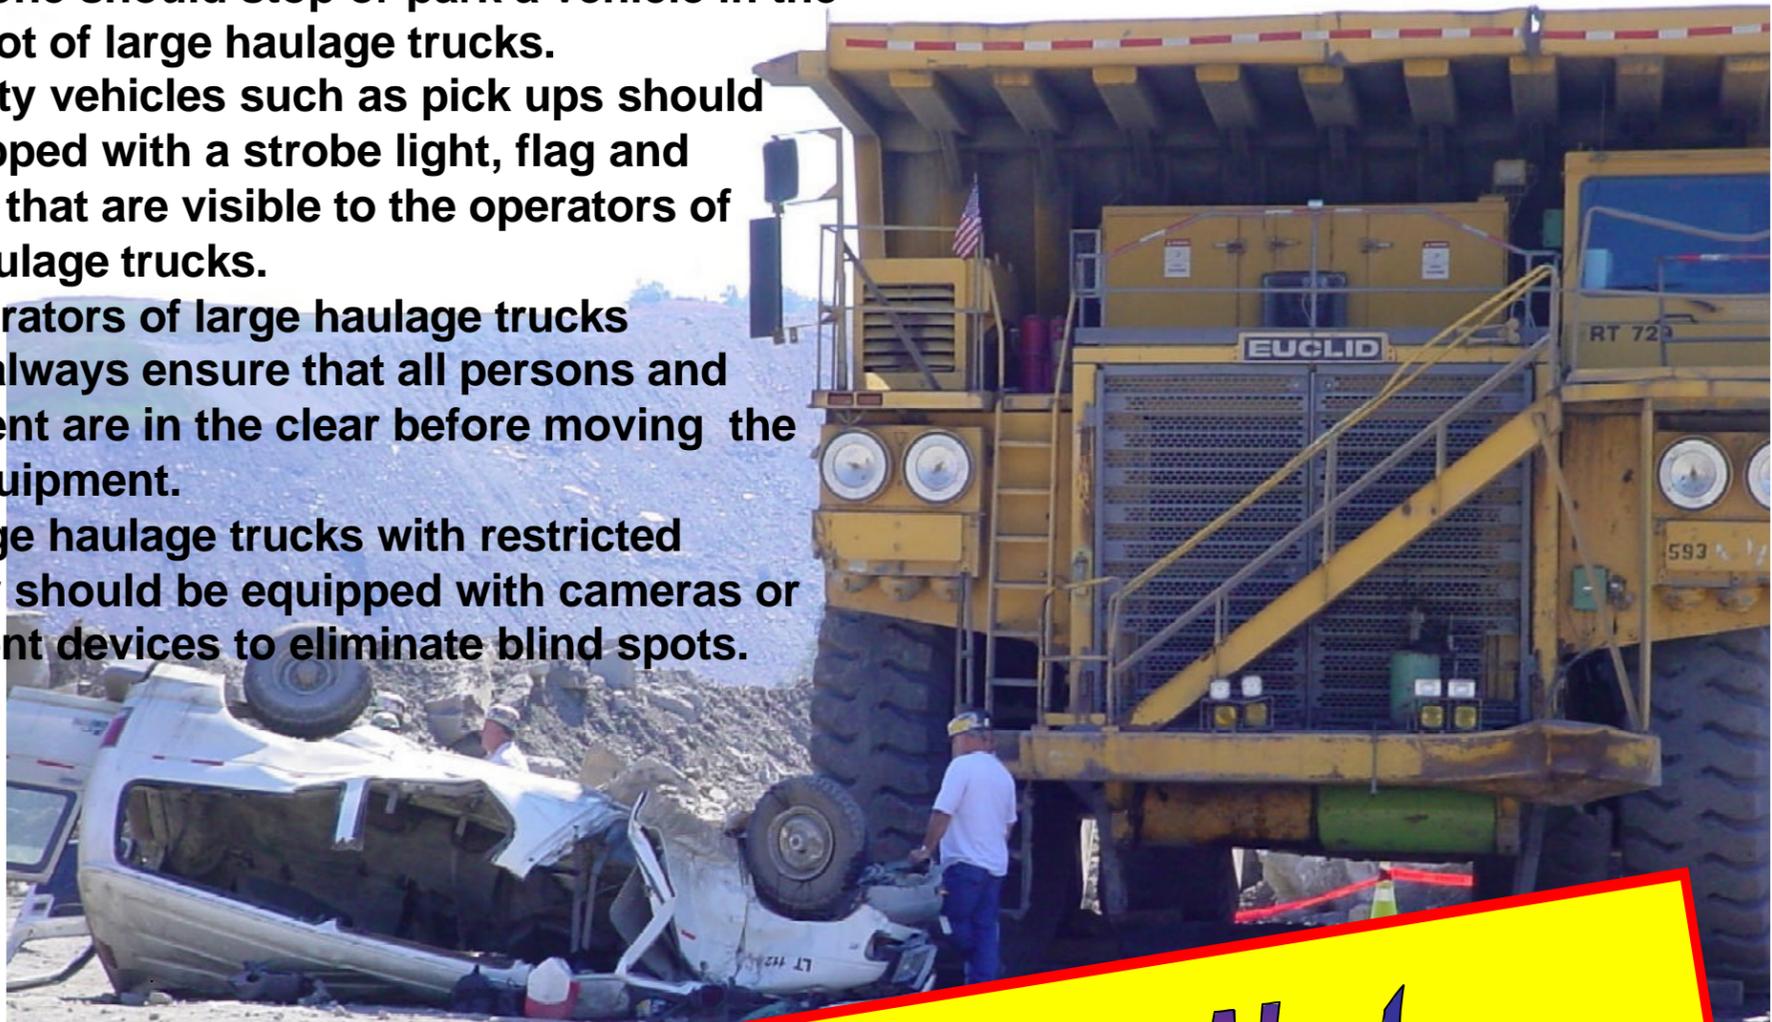
A double fatal surface haulage accident occurred when a 190 ton capacity haulage truck ran over a man-trip van killing two of the three passengers.

- ✓ No one should stop or park a vehicle in the blind spot of large haulage trucks.
- ✓ Utility vehicles such as pick ups should be equipped with a strobe light, flag and flagpole that are visible to the operators of large haulage trucks.
- ✓ Operators of large haulage trucks should always ensure that all persons and equipment are in the clear before moving the large equipment.
- ✓ Large haulage trucks with restricted visibility should be equipped with cameras or equivalent devices to eliminate blind spots.

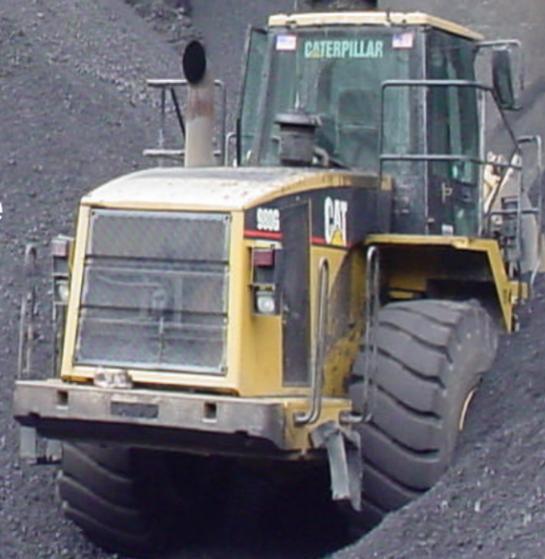
A recent fatality occurred at a Coal Processing Plant when a surge pile collapsed killing a maintenance foreman who was directing the placement of a steel plate over a feeder opening.

- ✓ Management shall establish safe work procedures around coal stock or surge piles that address all steps of the project planned.
- ✓ Before work is performed in a coal or surge pile area, the slope of the adjacent coal face(s) shall be trimmed to a low degree angle that will prevent slipping or sliding hazards.
- ✓ A buffer zone shall be provided between the work site and the toe of the surge pile sufficient to protect the work site.
- ✓ Other than the equipment necessary to perform the job at hand, all other equipment in the vicinity shall be stopped to prevent vibration, distracting noise and potentially hazardous movement of the surge pile.
