MNM Fatal 2015-2

- Hoisting
- January 11, 2015 (Nevada)
- Gold Ore Mine
- Shaft Miner
- 53 years old
- 35 years of experience

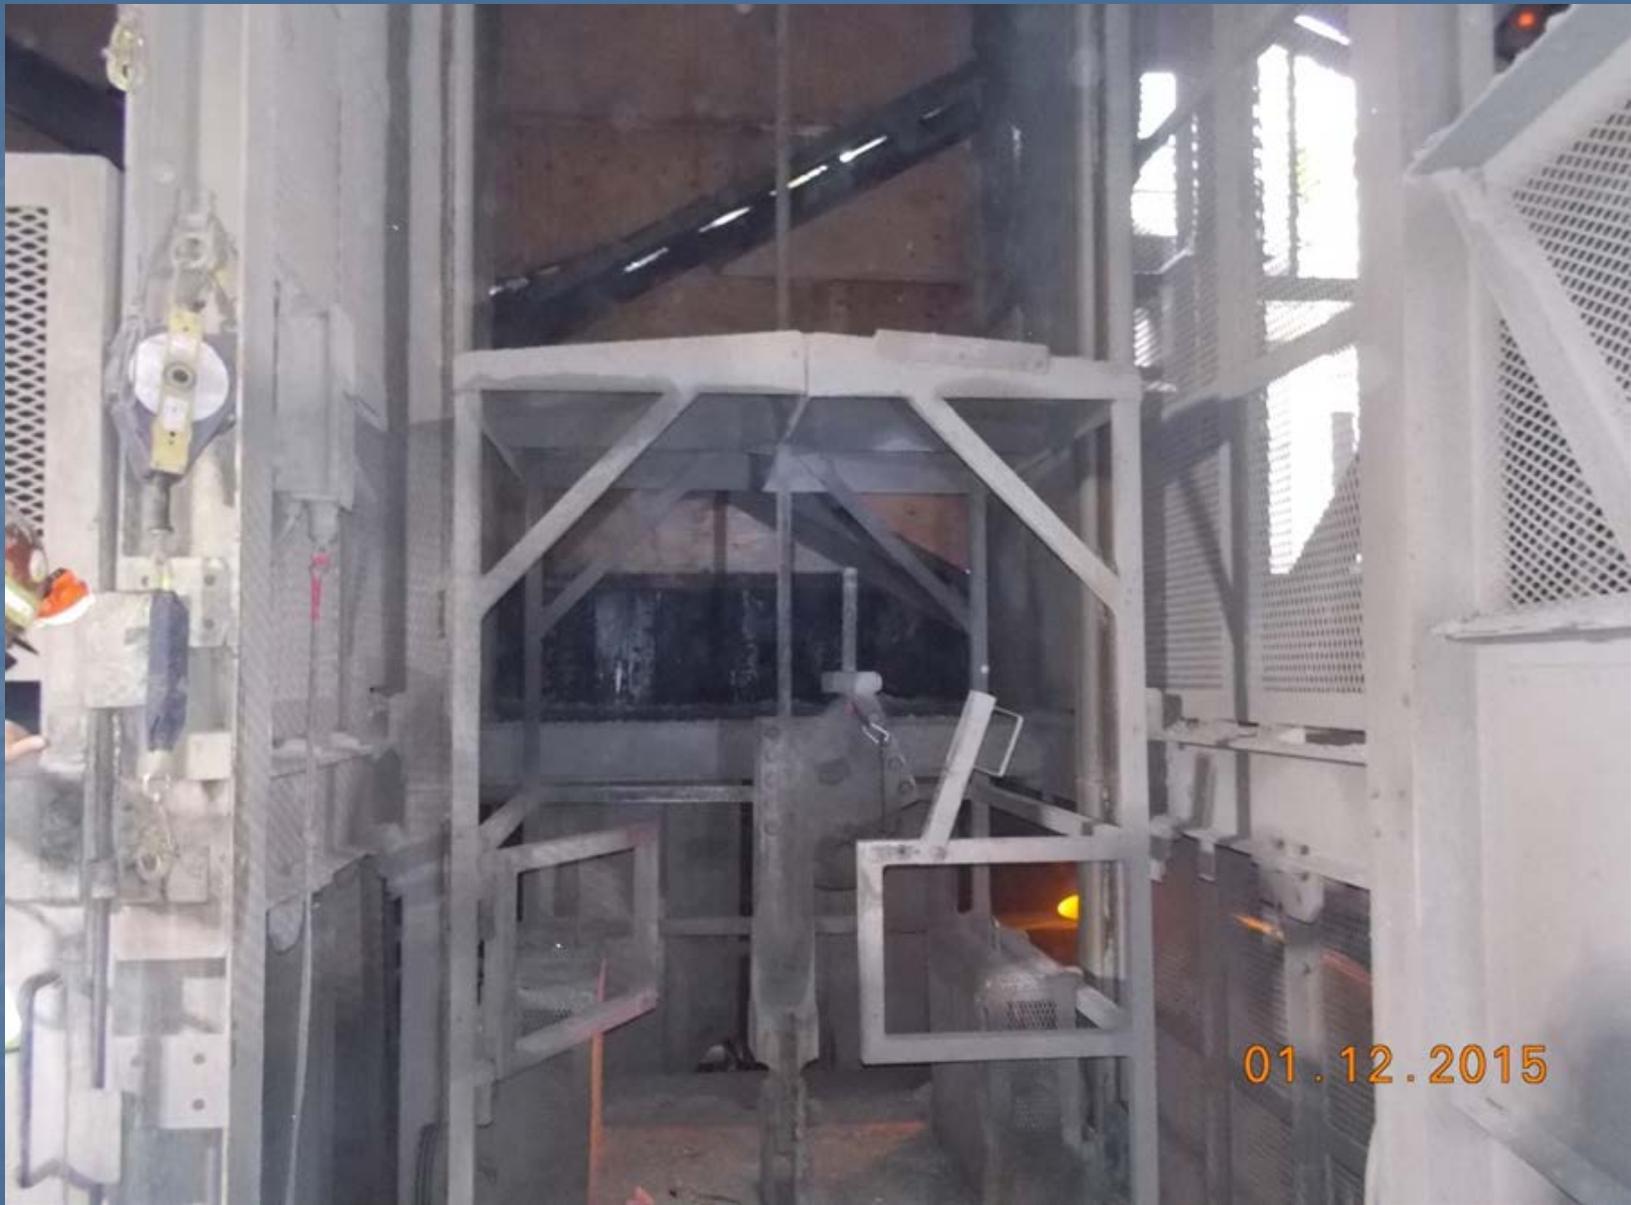
01.12.2015

On January 11, 2015, Brian Lee Holmes, Contract Shaft Miner, age 53, was killed while positioned on a work platform on top of a skip. The skip was traveling up a ventilation shaft when Holmes struck a steel beam in the shaft structure.

The speed of the hoist was too fast for the conditions present in the shaft. The hoist's speed did not allow the victim sufficient time to remain clear of the steel beam while the skip was moving. Additionally, the victim's lanyard was not short enough to prevent him from contacting the shaft steel beams while the skip was moving.

- **Root Cause:** Management failed to establish policies or procedures to protect miners by failing to identify possible hazards. The hoist speed was too fast for the conditions present in the shaft and on the skip at the time of the accident. The victim's lanyard was not short enough to prevent him from contacting the shaft steel beams while the skip was moving.
- **Corrective Action:** The mine operator installed new enclosed cages on top of the skips.
- **Root Cause:** Management failed to establish and train miners on safe procedures for the transportation of persons in conveyances.
- **Corrective Action:** The mine operator developed a new standard operating procedure for the transportation of persons in conveyances and has trained all miners who utilize the modified skips on this new procedure.

- •Train all persons in hazard recognition, awareness of their surroundings, and safe positioning when riding skips.
- •To prevent hazard exposure, require safe positioning for personnel who ride skips.
- •Monitor all persons for safe positioning when riding skips.
- •Place warning signs on skip platforms to remind persons to keep body parts inside the handrails.
