# Metal and Nonmetal Accident Review January – August 3, 2015

# Summary of Deaths

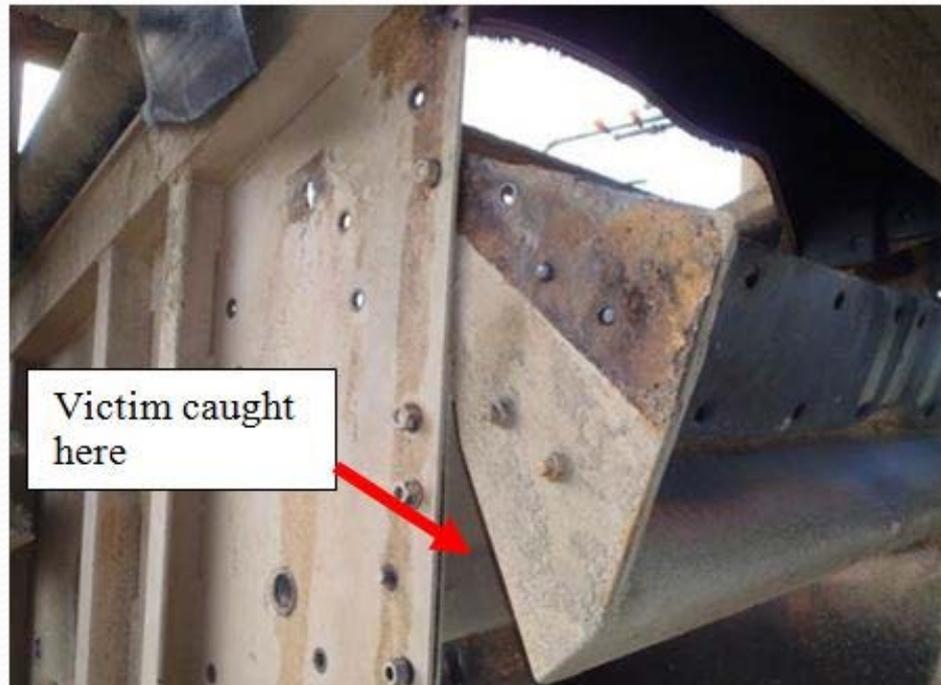
On January 8, 2015, a 63-year old sales manager with 11 years of experience was killed at a sand and gravel mine. He was installing new screen panels in the B tower screen. The feeder box pivoted, pinning him between the box and the rear support beam of the screen deck.

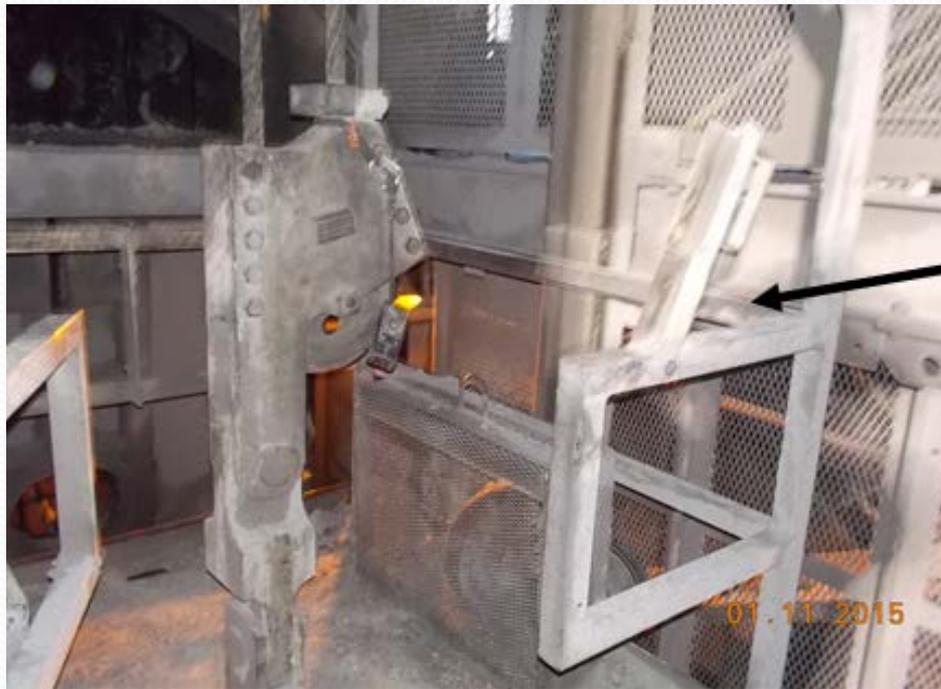
On January 11, 2015, a 53-year old contract shaft miner with 35 years of experience was killed at an underground gold mine. The victim was positioned on a work platform on top of a skip traveling up the ventilation shaft. He struck a steel cross member on a beam in the shaft.

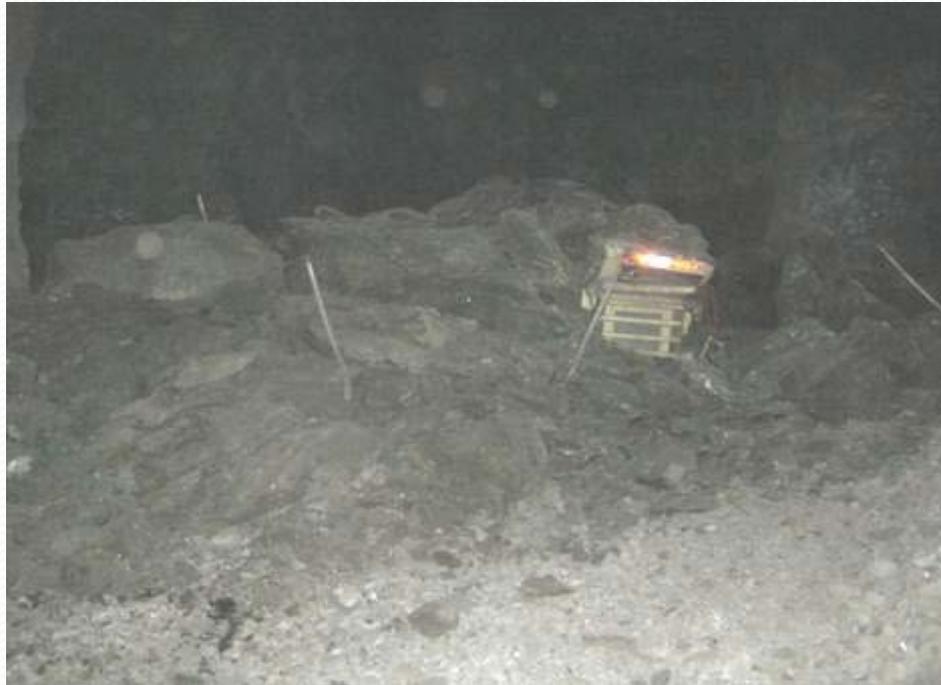
On January 21, 2015, a 54-year old miner (ground support) with 4 years of experience was killed at an underground lead mine. The victim was operating a mechanical scaler in an intersection when a roof fall (55 feet long x 20 feet wide x 6 feet thick) occurred, covering the machine.

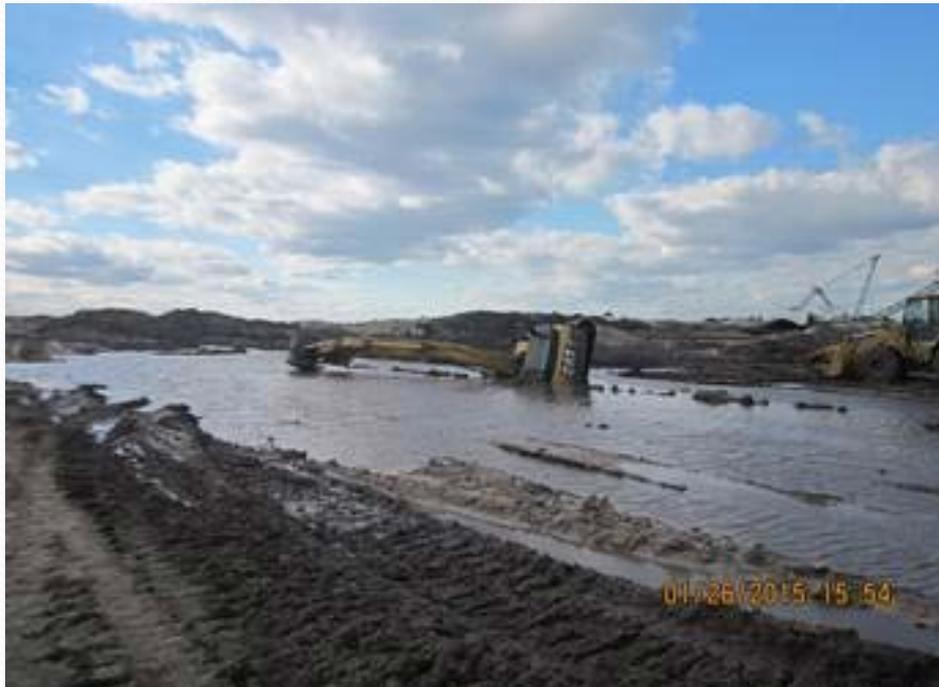
On January 26, 2015, a 57-year old heavy equipment operator with 36 years of experience was seriously injured at a phosphate mine. He was operating an excavator near a water filled ditch when the excavator tipped forward and went in the water, submerging the cab. The victim was removed from the cab and transported to a hospital where he died later that day.

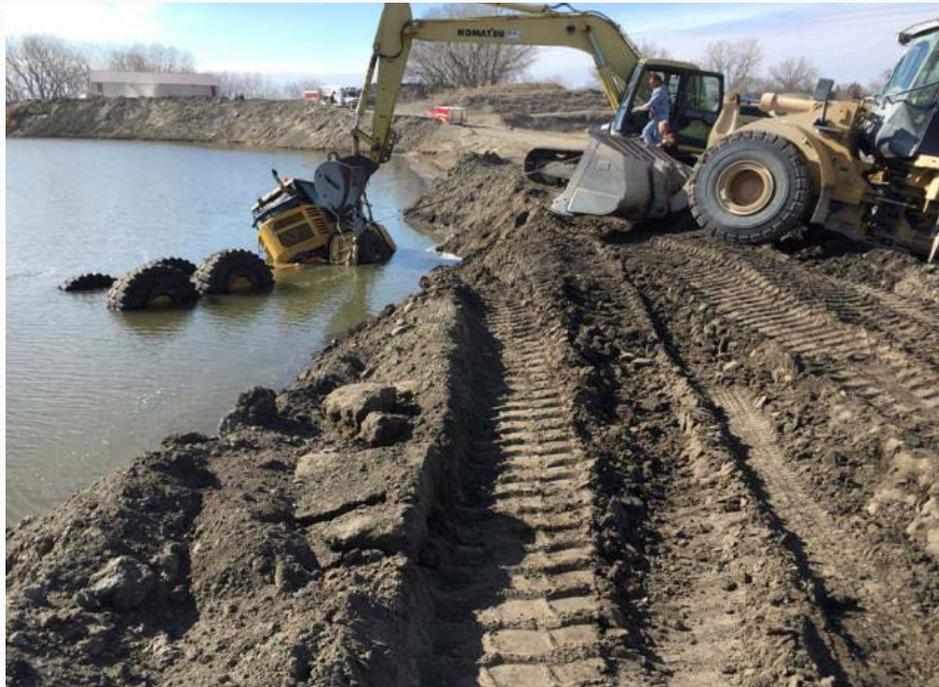
On March 17, 2015, a 44-year old haul truck driver with 4 days of experience was injured at a dredge operation. He was operating a loaded articulated haul truck along an elevated roadway next to a dredge pond. After traveling about 125 yards from the loading point, the haul truck drifted into the water. The victim was removed from the truck, transported to a hospital, and then transferred to a trauma center where he died on March 19, 2015.

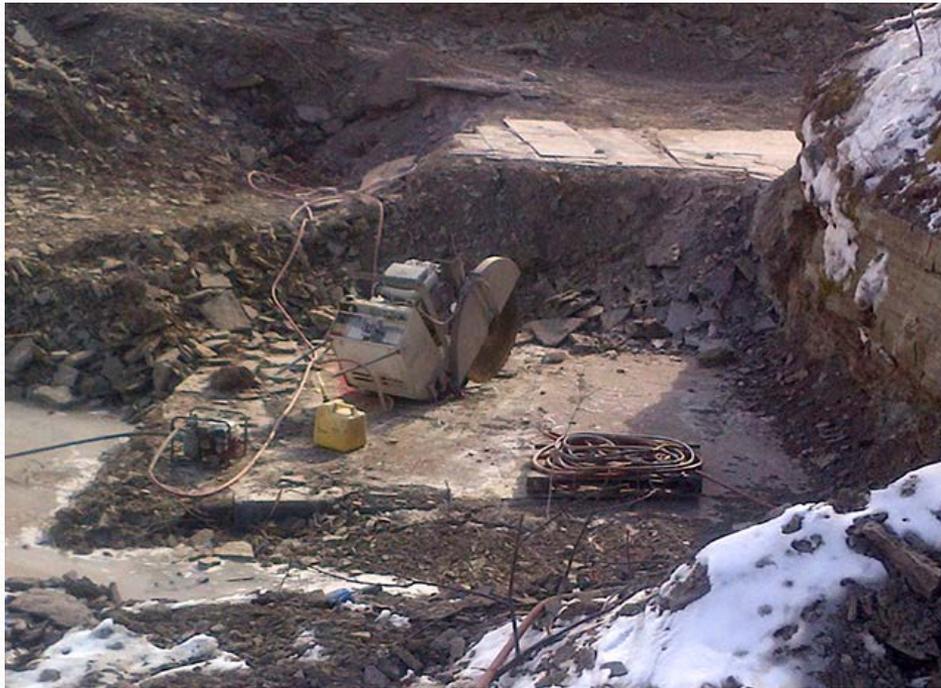
On March 23, 2015, a 48-year old mine operator with 20 years of experience was killed at a dimension stone operation. The victim was operating a walk-behind masonry saw, positioned between the saw and a ledge, when he tripped and fell. The victim and the saw went over the 4½-foot ledge, resulting in the saw falling on him.

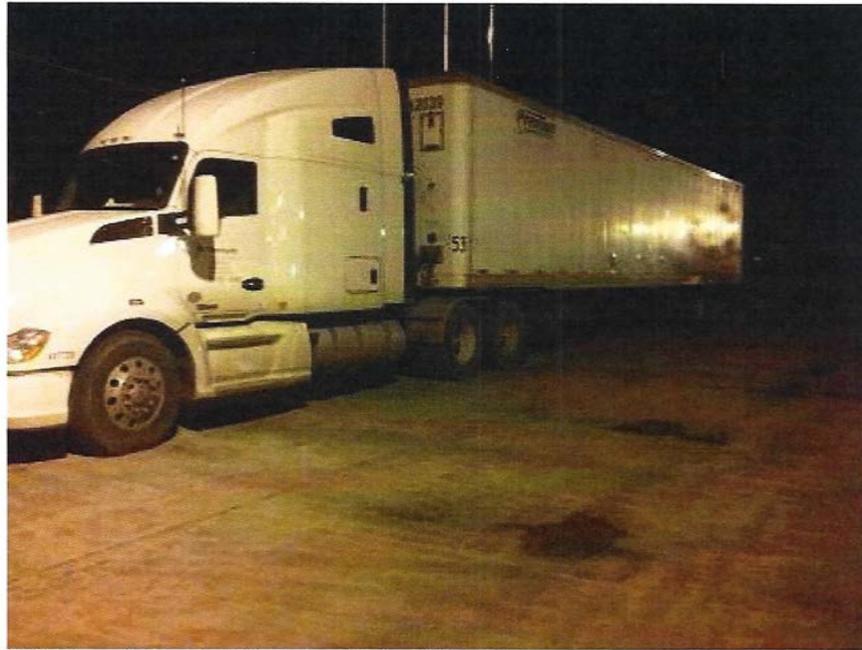
On May 18, 2015, a delivery driver arrived at the plant to deliver drums. After opening the trailer doors, the driver walked to the cab of his truck and proceeded to climb the steps to get back in the cab when he suddenly fell backwards onto the ground striking the back of his head.

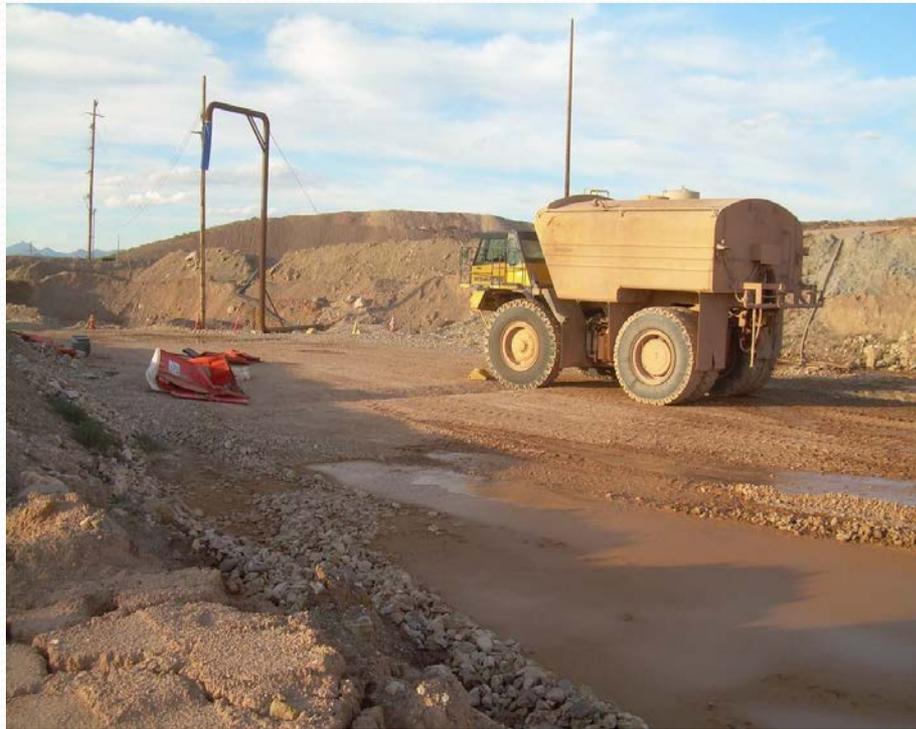
On May 28, 2015, a 61-year old water truck operator with 2 years of experience was killed at a surface gold mine. The victim was killed when a water truck ran over a portable toilet that was occupied by the victim.

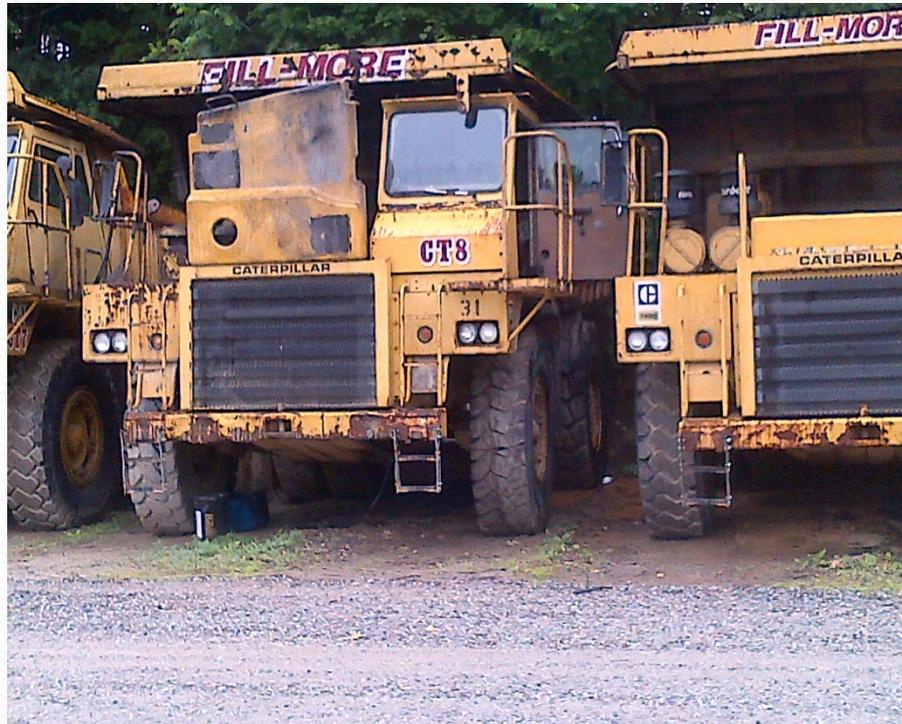
On June 12, 2015, a 66-year old contract service mechanic with 42 years of experience was killed at a sand and gravel surface mine. The victim reported to several witnesses that he had hit his head earlier in the shift and afterward was found unconscious. The victim was transported to the hospital where he died the next day.

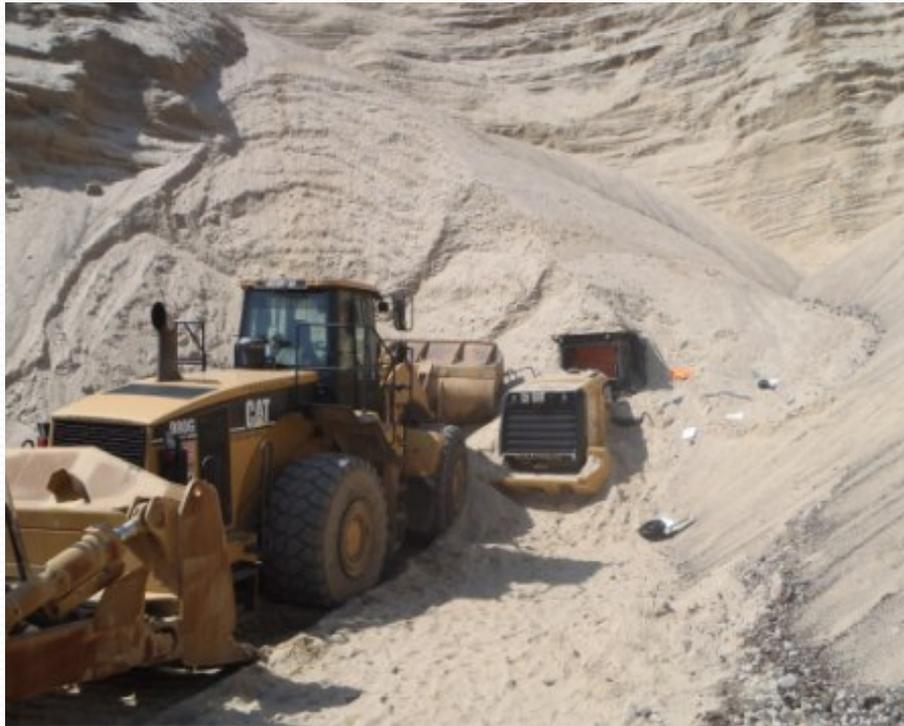
On June 30, 2015, a 65-year old equipment operator with 19 years of experience was killed at a sand and gravel surface mine. The victim was operating a front-end loader removing material from a sand bank when material above fell and engulfed the machine , entering the operator's cab and asphyxiating the victim.

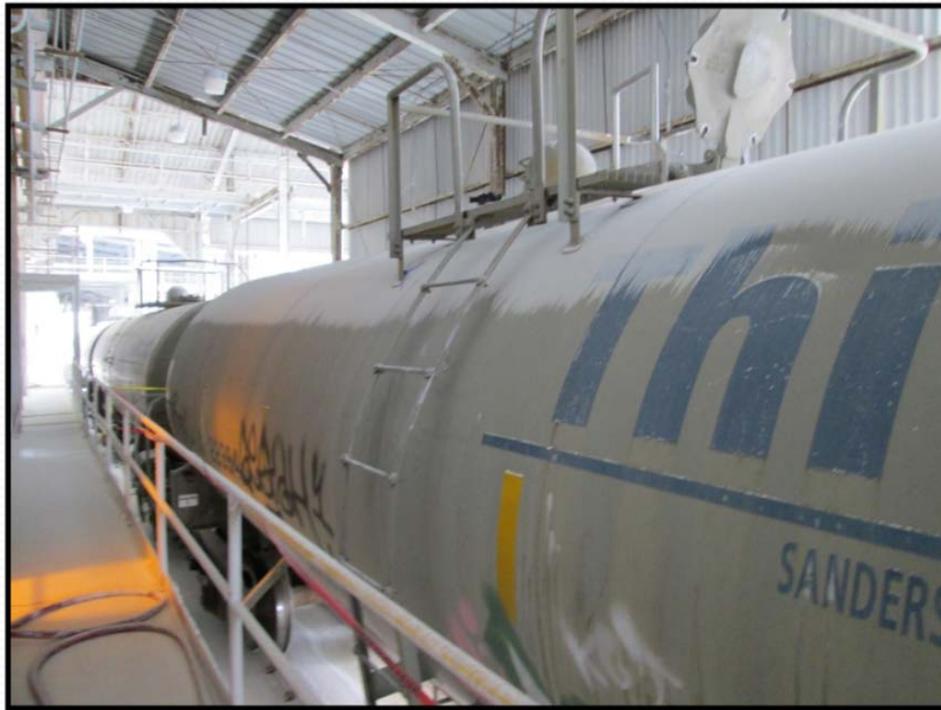
On July 15, 2015, a 25-year old contractor with 6 months of experience was killed at a Kaolin processing plant. The victim was working alone and entered a railcar to wash out residual product. The victim was later found unresponsive inside the railcar.

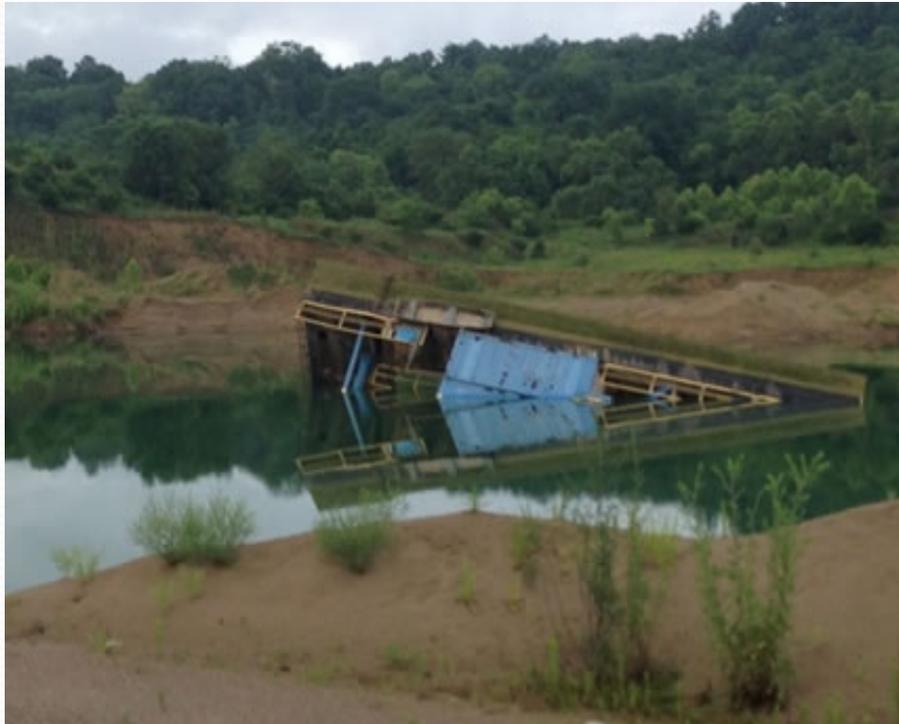
On July 10, 2015, a 50-year old Superintendent with 26 years of experience was killed at a sand and gravel dredge operation. Two miners were attempting to dislodge the clam shell bucket from the bottom of the pond when the dredge capsized. One miner was injured but was able to swim to shore and summon assistance. The victim was recovered eight days later.

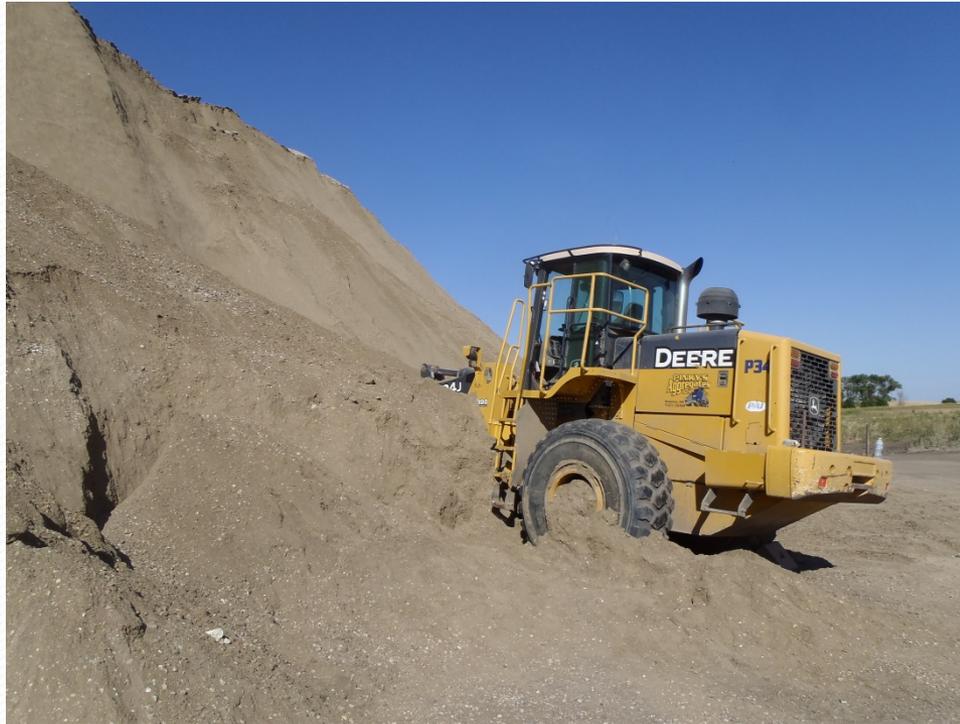
On August 3, 2015, a 64-year old loader operator was engulfed by a stockpile failure while standing outside his loader.

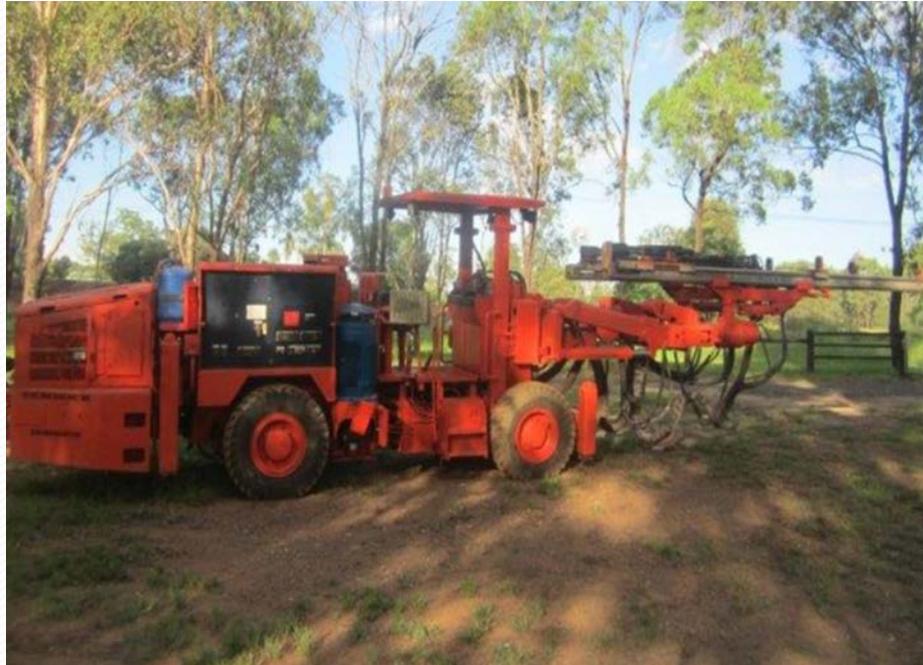
On August 3, 2015, a 26-year old miner was struck by a jumbo drill that he was operating in an underground gold mine.

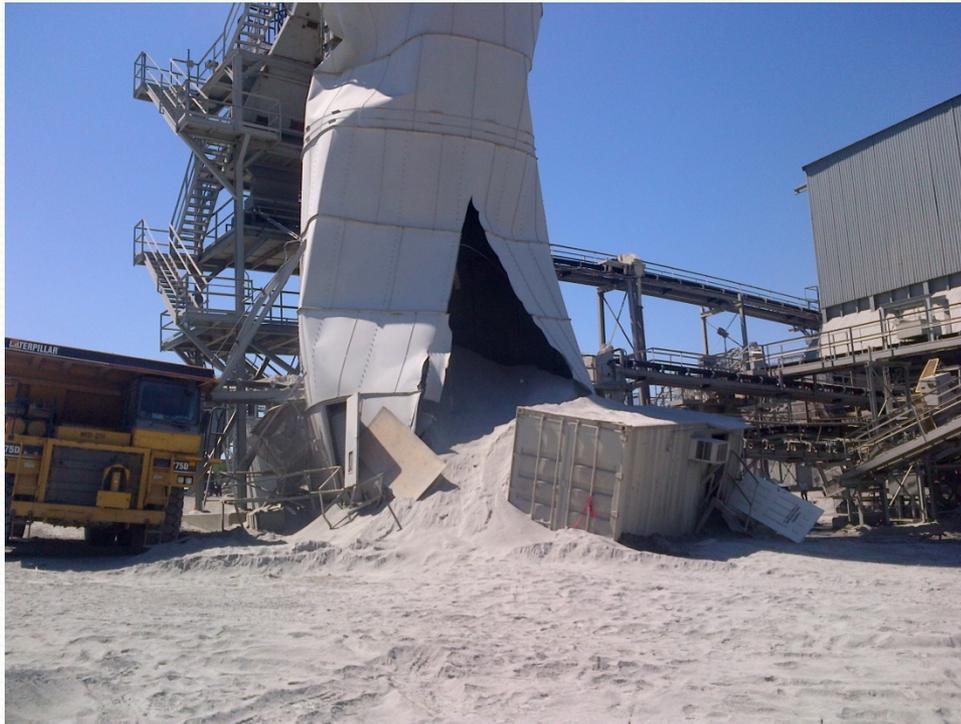
On August 3, 2015, a 18-year old truck driver (seasonal associate) went underneath a storage tank when the tank ruptured covering the miner with material.
