**SAFETY ALERT**

**Continuous Mining Machine Safety**

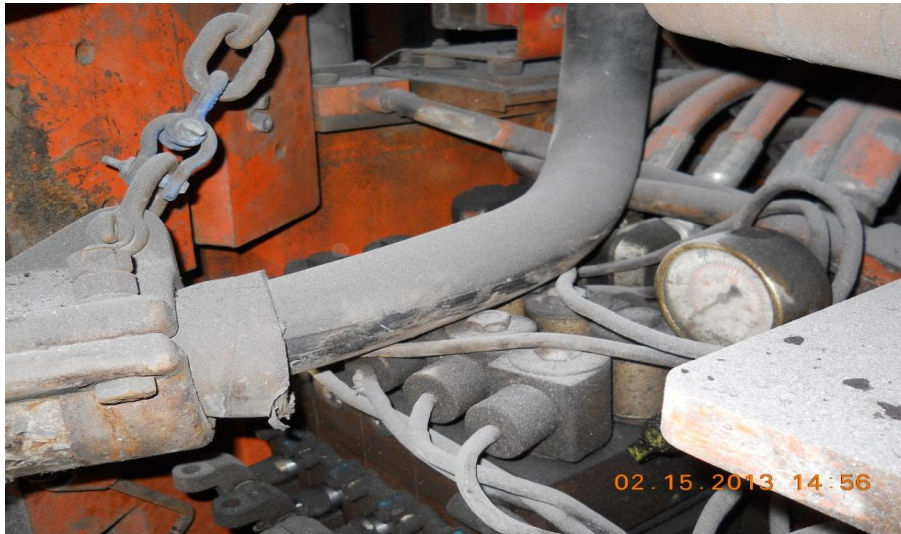
Inadvertent movement of remotely-controlled continuous mining machines has been observed in cases where solenoids, associated with hydraulic valve banks, were damaged. The solenoids were damaged by “side loading” due to contact with a trailing cable, when that cable was flexed.

- Install guarding to protect the valve banks, valve spools, solenoids, and solenoid cables from damage and prevent these items from contacting other machine components.

- Position the trailing cable to prevent it from damaging components that are essential to the machine's proper operating functions.
- Ensure that continuous mining machine operators and maintenance personnel examine valve banks, valve spools, solenoids, solenoid cables, and the trailing cable and keep areas where these components are located free of obstructions.

- De-energize the continuous mining machine and remove it from service when worn or damaged components are found,
- Develop programs, policies and procedures and train all production and maintenance crews to examine these areas on remote controlled continuous mining machines.
