# BLASTING SAFETY ALERT

## 6 Fatalities from blasting accidents 2010-2013

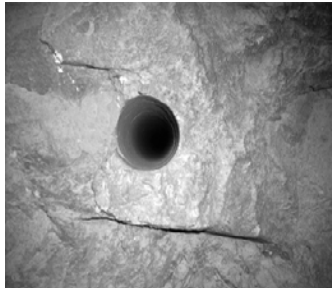
Rock from a blast struck the front-end loader and covered it.

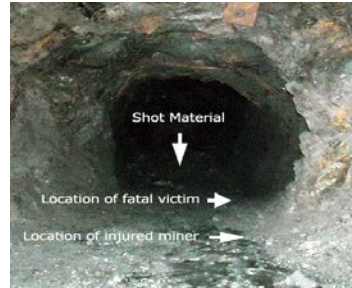
Victim was struck by blast debris that traveled through a diamond core hole.
