MSHA Safety Alert

Supervisor Fatalities Due To Falls of Roof, Rib or Face

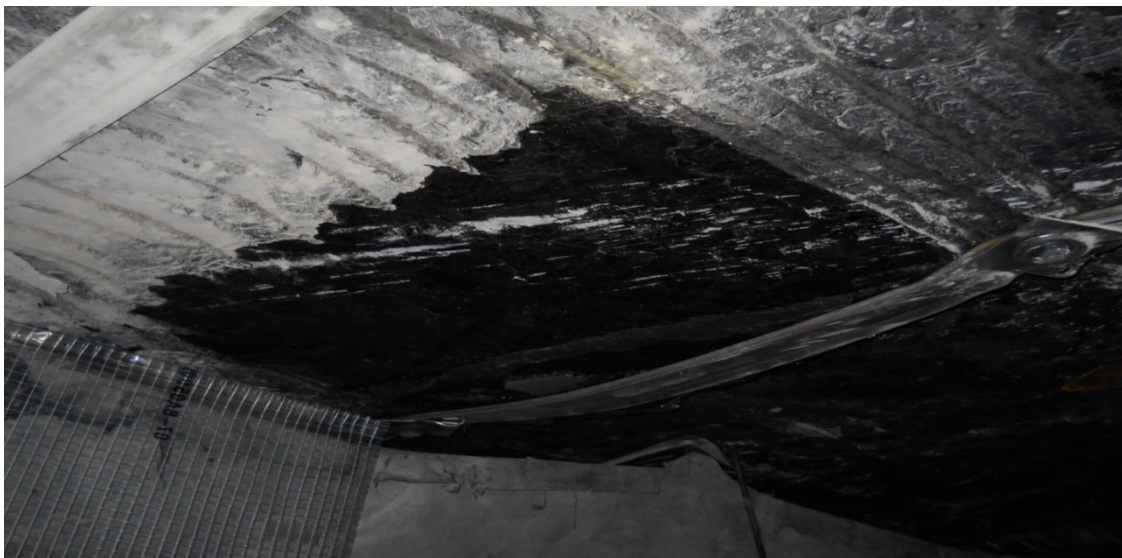
On February 23, 2017, a foreman on the active mining section was struck by a loose rock that fell out from between installed roof bolts. The victim, who had remained hospitalized since the accident, died from his injuries on April 6, 2017. Since June 27, 2011, nine supervisors have been killed as a result of falls of roof, rib or face. During this time period these supervisor fatalities accounted for 45% of all deaths arising from these types of accidents, which can be reduced if not eliminated when miners use the following Best Practices as a guide.

- Know and follow the approved roof control plan.
- Make frequent examinations and be alert to changing conditions that may affect roof or rib conditions.
- Scale loose roof or ribs.
- Use test holes to check for cracks and other hazards above the anchorage of the roof bolts.
- Inform mine management and other miners about unusual roof or rib conditions.
- Install additional roof and/or rib support when adverse conditions are encountered or anticipated.
- Use supplemental support for roof skin control such as screen, steel straps, header boards or larger roof bolt plates.
- Never travel under unsupported roof.
