METAL / NONMETAL

Serious Injury Accident

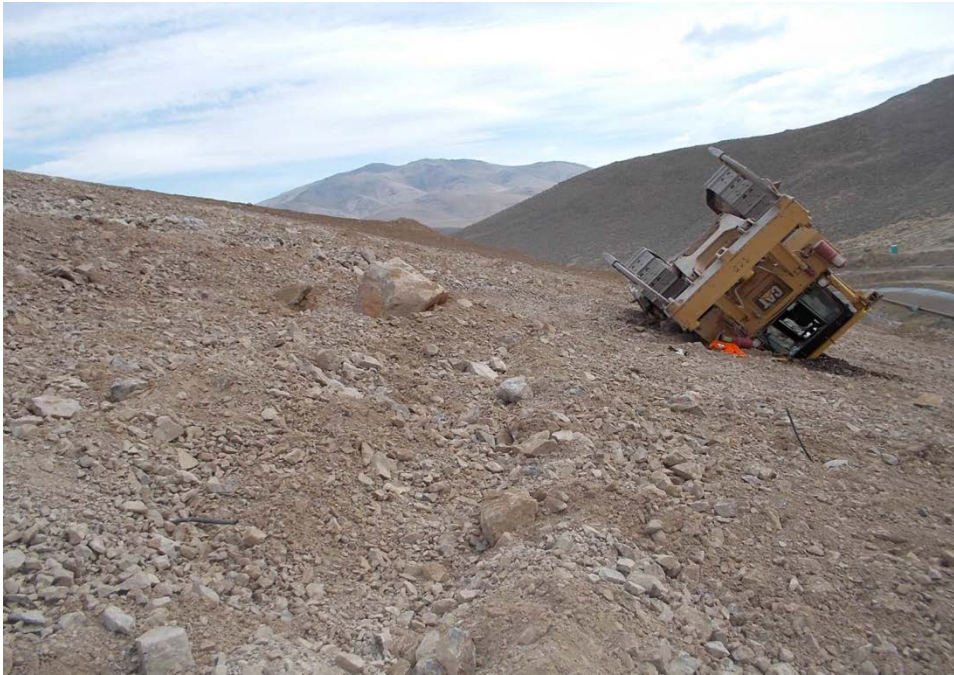
Gold Ore Mine – A dozer operator was ripping material perpendicular to a 30% slope when it struck a large rock, tipping the dozer on its right side. The dozer operator was wearing a seat belt and while still suffering injuries, was able to return to work the next day.

- Conduct a thorough visual examination of highwalls and spoil banks immediately before any work is performed and thereafter as conditions warrant.
- Train all equipment operators on proper work procedures and hazard recognition before they operate equipment.
- Conduct pre-operational checks to identify any defects affecting safe equipment operation before placing into service.
- Maintain equipment braking and steering systems in good repair.
- Ensure equipment operators receive proper task training.
- Consult the owner's manual to determine operator skills and use of proper equipment when operating in extreme slope conditions.
- Keep the dozer blade between you and the edge when operating close to drop offs.
- Always wear seat belts when operating mobile equipment.
