# METAL / NONMETAL Serious Injury Accident

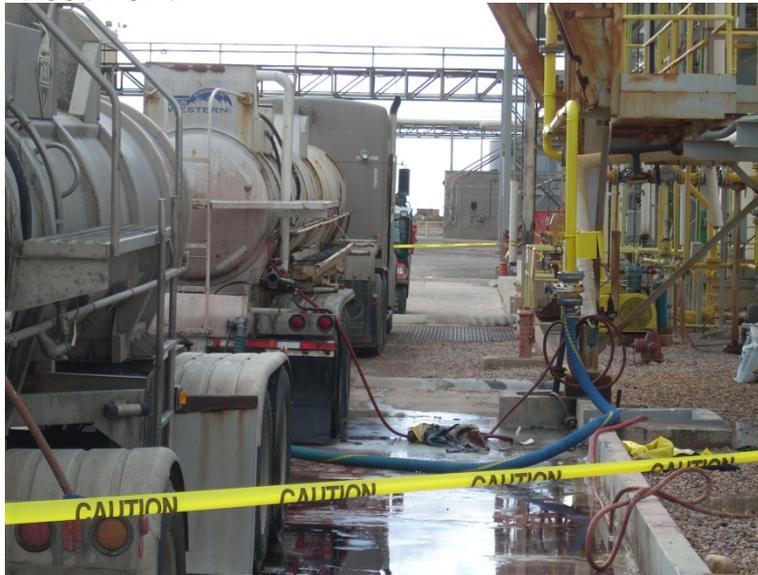
Surface Lime Mine –A truck driver, with a bulk load of sulfuric acid, was off-loading 94% sulfuric acid. During the off-loading process, a pressurized 3-inch hose uncoupled, saturating the victim with sulfuric acid. The victim rinsed in an on-site chemical shower and was immediately transported to the hospital. The victim was then transported via life-flight to a burn center to undergo further evaluation and treatment.

- In the case of a ruptured unloading hose, the air shutoff valve and liquid isolation valves should be far enough removed from the loading area so that the leak can be stopped quickly and safely.

- Conduct spill response exercises: stage mock spills to practice techniques and reinforce training.
- The truck driver must make sure that all equipment on his/her truck, including unloading hoses, are in good order.

- Open the main valve on the trailer and any valves to the storage tank. This allows the acid to begin flowing as soon as enough pressure is available in the trailer.
