MNM Fatal 2004-13

- Slip or Fall of Person
- July 19, 2004 (Georgia)
- C & B Granite Operation
- Driller Trainee
- 41 years old
- 20 years experience

The victim was attempting to re-thread a drill steel while standing near the edge of a highwall when he fell 90 feet to the pit floor.

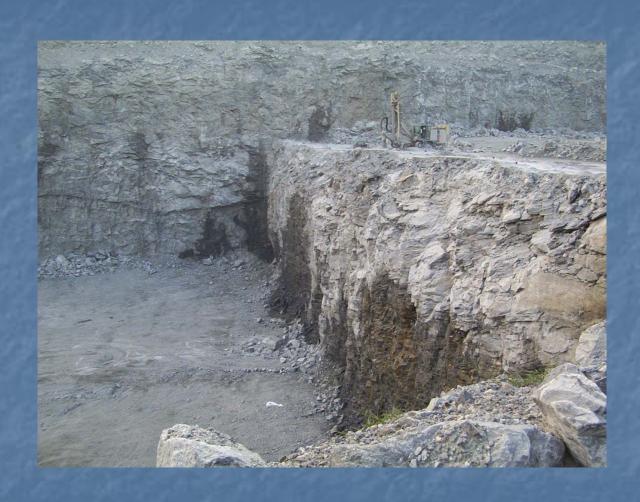
Highwall where accident occurred

- Wear fall protection where there is a danger of falling.
- Train all personnel to help them recognize potential hazards and understand procedures to safely perform tasks.
- Establish operating procedures for contractor employees to safely perform tasks and routinely monitor to ensure safe procedures are followed.

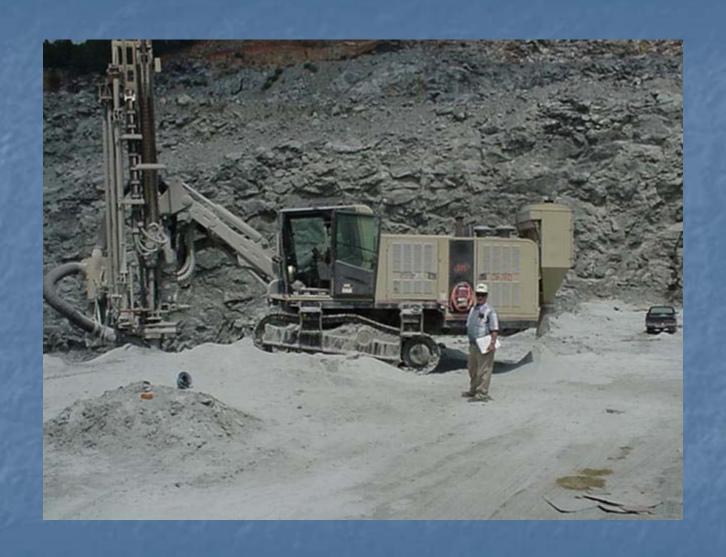
Victim was attempting to re-thread steel on vertical boom of drill.

The victim was working near the edge of the highwall and was not wearing a safety harness and lanyard that was securely anchored. He was positioned between the boom of the drill and the edge of the highwall and slipped or fell to the quarry floor below.

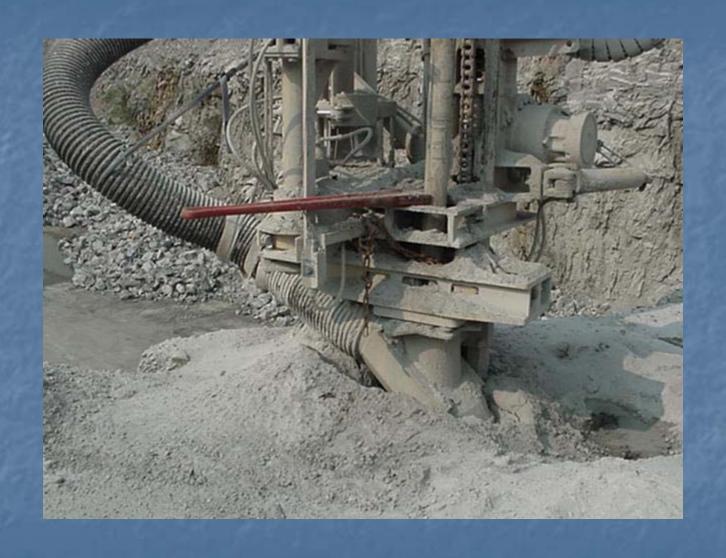
Position of drill boom showing wrench used to re-thread drill steel.
