MNMM Fatal 2004-19

- Powered Haulage
- September 28, 2004 (Tennessee)
- Sand & Gravel Operation
- Plant Operator
- 64 years old
- 17 years experience

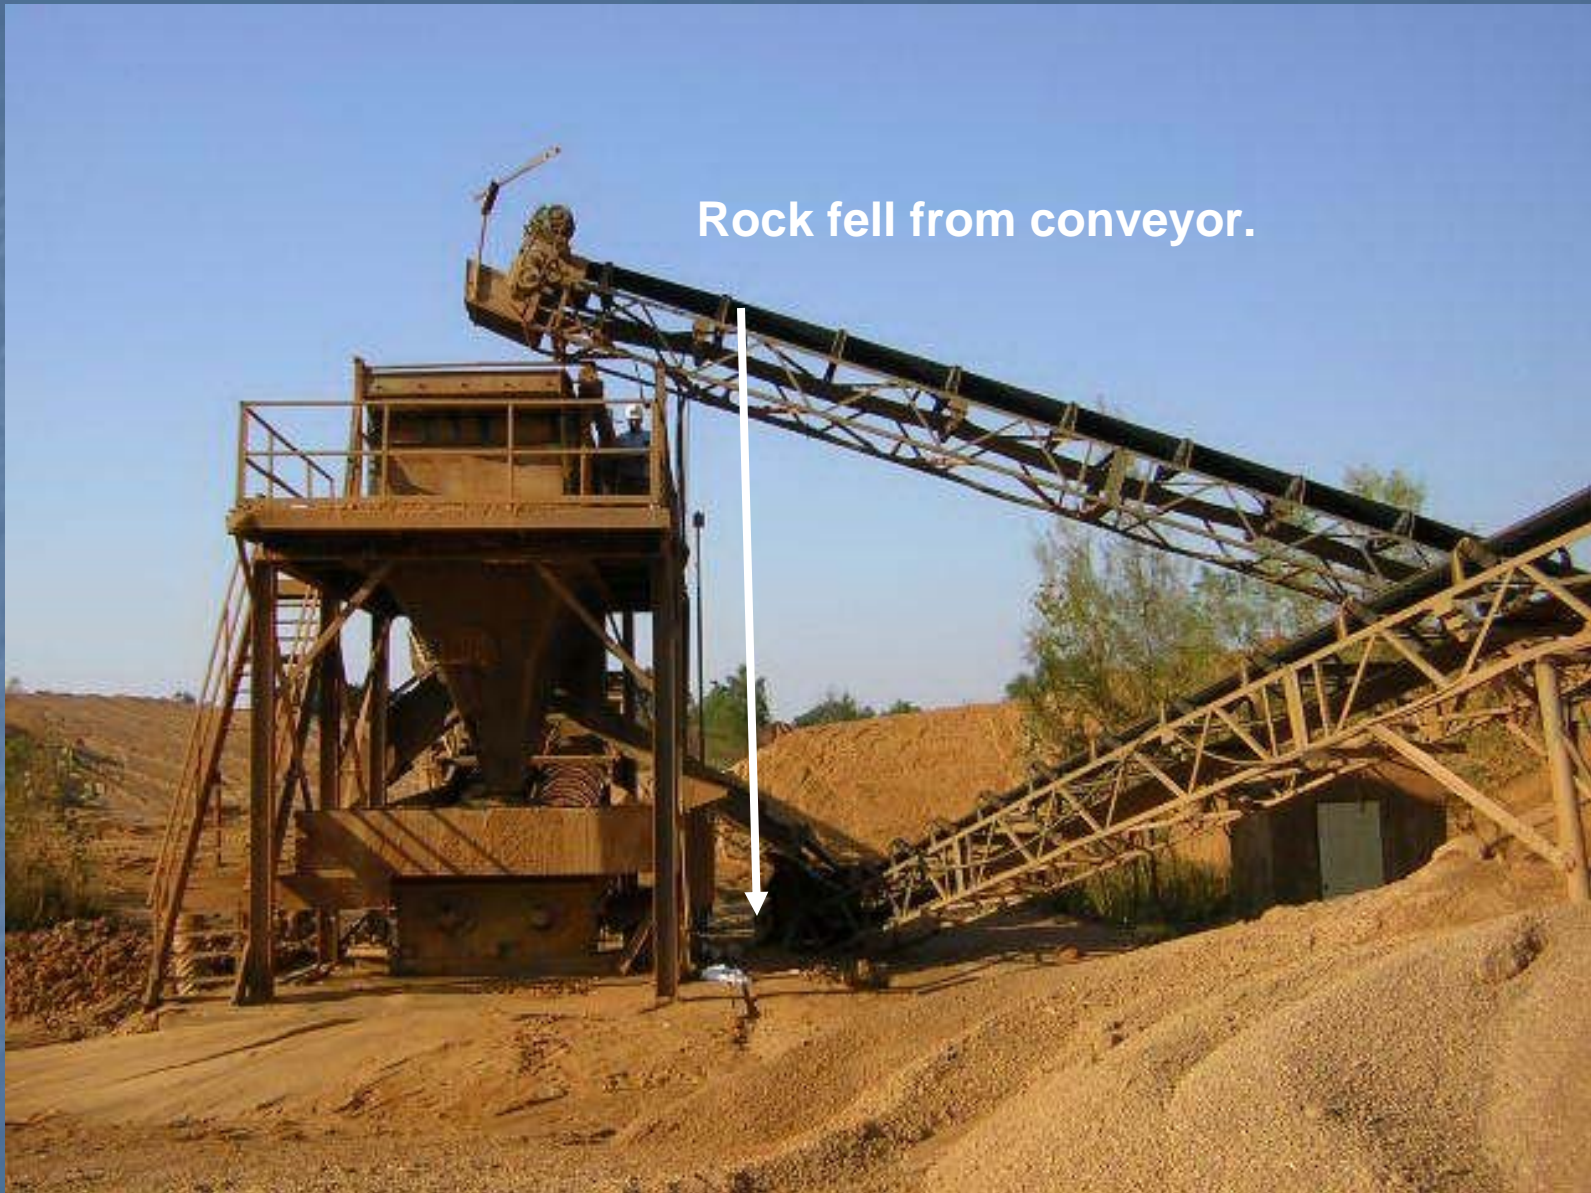
- The victim was using a water hose to clean spillage under a conveyor. Apparently, a large rock fell from a conveyor located overhead and struck him, resulting in fatal injuries.

Rock fell from conveyor.

- Conduct a Risk Assessment evaluating all tasks and identifying potential hazards before performing work.
- Never walk under or perform work near moving conveyor belts where there is a danger of being stuck from falling material.
- Ensure that guards, shields, or other devices are installed to protect persons from hazards of falling material near conveyors, screens, or crushers.

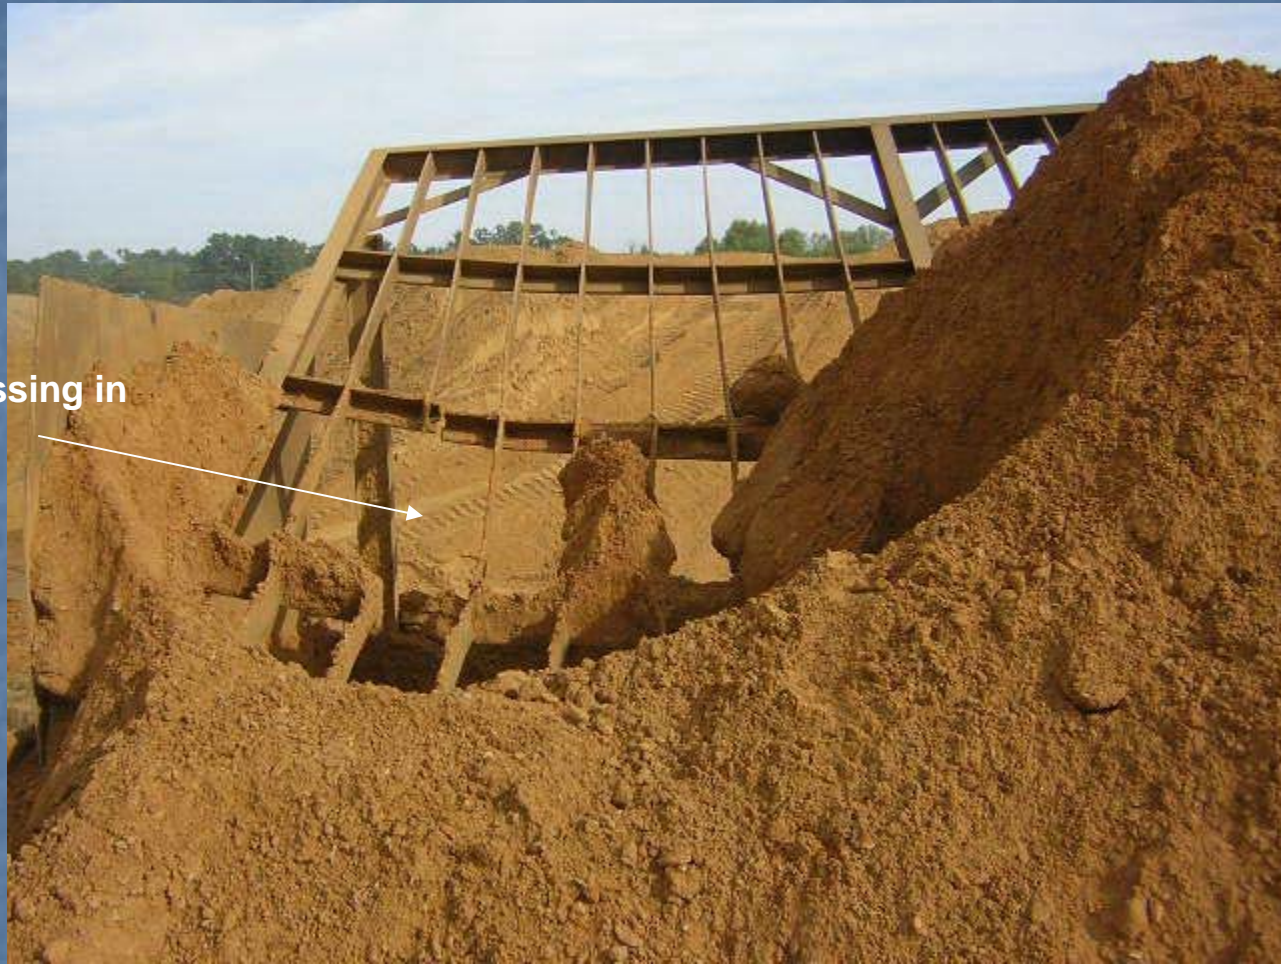
- Guards, shields, or other protective devices were not provided to protect persons from falling material while they traveled or worked in this area. Failure to replace a divider bar in the grizzly on the feed hopper allowed large rocks to pass through and contributed to the accident.

Divider bar missing in
grizzly screen.

- Policies and controls were inadequate and failed to identify the missing metal bar on the grizzly for repair. The grizzly at the feed hopper was not included in the daily workplace examination. The missing bar in the grizzly enabled large rocks to pass onto the inclined conveyor belt.
