Fatality #2 - January 22, 2004
Powered Haulage – Surface at Underground - UT
Andalex Resources, Inc. - Pinnacle

SHIELD AND EIMCO UTILITY VEHICLE

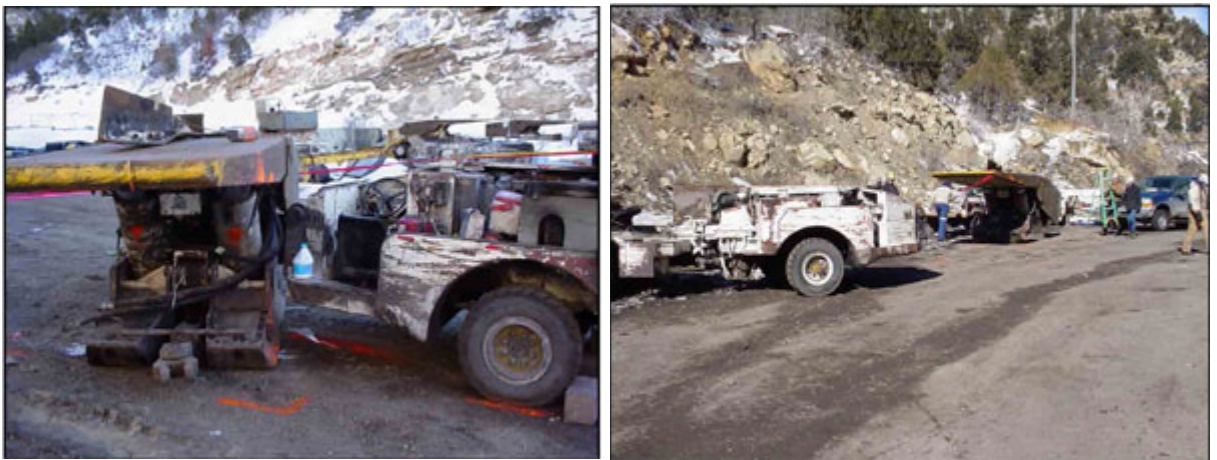
COAL MINE FATALITY - On Thursday, January 22, 2004, at approximately 11:00 p.m., a 29-year-old laborer with seven years experience was fatally injured on the surface of an underground coal mine. The victim was operating an Eimco 975 diesel-powered utility vehicle to obtain a water tank trailer when he collided with the canopy of a longwall shield that was stored in the supply yard. The collision resulted in fatal injuries. The utility vehicle was not equipped with a protective cab or canopy.

NOTE: The shield is shown after being rotated about 60° after the accident.

- Ensure that surface work areas are sufficiently illuminated at night so that obstacles can be clearly seen.
- Equipment operators should always look in the direction of movement.
- Design and arrange equipment storage yards to provide safe access and egress.
- Equipment operators should be aware of their surroundings and any potential hazards.
- Routinely monitor work habits and examine work areas to ensure that safe work procedures are being followed.
- In addition to mandatory applications, consider providing protective cabs, canopies, or vertical intrusion shielding pipes on mobile equipment whenever mining height permits.
