Fatality #9 – May 18, 2004
Machinery - Underground - IN
Black Beauty Coal Company - Air Quality #1 Mine

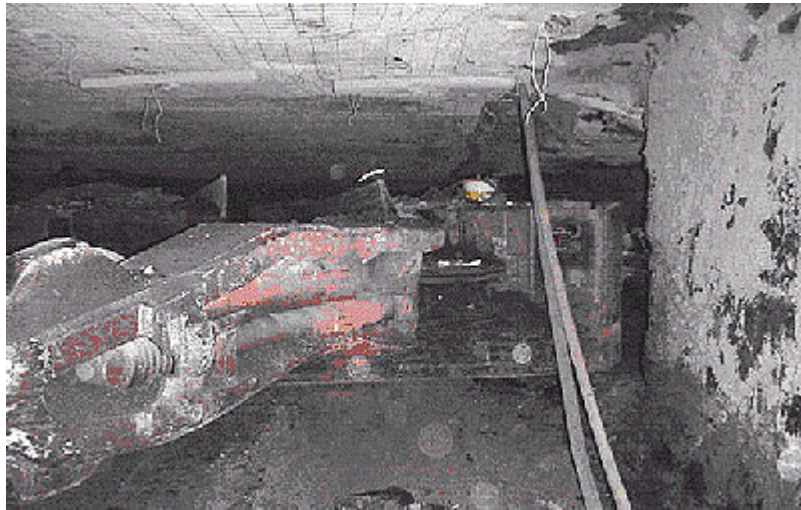
COAL MINE FATALITY - On Tuesday, May 18, 2004, a 30-year old mechanic with one year experience was fatally injured while positioning the continuous mining machine for servicing with a remote control unit. The victim was found pinned between the right side of the discharge boom and the coal rib.

- Ensure the continuous mining machine operator and all others are well beyond the turning radius of the machine before starting or moving equipment.
- Ensure the continuous miner is de-energized before positioning the trailing cable.
- Alert anyone who will be operating a continuous miner by remote control that controls will move the machine in the opposite direction when facing towards the boom.
- Establish safe operating procedures for remote control continuous mining machine operations, including tramming and cable handling.
- Ensure everyone including maintenance personnel are thoroughly task trained before operating the continuous miner by remote control.
