MNMM Fatal 2005-25

- Slip or Fall of Person
- September 15, 2005 (Texas)
- Cement Operation
- Welder Repairman
- 35 years old
- 7 years mining experience

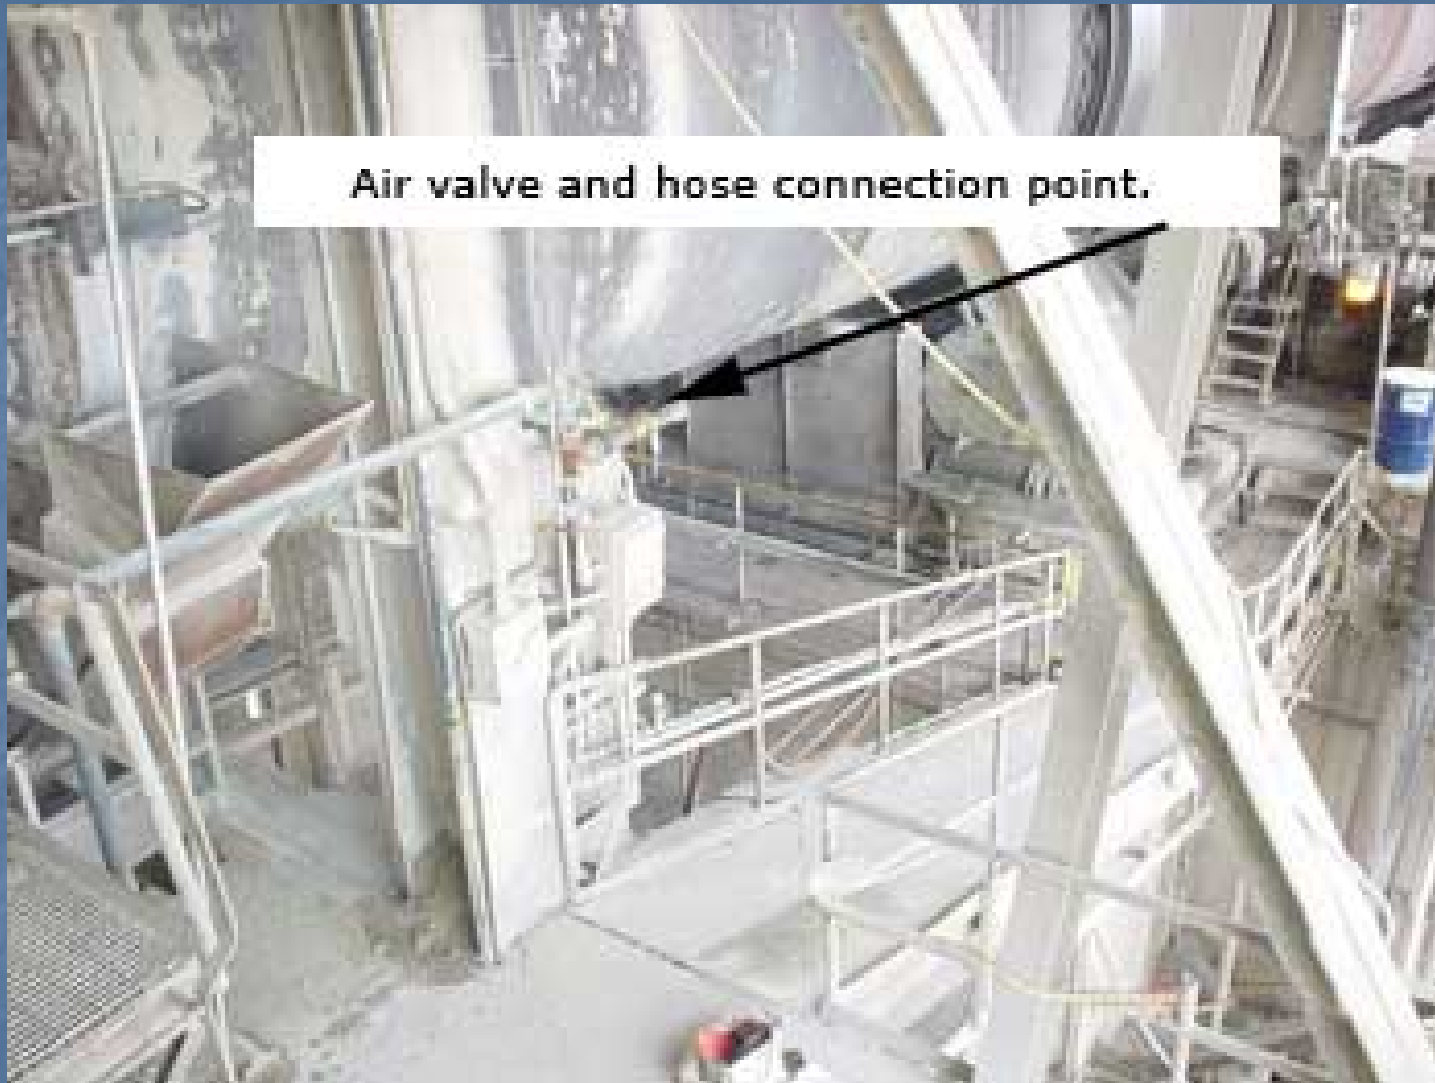
The victim fell 37 feet from an inclined walkway near the feed end of a kiln. He had been standing near or on the handrail or mid-rail along the walkway, disconnecting a temporary air line located seven feet above the walking surface.

Air valve and hose connection point.

Administrative controls needed improvement in that a risk assessment was not conducted prior to installing the air valve for the temporary air line seven feet above the walkway, equipped with hand rails, that was inclined at a 29 degree slope. The victim may not have recognized the hazard associated with reaching above the hand rails to uncouple the air hose. The victim was working where there was a danger of falling and was not secured by a safety belt and line.

- Stop, Look, Analyze, and Manage, SLAM each task to identify all potential hazards. Initiate action to protect yourself when performing every task.
- Train all miners to recognize hazards from falling and ensure that safety harnesses are located throughout the plant.
- Always wear appropriate fall protective equipment where hazards from falling exist.
- Locate connection points or valves where miners can safely access them.
