# MNMM Fatal 2005-26

- Machinery
- September 27, 2005 (Florida)
- Phosphate Operation
- Dozer Operator
- 60 years old
- 35 years mining experience

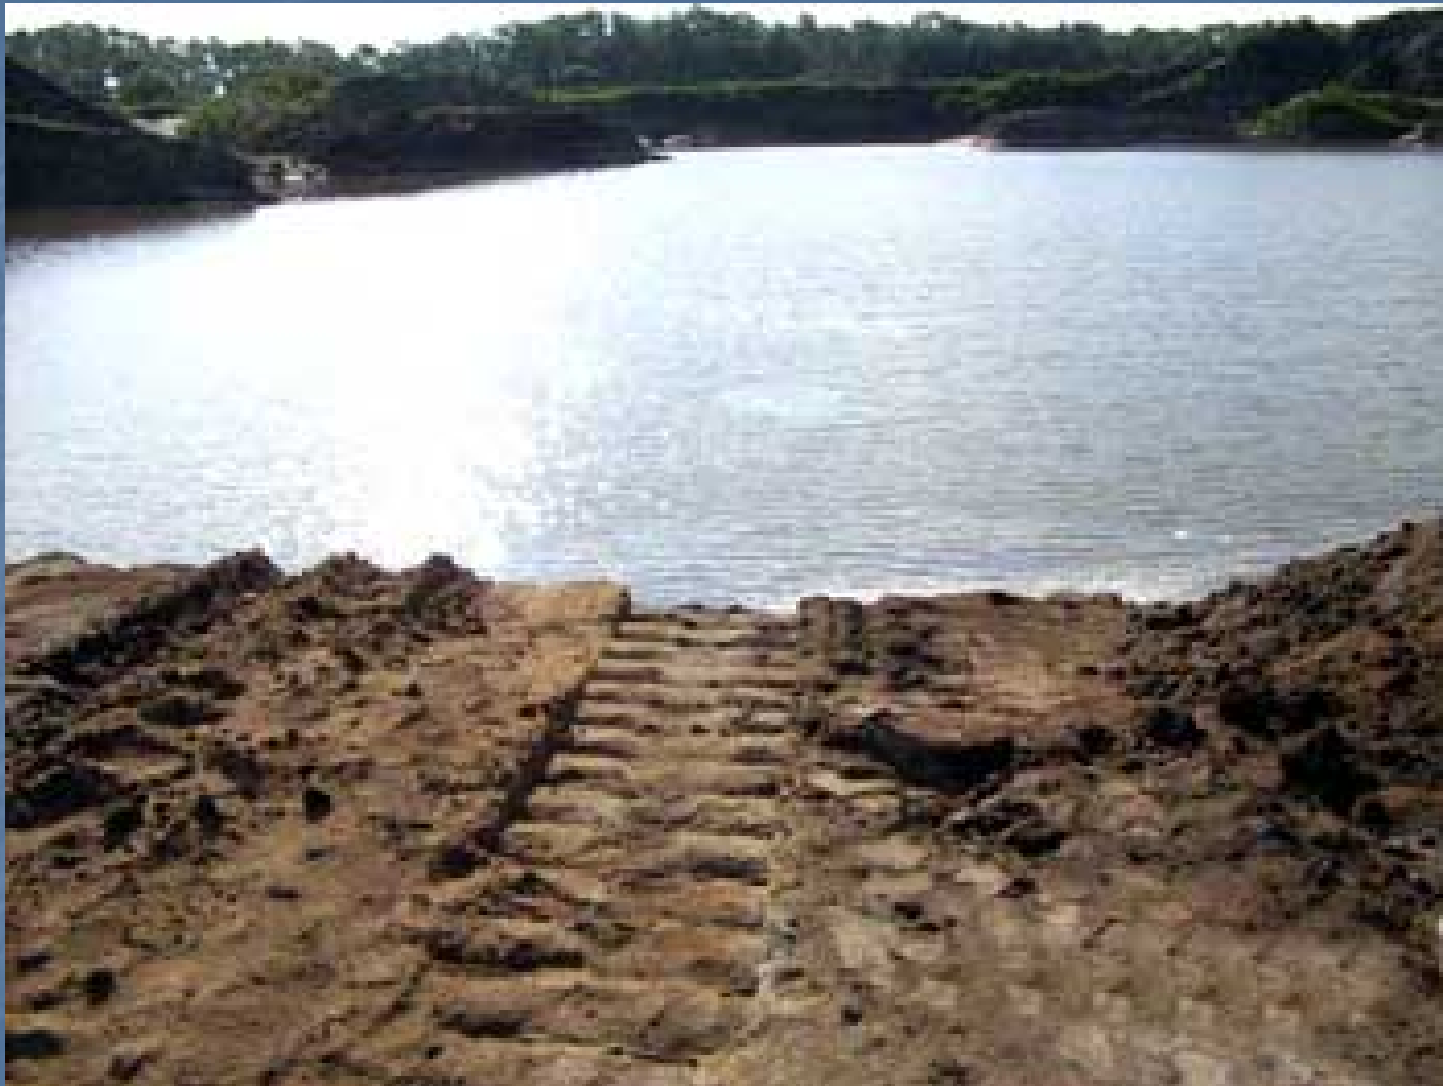
- The victim was operating a dozer that slid into a water filled pit. The dozer was pushing material at the edge of the pit to construct a ramp for a pump when the ground underneath it failed.

- Policies, standards, and controls were inadequate and failed to ensure that the ramp was designed and constructed of materials capable of supporting the load that it would be subjected to.
- No risk assessment was conducted to identify all foreseeable hazards and discuss methods to minimize the hazards associated with the construction of the ramp.

- Stop, Look, Analyze, and Manage, SLAM each task to identify all potential hazards. Initiate action to protect yourself when performing every task.
- Evaluate the stability of the ground prior to operating equipment near any drop off or edge.
- Use equipment (excavator) that can perform the work from a safe distance away from the edge of a pond where the stability of the ground may be unknown.
- Require that flotation devices be worn by persons performing work where there is a danger of falling in the water.
