MNMM Fatal 2006-13

- Machinery
- May 26, 2006 (Florida)
- Phosphate Operation
- Dozer Operator
- 58 years old
- 12 years experience

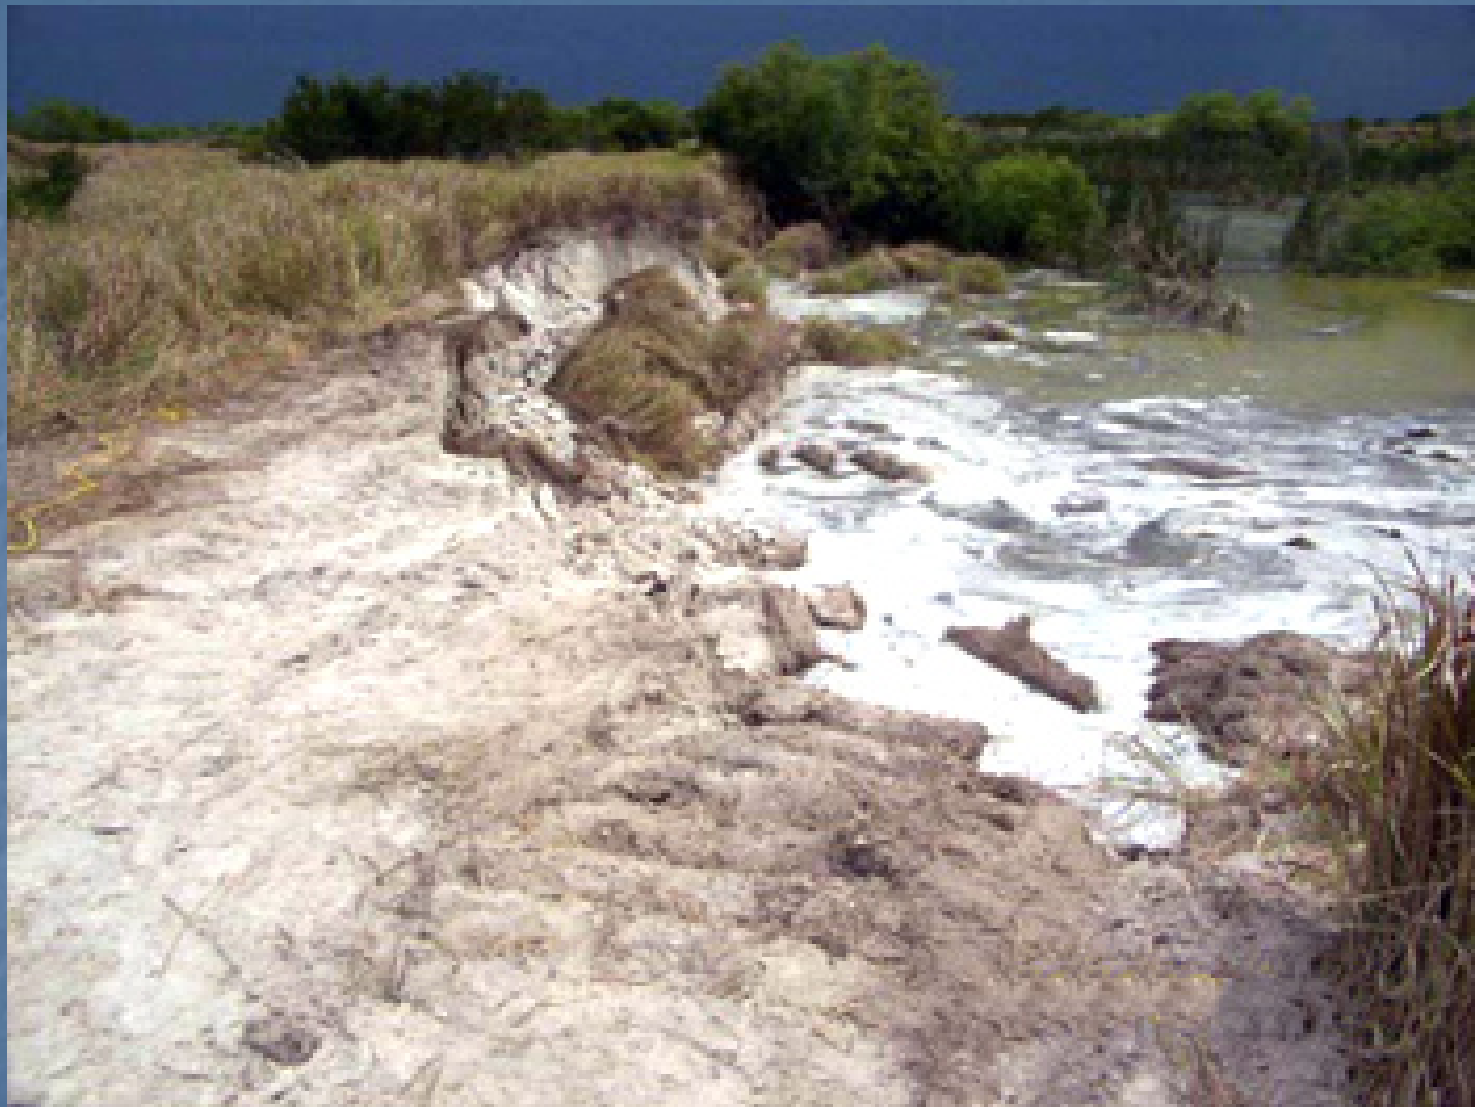
The victim was fatally injured when the dozer he was operating fell into a water filled pit. He had been pushing the top layer of dirt and vegetation from reclaim piles into adjacent water filled ponds.

- Stop, Look, Analyze, and Manage, SLAM each task to identify all potential hazards. Initiate action to protect yourself when performing every task.
- Evaluate the stability of the ground prior to operating equipment near any drop off or edge.
- Use equipment (excavator) that can perform the work from a safe distance away from the edge of a pond where the stability of the ground may be unknown.

- Require that flotation devices be worn by persons performing work where there is a danger of falling in the water.
- When dozing toward a highwall edge, constantly examine the ground surface for development of cracks or fissures indicating separation, push perpendicular to the highwall face, and always keep a full blade in front of you.
- When dozing soft or unconsolidated material, be aware of changes in the feel of the footing under you and immediately back out of material that feels like it is softening up.
