**Fatality #19 - February 1, 2006**

**Fire - Surface - WV**

**Elk Run Coal company Inc. - Black Castle Mine**

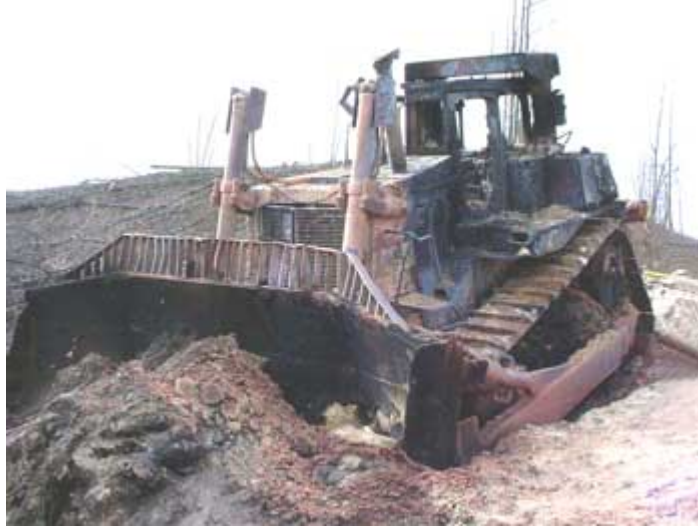
**COAL MINE FATALITY** - On Wednesday, February 1, 2006, a 58-year old bulldozer operator with 15 years mining experience was fatally injured while cutting a bench in the natural slope of a hillside in preparation for surface mining. The accident occurred when the blade of his bulldozer ruptured a buried 16-inch, low pressure, high volume, natural gas transmission pipeline. Natural gas escaping from the pipeline immediately burst into flames, engulfing the bulldozer.

- Identify and mark all right-of-ways for pipelines and other buried utilities in the proposed mining area before mining begins.
- Ensure that utility markers are installed, maintained conspicuous, and not removed for any reason.
- Maintain a safe distance between active mining and right-of-ways.
- Ensure that certified mine maps accurately depict the location of all active and abandoned gas wells and buried utilities.
- Utilize an independent utility location contractor to verify utility locations.
- Review the identification and location of buried utilities with all employees (additional information at [http://www.msha.gov/Accident\\_Prevention/Tips/gaslines.htm](http://www.msha.gov/Accident_Prevention/Tips/gaslines.htm)).
