Fatality #3 - February 13, 2006
Machinery - Pennsylvania - Dimension Stone
Pyramid Materials-Div/Haines & Kibblehouse Inc. - Pyramid Materials

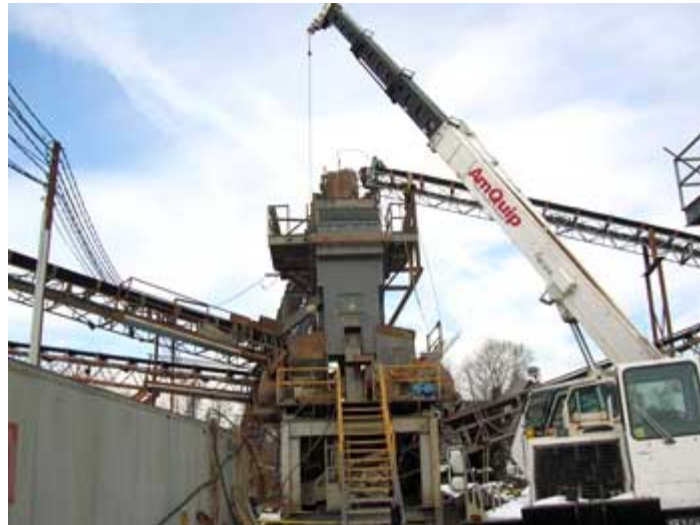
METAL/NONMETAL MINE FATALITY - On February 13, 2006, a 25-year old superintendent with 2½ years mining experience was fatally injured at a crushed stone operation. A crane, operated by a contractor employee, was being used to lift a pitman from the secondary crusher. The victim was standing on the work platform and was struck by the pitman as it was being lifted.

- Train miners in safe work procedures before beginning repairs and ensure they are familiar with the manufacturer's recommendations.
- Stop, Look, Analyze, and Manage (SLAM) each task to identify all potential hazards before performing work.
- Prior to hoisting loads, crane operators should ensure that all persons are positioned in areas where they will not be exposed to hazards of suspended loads.
- Arrange the rigging to prevent shifting of the load being lifted. Balance the load by placing the crane or hook block directly above the load's center of gravity and ensure the pick line isn't contacting or deflected by any structure.
