Fatality #16 - June 28, 2006
Fall of Person - Michigan - Iron Ore
Tilden Mining Company, LC - Tilden Mine

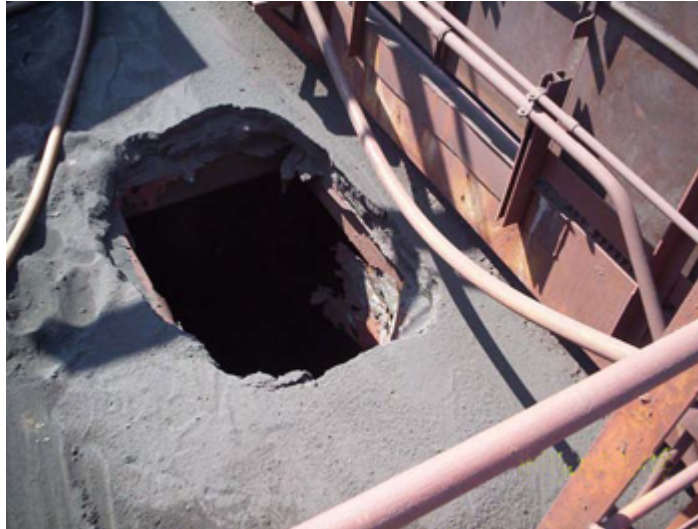
METAL/NONMETAL MINE FATALITY - On June 28, 2006, a 49-year-old utility man, with 20 years experience, was fatally injured at an iron ore mine. The victim was washing the roof over a kiln when he fell through a hatch cover.

- Ensure that covers installed over openings are substantially constructed, inspected frequently and properly maintained.
- Inspect metal structures located in wet or corrosive environments frequently to identify deterioration that may present a safety hazard.
- Evaluate the integrity and support strength of any cover that was not designed as a walkway prior to walking on it.
- Restrict access to covers over openings that were not specifically designed to serve as travelways.
- If the travel surface integrity is unknown or can't be readily confirmed, ALWAYS wear fall protection to be on the safe side.
