Fatality #20 - August 29, 2006

Powered Haulage - Pennsylvania - Limestone (C&B)

New Enterprise Stone & Lime Company, Inc. - Somerset Quarry & Mill

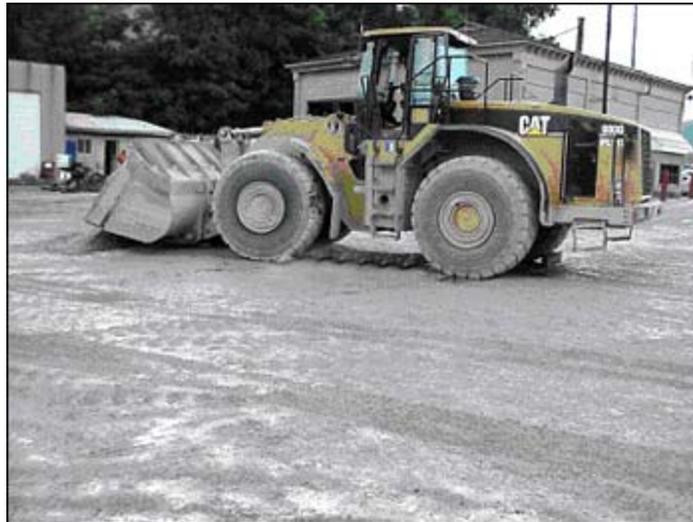
METAL/NONMETAL MINE FATALITY - On August 29, 2006, a 61-year old contractor paving supervisor, with 31 years experience, was fatally injured at a crushed stone operation. The victim was walking from the mine's main shop toward the plant when he was struck by a front-end loader. The bucket was loaded with rock and was positioned several feet off the ground, blocking the operator's view of his surroundings and the victim. The crew was preparing to pave an area behind the main shop.

- At locations where pedestrians and mobile equipment are both performing tasks, rules should be established and signs or signals warning of hazards should be utilized.
- Initiate action to protect yourself when performing every task (SLAM). Train all miners to recognize the hazards associated with mobile equipment traveling nearby when they are on foot.
- When tramming a front-end loader from one location to another, position the loader bucket as low to the ground as possible.
