MNMM Fatal 2007-29

- Fall of Person Accident
- October 25, 2007 (California)
- Cement Operation
- Iron Worker Helper (Contractor)
- 19 years old
- 20 weeks experience

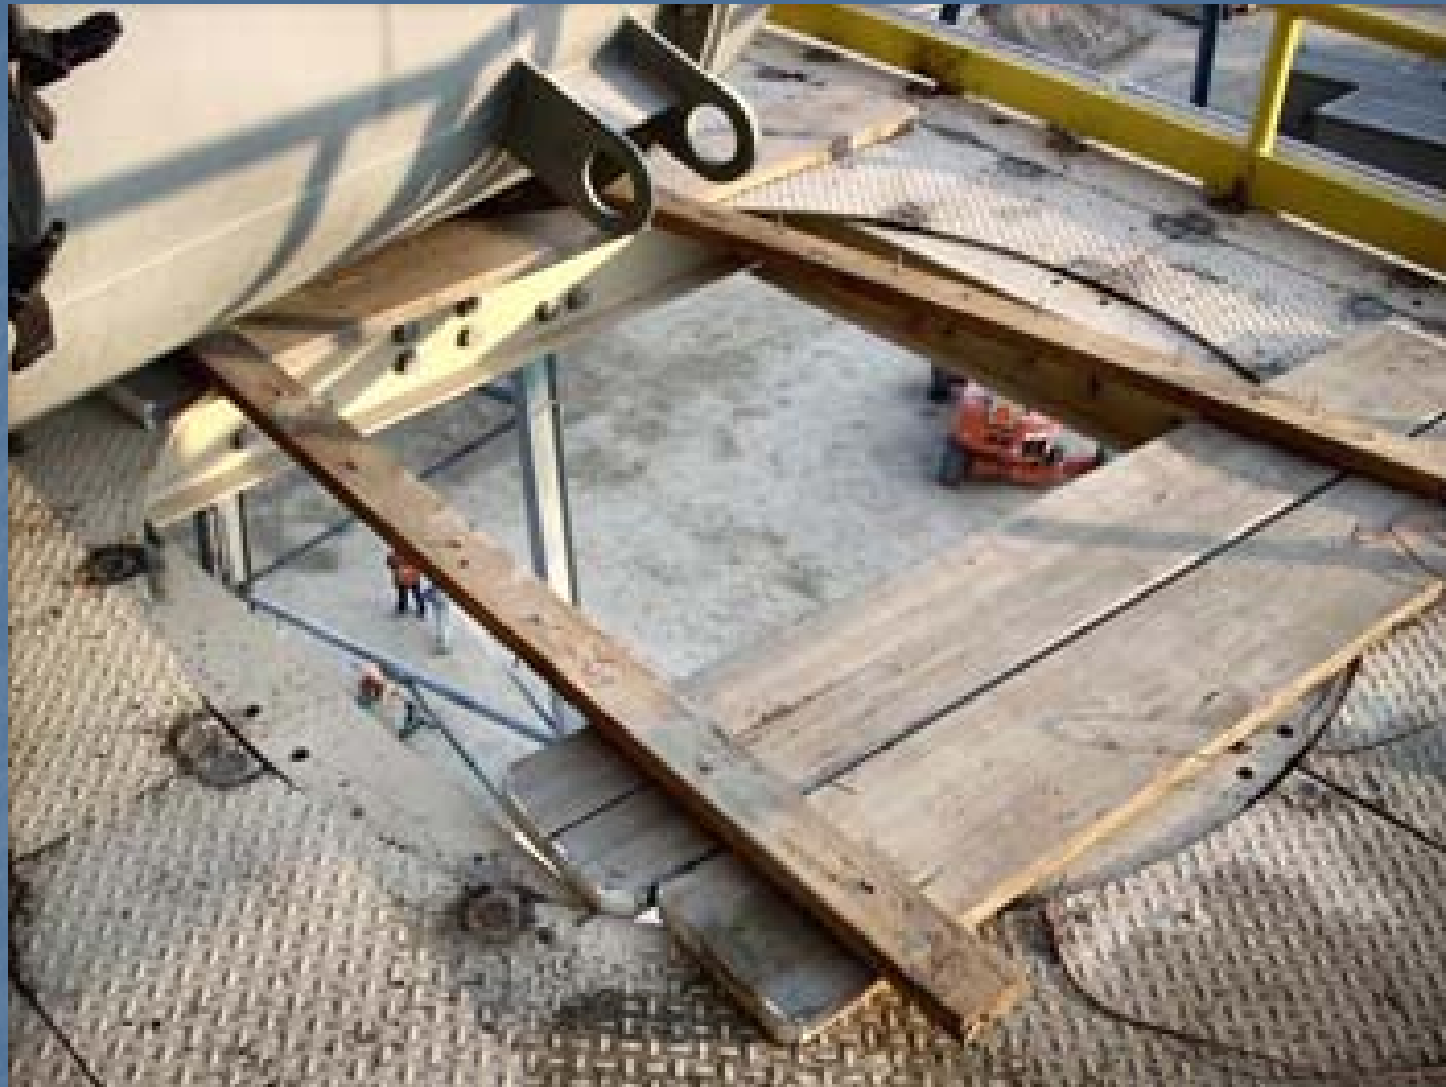
The victim was fatally injured when he stepped on wooden planking covering an opening on the coal mill tower deck. The planking gave way and he fell through the hole 57 feet to the ground below. The victim and two co-workers were attempting to line up an air receiver tank for a dust collector on the fifth level of the tower.

- Contractor management policies and procedures were inadequate and failed to ensure that persons could safely work on the deck of the fifth level of the coal mill tower. The wooden platform covering the opening was not substantially constructed and maintained in good condition.
- Contractor management policies and work procedures failed to ensure that fall protection was properly used by persons where there was a danger of falling.
- Contractor management policies and work procedures failed to ensure that persons were aware of safety hazards not immediately obvious. No barricades or warning signs were posted at the approaches to the opening on the deck.

- Ensure that floor openings are protected by railings, barriers, or covers that are properly constructed, installed securely, and maintained to control all hazards.
- Ensure that areas are barricaded or have warning signs posted at all approaches if hazards exist that are not immediately obvious.
- Examine your work places for all possible hazards and correct them before you perform work.
- Remember and use SLAM: Stop, Look, Analyze, and Manage.
